TAYLOR ENGINEERING, INC.

Twin Rivers Shoreline Stabilization Project

February 5, 2026

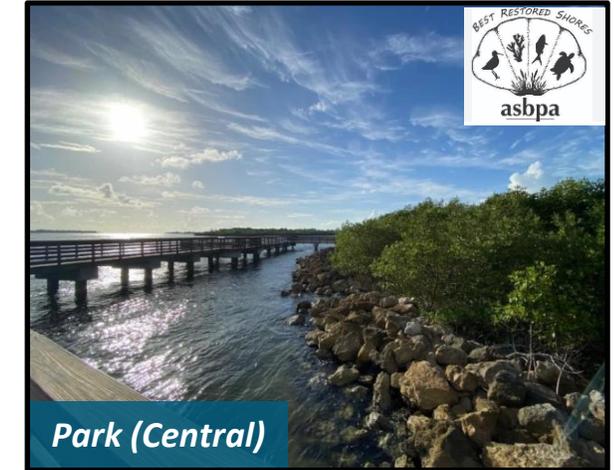
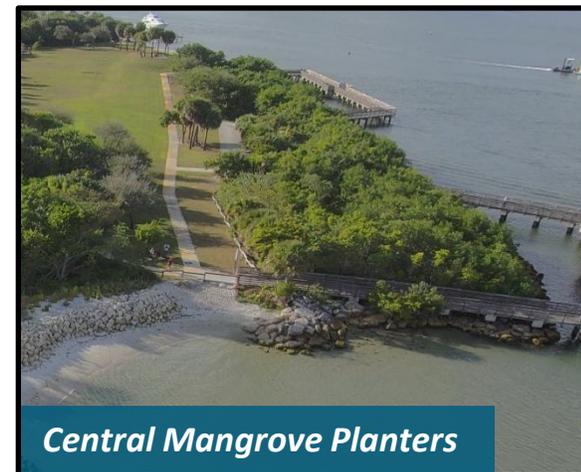
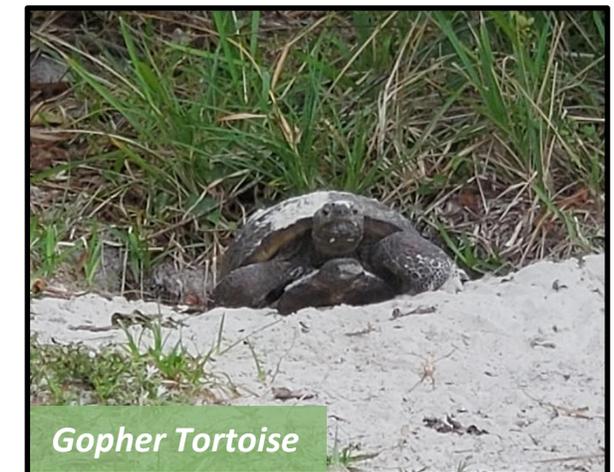
Existing Site Conditions Prior to Project

- 300 linear feet of severely eroded shoreline
 - Scarps up to 8 feet tall
- 100 feet of shoreline lost over past 25 years
- Mangrove forests align portions of the shoreline
- Dense seagrasses in the nearshore
- Primary cause of erosion
 - Extreme storm events
 - Boat wakes

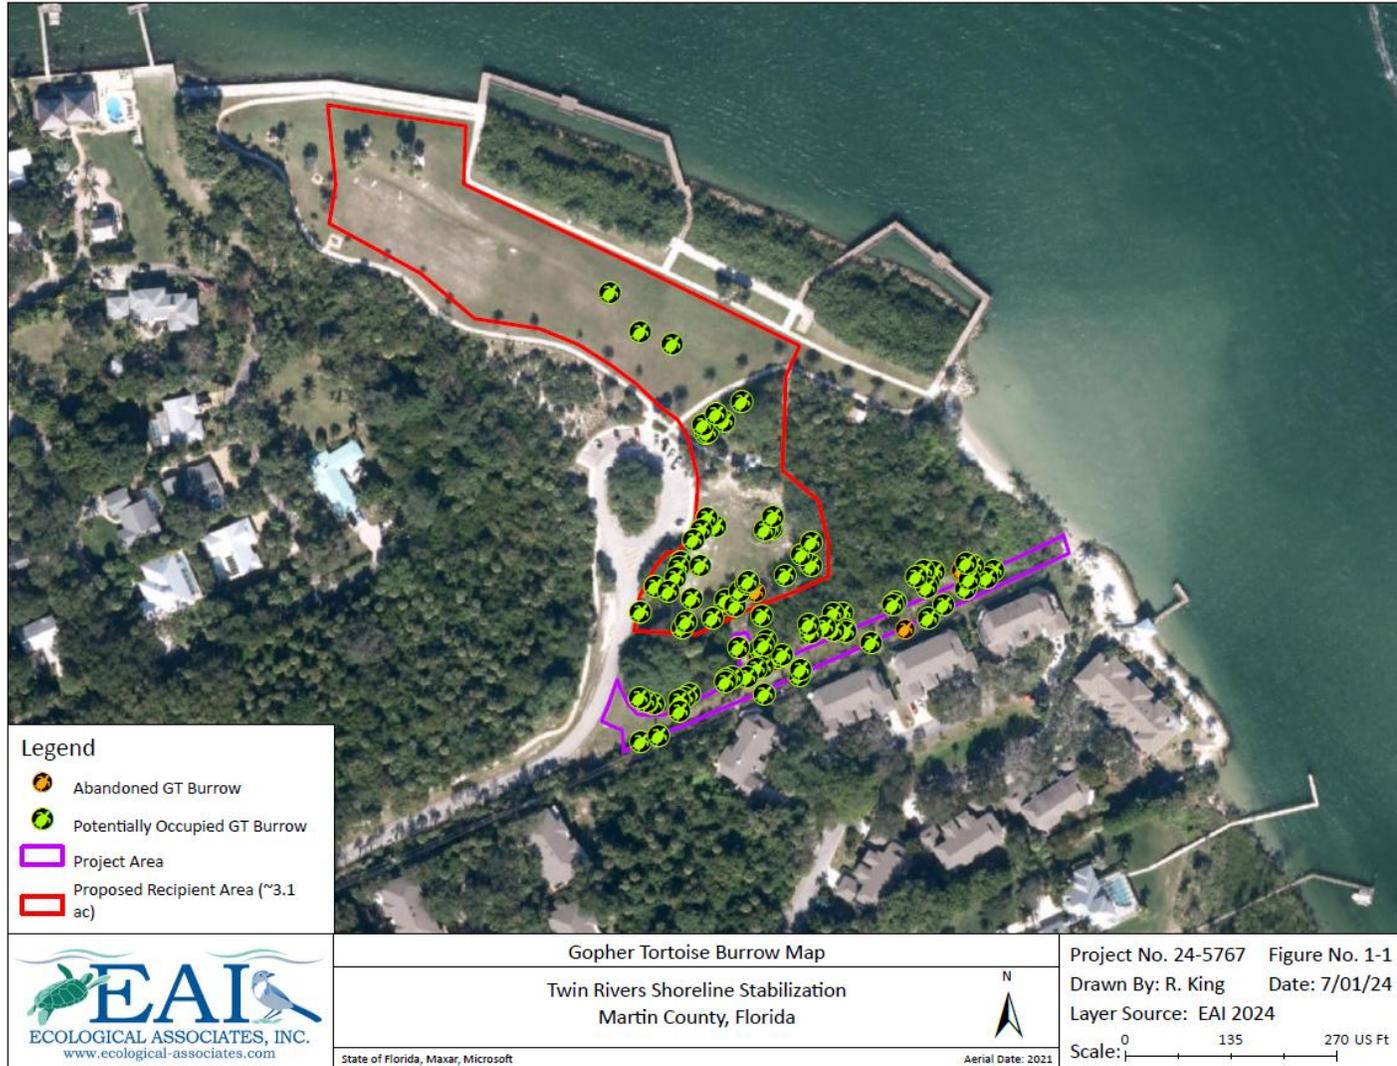
Gopher Tortoise Considerations/Relocation

- Over 70 GT burrows identified
 - 14 within corridor
- Recipient area on-site outside of construction area
- Robust exclusion measures installed
 - Double silt fences
 - Mobi-matts
 - Daily inspections

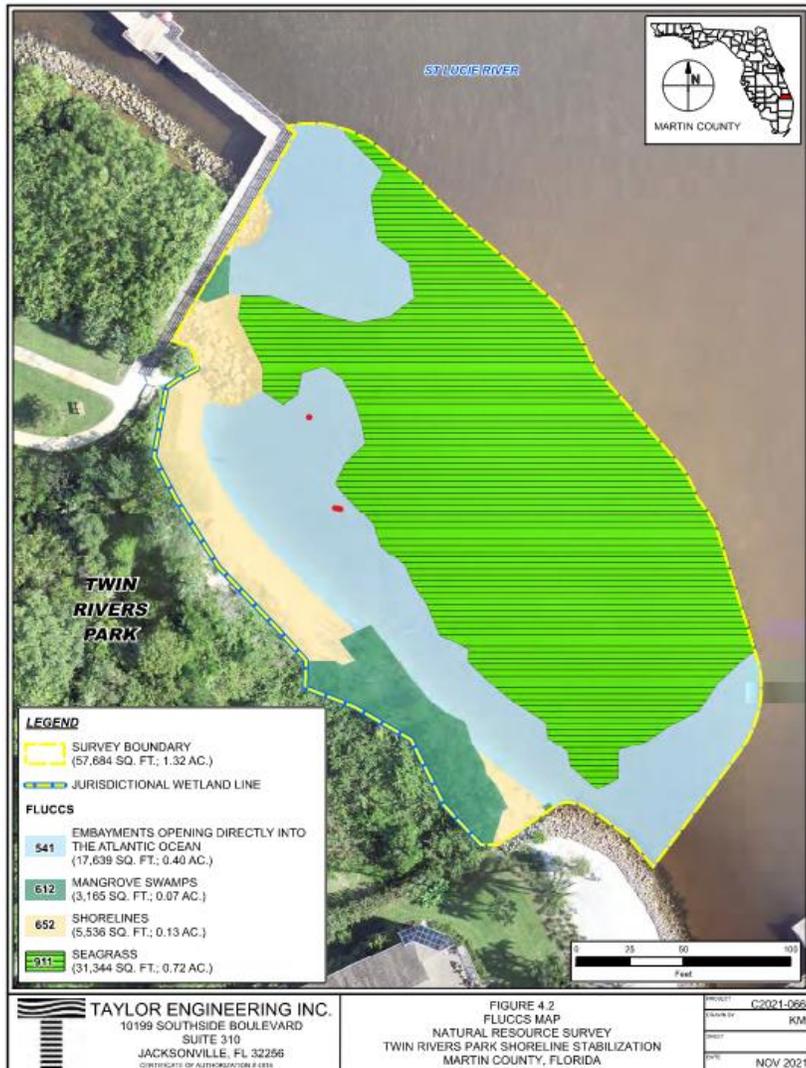
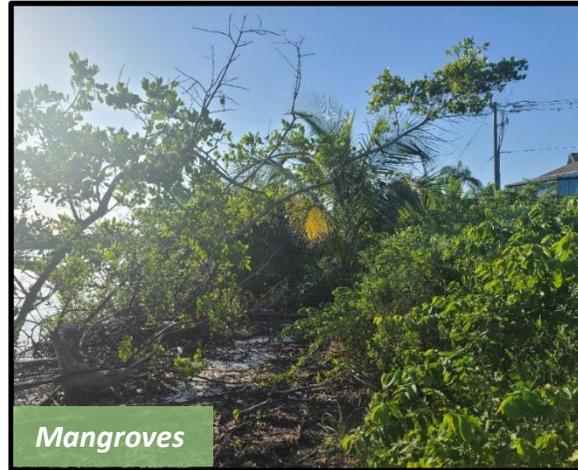
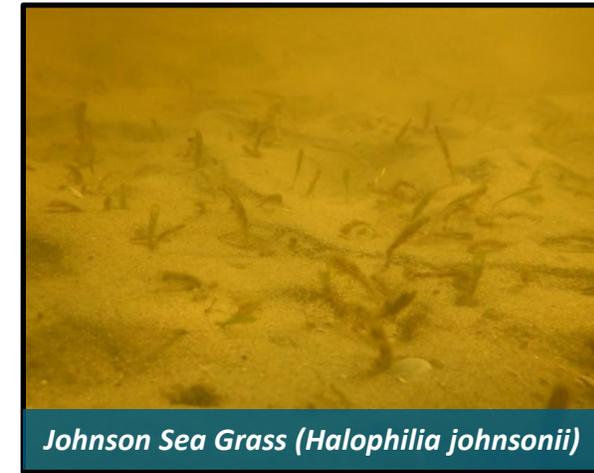
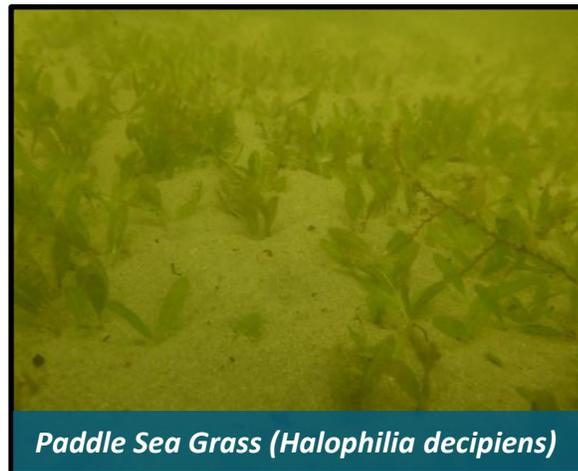
Mangrove/Sea Grass Considerations

- 0.07 AC Mangroves
- 0.21 AC Shoal Grass
- 0.47 AC Johnsons Sea Grass
- 0.04 AC Paddle Grass

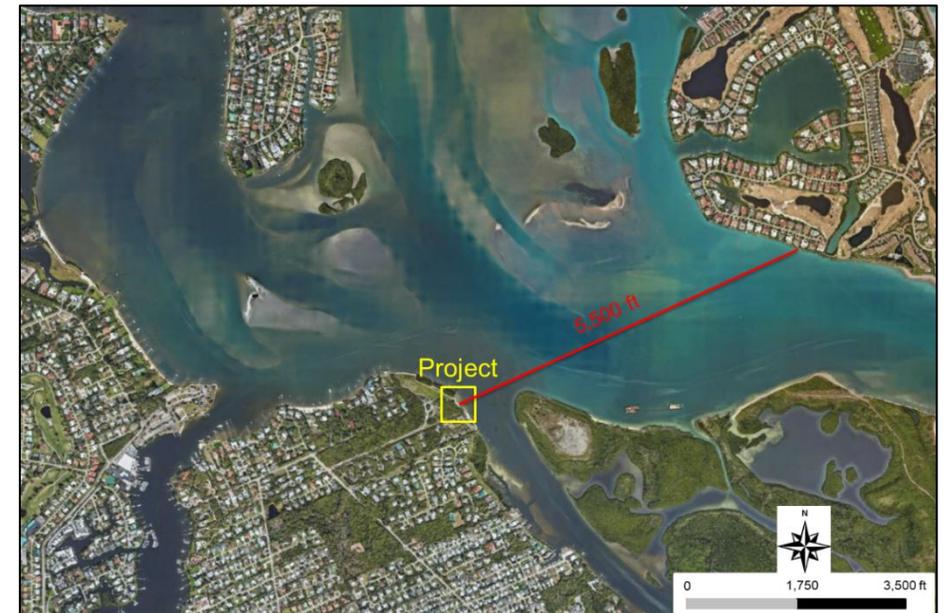
Coastal Conditions Review

- Design Storm
 - 2050 SLR
 - 25-year return period
- Significant Wave Height
 - 3.5 ft
- Peak Wave Period
 - 3.2 sec
- Stone Size
 - Limestone Armor Stone, W_{50} : 918 lbs

Period	Sea Level Rise (ft)	Source
1992 – 2020	0.47	Virginia Key, measured
2020 – 2050	0.74	IPCC MED (Key West), projected
2020 – 2060	1.01	
2020 – 2070	1.33

Annual Exceedance Probability	Return Period (yrs)	Significant Wave Height (ft)	Peak Wave Period (sec)
10%	10	2.4	2.8
4%	25	3.5	3.2
2%	50	3.9	3.4
1%	100	4.3	3.6

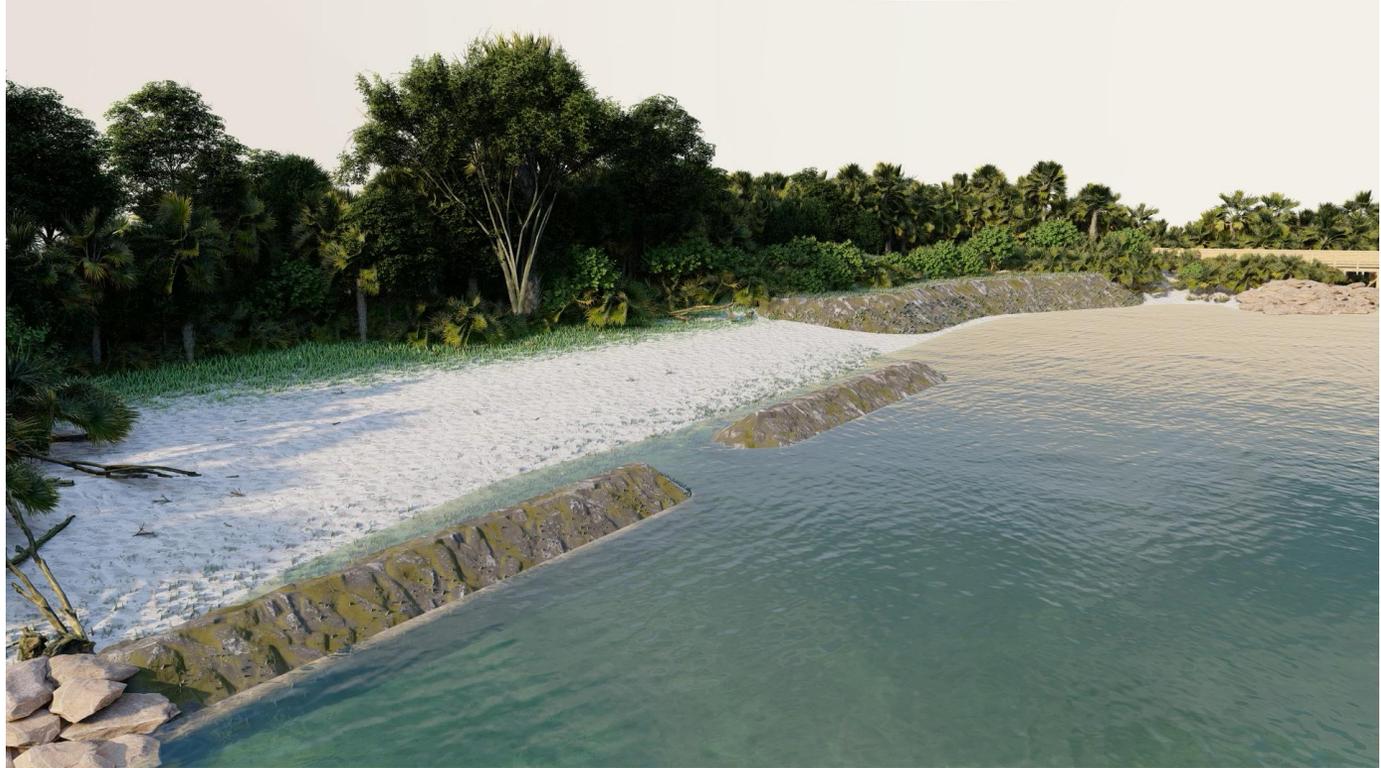
Design Criteria/Approach

- Nature-Based Approach
- Native limestone structures to enhance habitat
 - Two segmented breakwaters
 - Limestone revetment
 - Preserve shoreline access for recreational activities
- Native Plantings
 - White, Red, and Black Mangroves
 - Sea Grapes
 - Buttonwoods

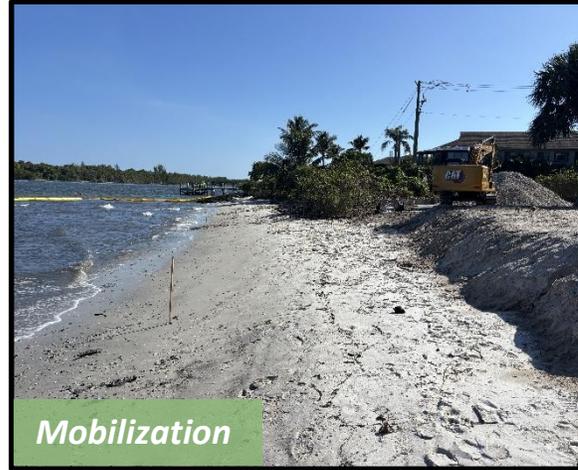
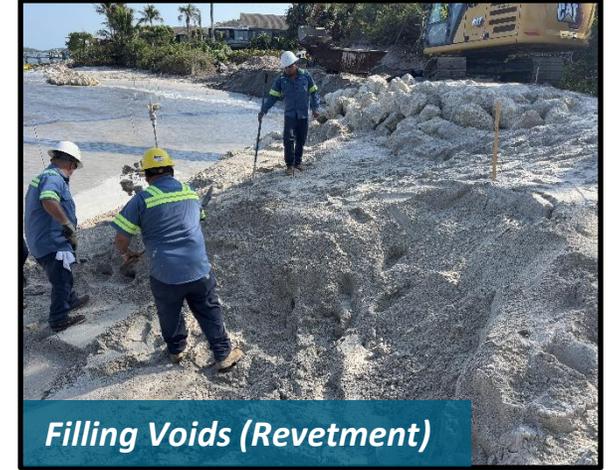
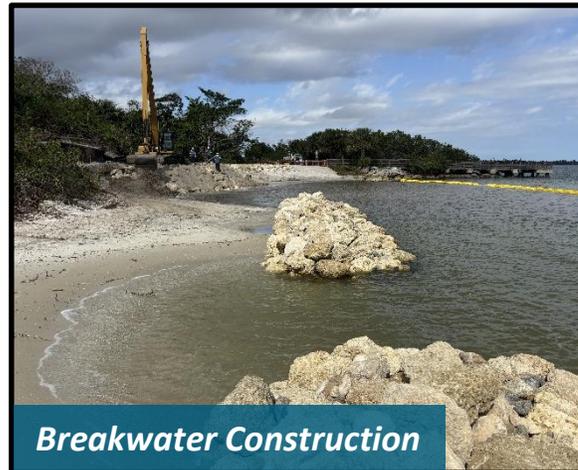
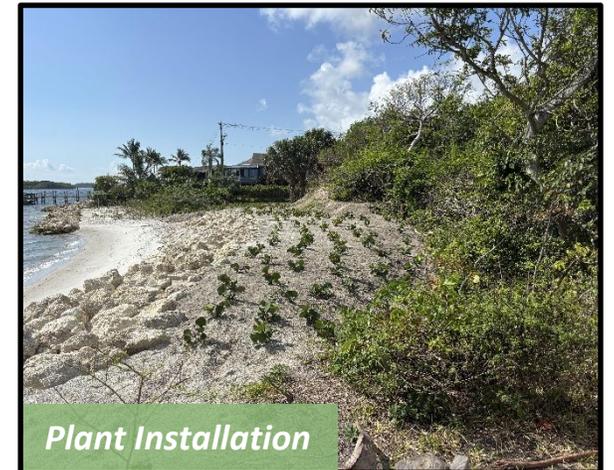
Construction Progress and Overview

- Construction Start: Nov 2024
- Completion: May 2025
- 842 tons of limestone armor
- 213 Sea Grapes
- 141 Button Woods
- Mangrove Planting
 - 40 Red
 - 53 Black
 - 37 White

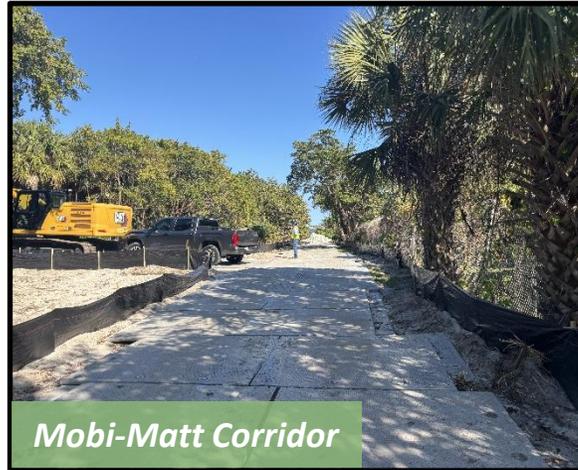
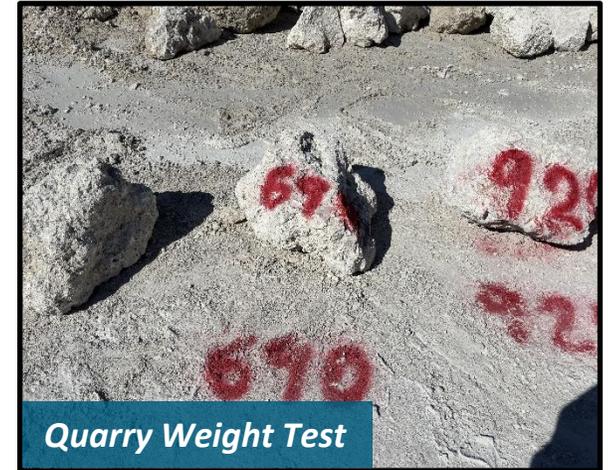
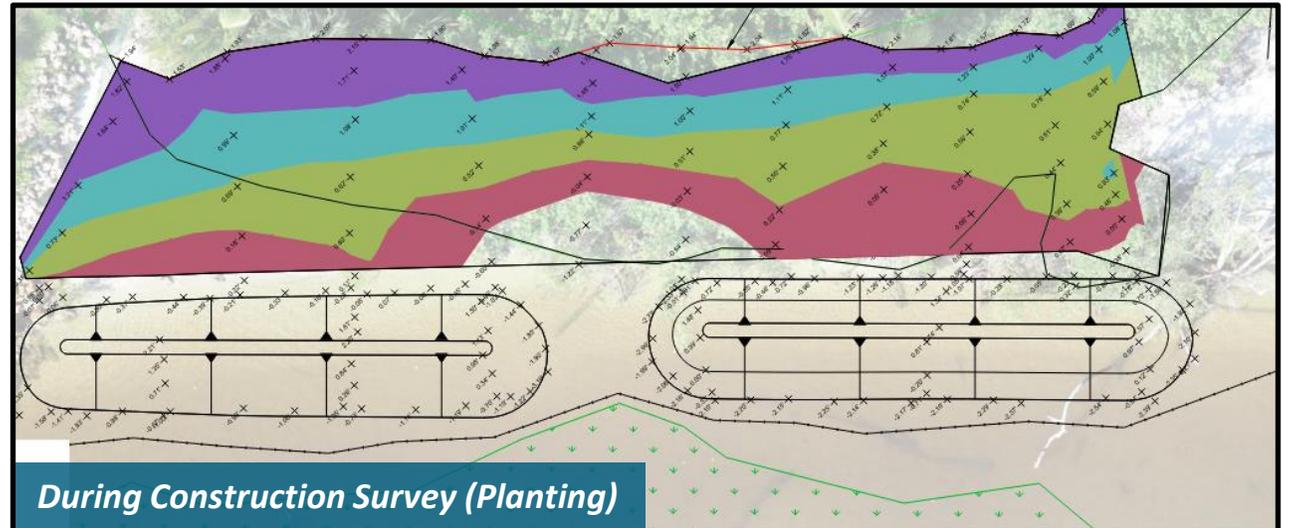
During Construction Considerations

- Gopher Tortoise Exclusion Controls
 - Double silt fence
 - Mobi-matt corridor
- Updated seagrass survey
- Quarry Site Visit/ Weight Tests
- Pre-planting survey
 - Capture shoreline behavior
 - Identify suitable planting areas
