An Overview of Pinellas County's Coastal Management Program followed by The Long Road to Stabilizing Upham Beach

An Overview of Pinellas County's Coastal Management Program

The Long Road to Stabilizing Upham Beach

Hurricane Irma Reflections

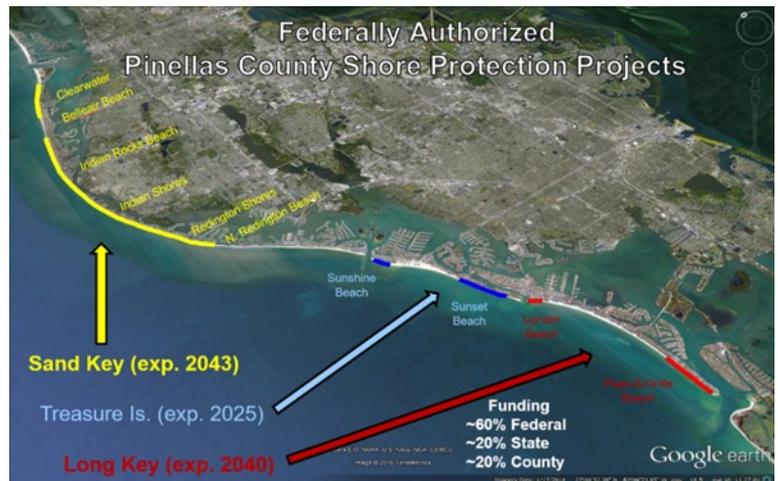
Figure 1. Pinellas County Shore Protection Projects

Pinellas County is the local sponsor for three Federal Shore Protection Projects on the barrier islands (Figure 1) of Sand Key, Treasure Island, and Long Key. The Army Corp is also authorized to nourish, as needed, the remaining portions of these three barrier islands plus the very popular tourist destination of Clearwater Beach located just north of Sand Key. In addition to the federal projects, Pinellas County has also partnered with the Florida Department of Environmental Protection and has nourished the beach at Honeymoon Island State Park and built four low profile semi-permeable rock groins. At the north end of Long Key, the County is currently building four rock groins to stabilize Upham Beach.

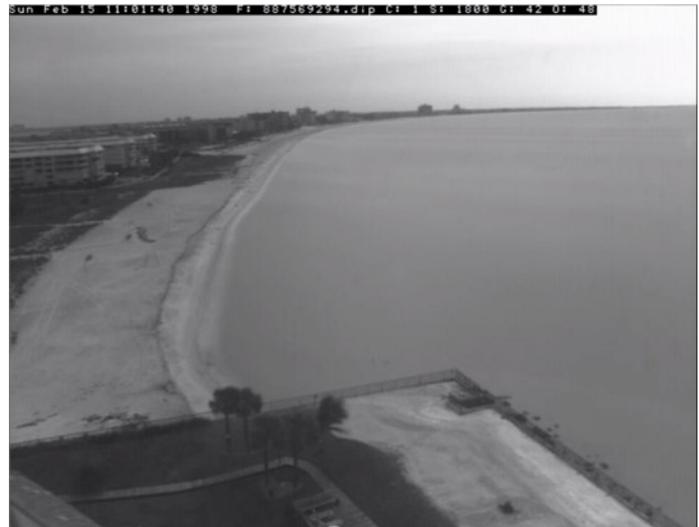
Figure 1. Time laps photo by Nicole Elko Feb 15, 1998

Pass at Upham Beach has been mitigated with seawalls and beach nourishment. The severity of the erosion is shown in Figure 1 and Figure 2. In Figure 1, the shoreline had eroded to about halfway seaward along the shore perpendicular seawall; in Figure 2, the shoreline had eroded further landward. During the 1990s and early 2000s, typical nourishments varied from 250-350 thousand cubic yards of sand placed along about 2000 feet of beach. However, the majority of placed sand commonly eroded within 2 years following nourishment.

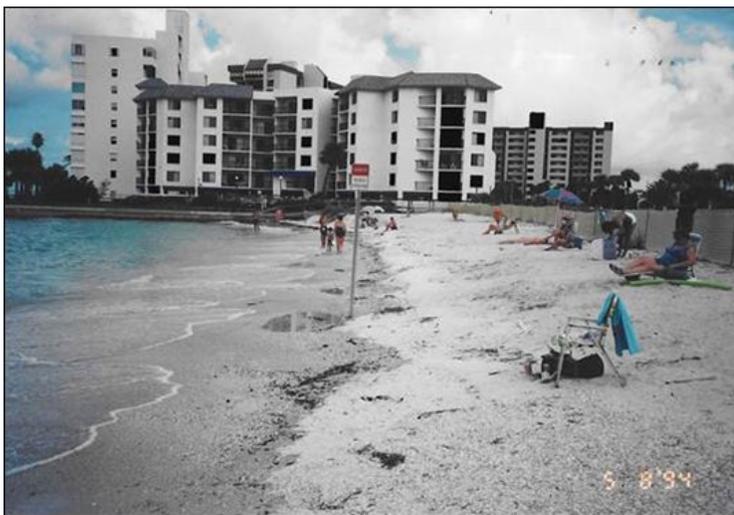
Figure 2. Photo by Douglas W. Mann, P.E., D.CE. 1994

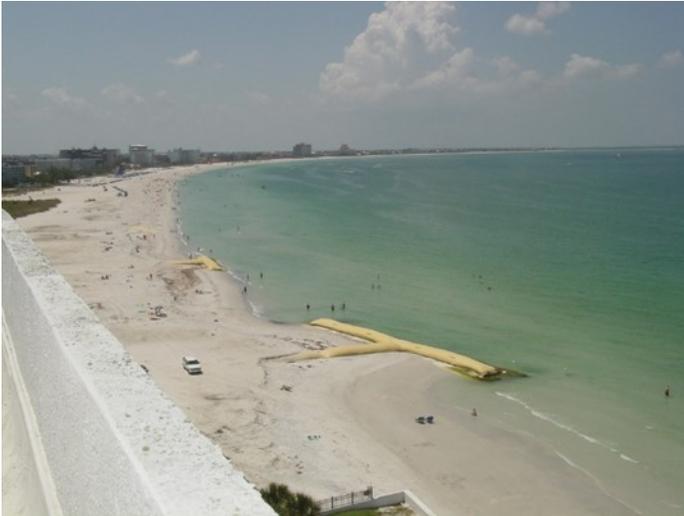
Figure 3. Photo approximately 2006 after the geotube groin construction is finished

with local residents and an application for a permit to install structures was submitted to Florida Department of Environmental Protection (FDEP) that same year. In 1997, Jim Terry (Pinellas County's Coastal Manager) expected groin installations within 12 months; ultimately, it took much longer. The first two attempts to permit a structural solution failed because FDEP was concerned about potential adverse downdrift impacts. In the end, it was the temporary solution of installing geotextile tube groins to "field test" the effects of structural stabilization on the neighboring beach that was approved (Elko, 2008). The final permit application submitted in 1999 was approved February 28, 2003. The Final Order for the FDEP Joint Coastal Permit was issued to install five temporary geotextile tube groins and place 330,000 cubic yards of sand. Two years later, the project began and was completed in 2006 (Figure 3).

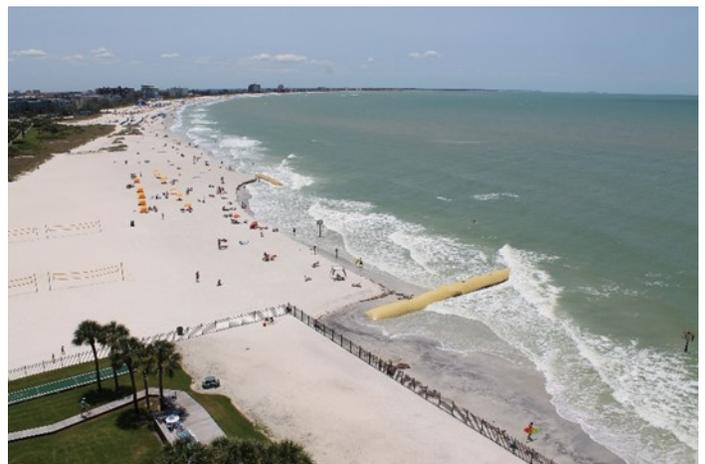
Figure 4. May 06, 2016 Post Geotextile tube removal.

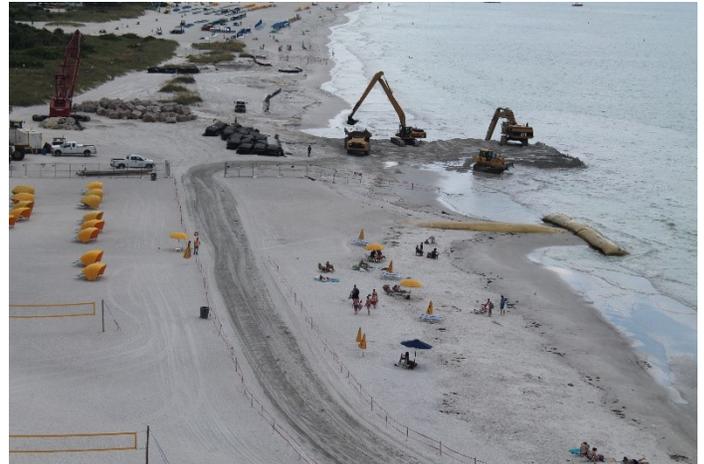
Figure 5. Progress photo August 18, 2017

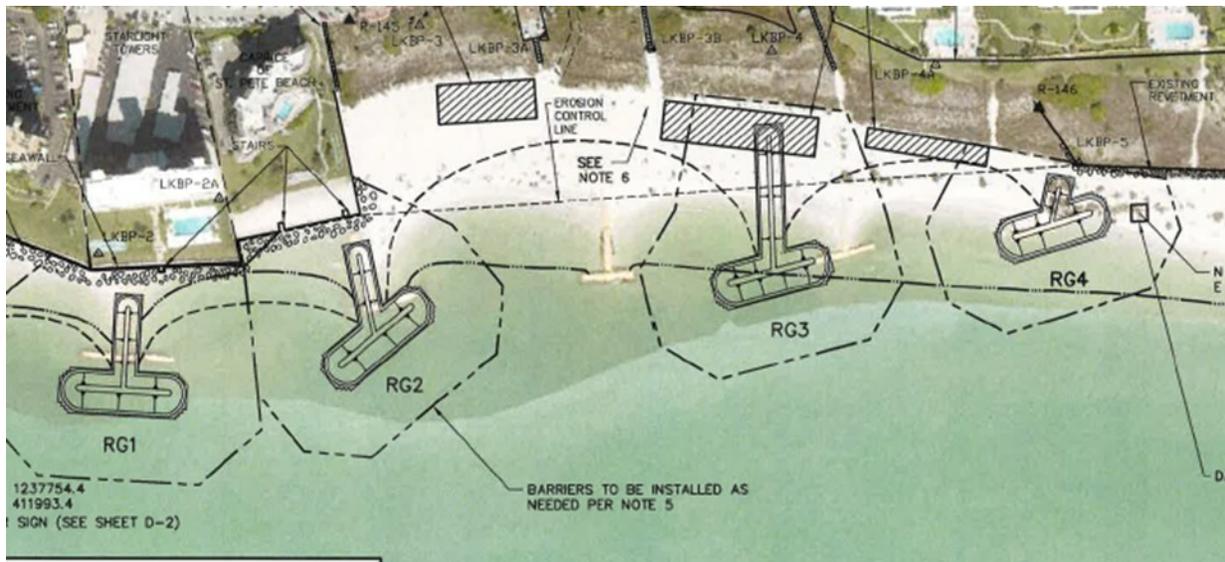
Figure 6. Rock groin configuration

In 2010, Coastal Planning & Engineering, Inc. (CPE) modeled four alternative rock groin designs with input from stakeholder meetings and lessons learned from the effects from the geotextile tube orientation. The design that was ultimately chosen included four rock structures in a slightly different configuration than the temporary geotextile tubes (Figure 6).

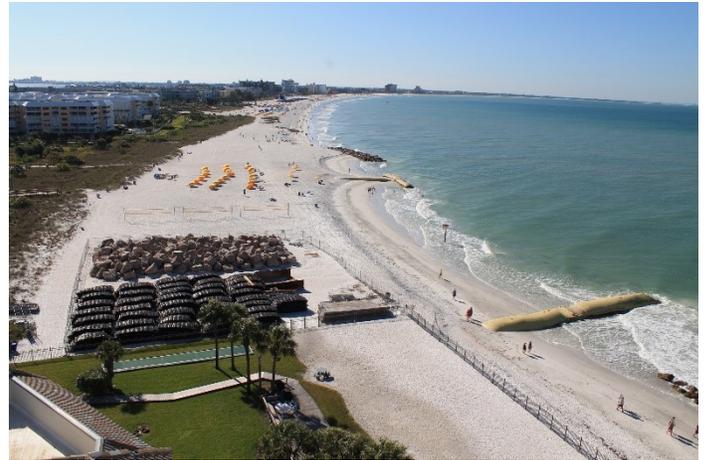
Figure 7. Southern 2 rock groins installed

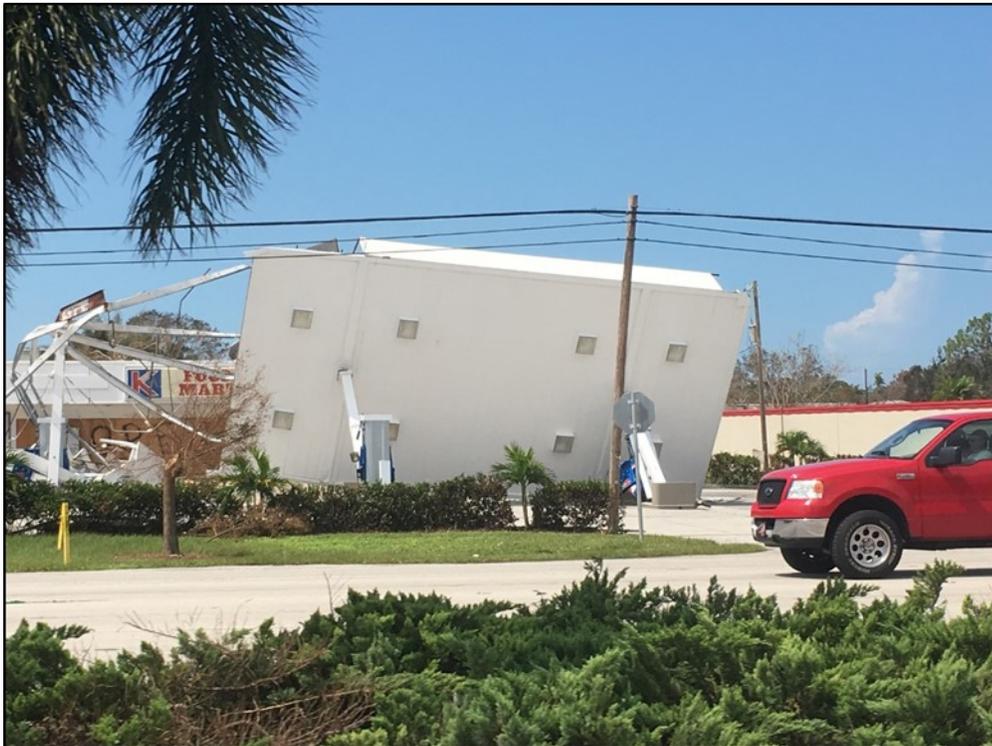
Damaged gas station in Collier County post-Hurricane Irma, September 2018

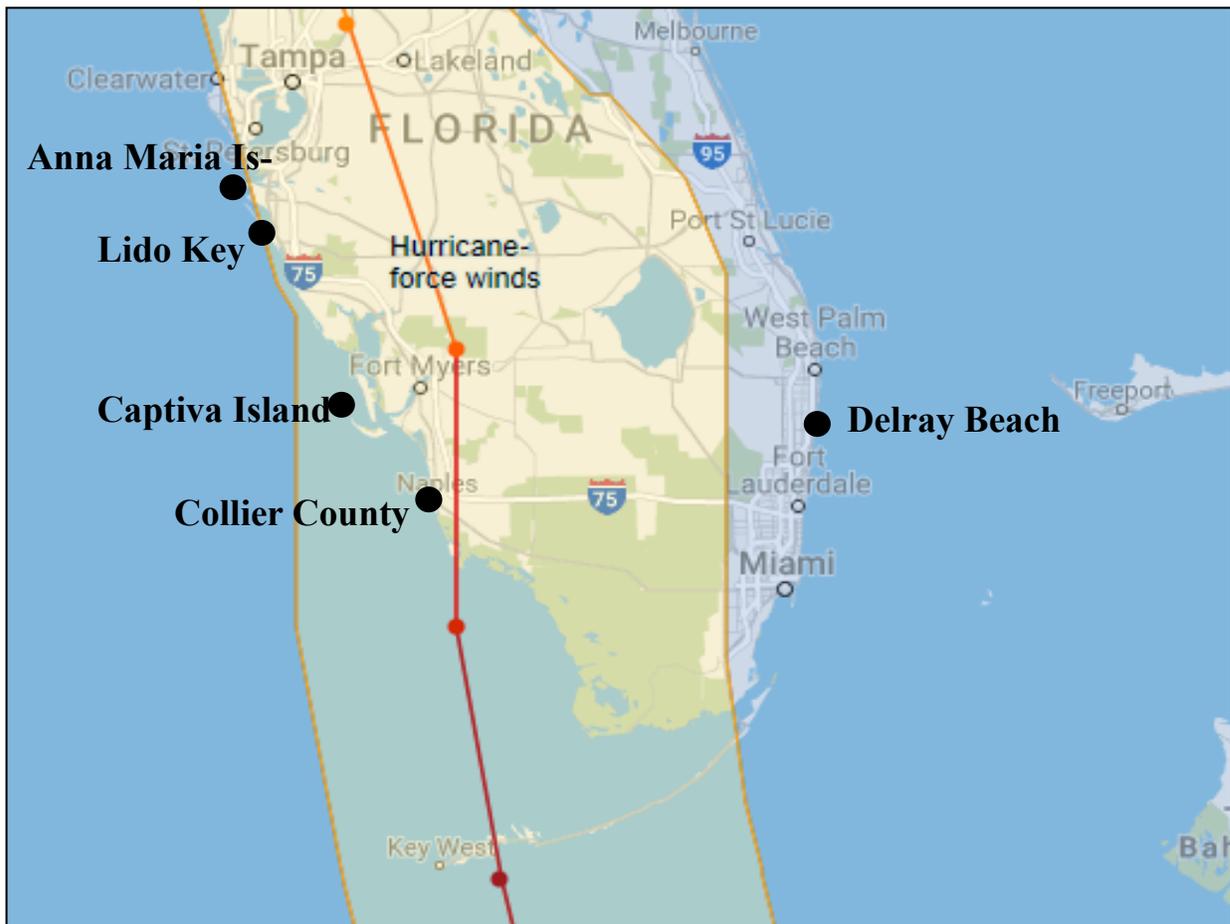
Project locations and Hurricane Irma storm track
(Source: National Weather Service; www.nytimes.com)

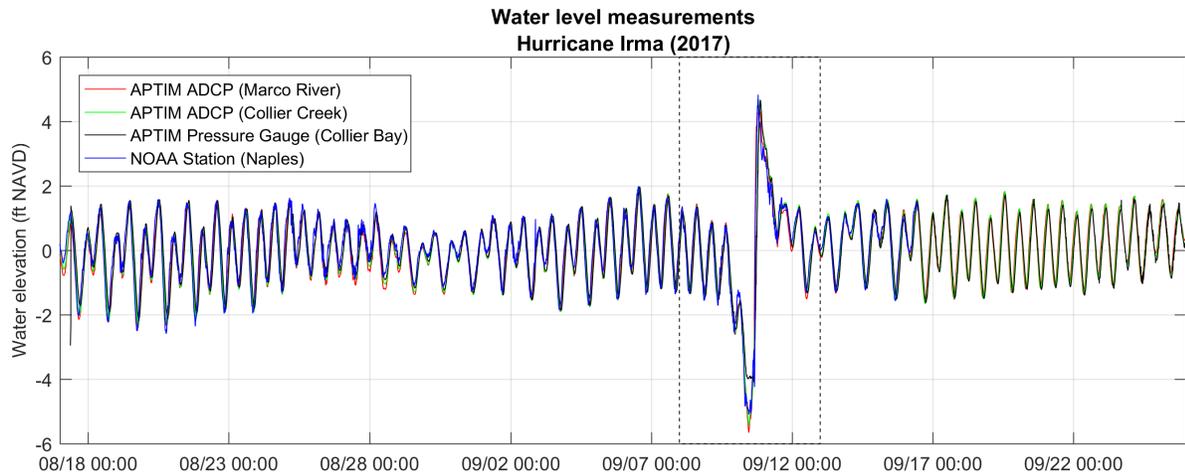
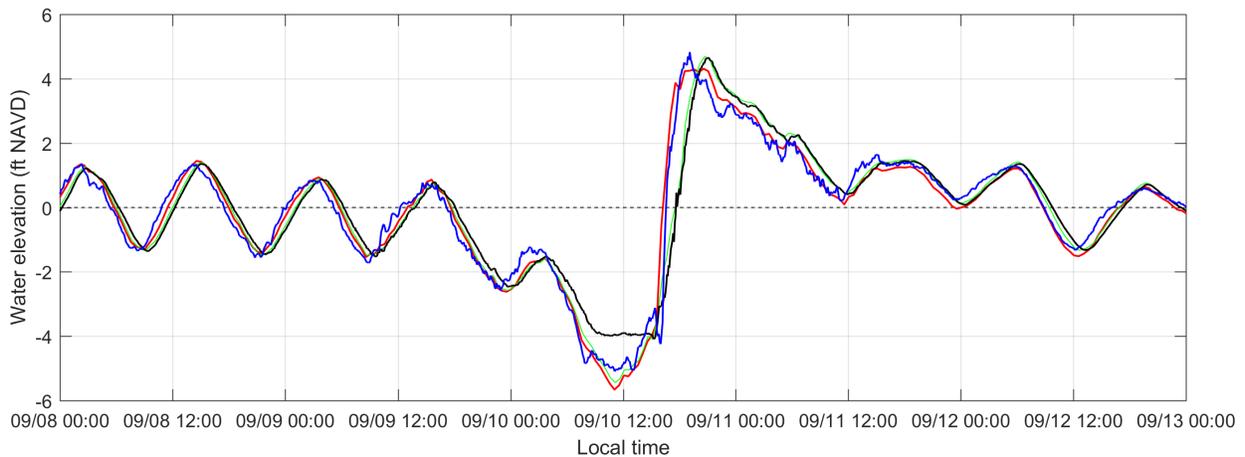
Water levels in Collier County (APTIM)

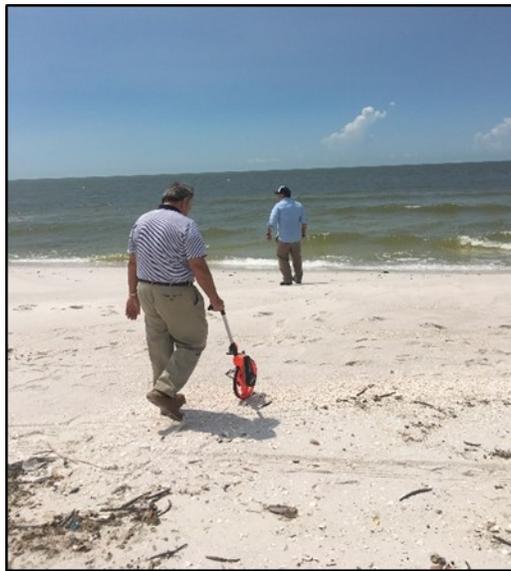
The post-storm assessment site visit was conducted on September 14th, four days after the passage of Hurricane Irma in Collier County. With a Category 3 hurricane making landfall on Marco Island, significant losses were expected. During the site visit, the beach was observed to be scoured and low with a recessed and narrow beach width, and widespread overwash evident in the dunes. Once the post-storm (full profile) surveys were available for analysis, it was determined that much of the apparent sand losses observed from the dry beach, had been deposited in the bar system landward of the depth of closure, or had been moved by alongshore currents outside the project area. The track of the hurricane created moderate wave heights in Collier County (just under 5 feet at APTIM's Marco River gauge) and a tidal rise of over 8 feet within 3 hours based on two local tidal gauges (NOAA at Naples Pier and APTIM at Marco River). These conditions caused overwash and significant berm and dune erosion, but the lack of prolonged wave action led to relatively weak cross-shore and offshore forces. The resulting deposition of eroded material within the submerged portion of the active profile was not observed by visual observations during the initial post-storm assessment but was identified in the later beach profile surveys.

Post-storm assessments of Collier County's beaches

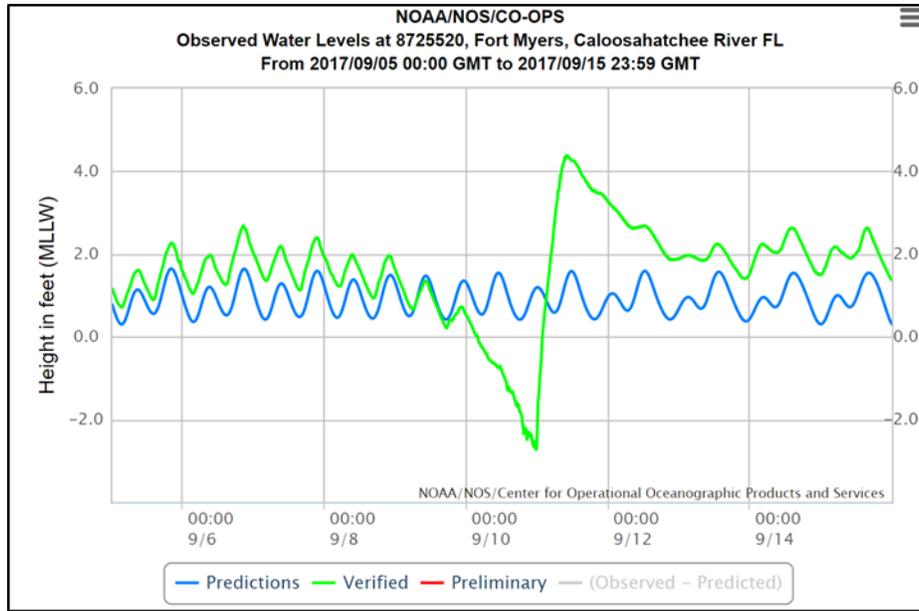
Water levels at Fort Myers, FL between September 5 – September 15, 2017

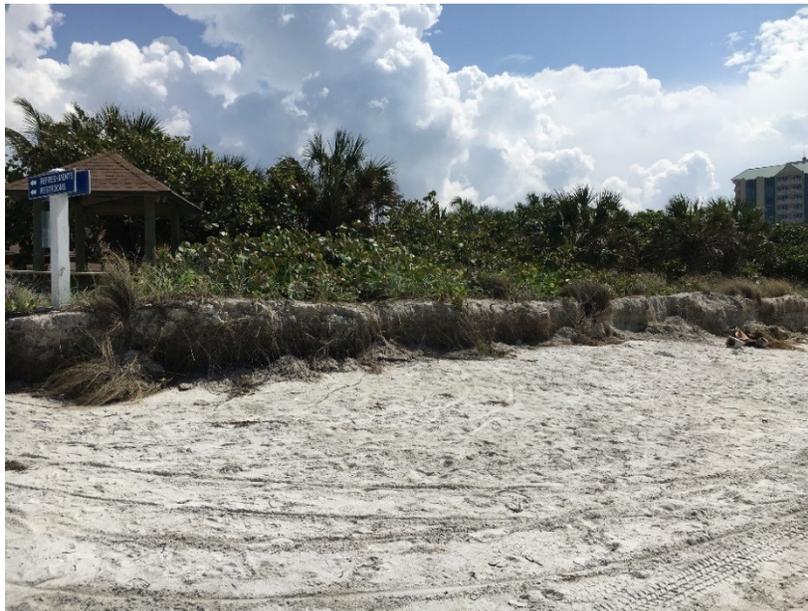
Similar to water levels observed in the other west coast projects, Lido Key experienced a draw down during the day before the storm and a rapid increase in water level of about 5 feet as the storm passed (water levels at Port Manatee, FL, <http://tidesandcurrents.noaa.gov>, NOAA, 2017). As a result of the storm, Lido Key sustained impacts to the beach and dunes resulting in a measured volumetric loss of approximately 37,000 cy. Infilling of the nearshore trough occurred in some areas, and in others, the nearshore bar was lowered and shifted further offshore. The beach was in a relatively low and narrow state prior to the storm, which may have contributed to the conditions that allowed water levels and wave impacts to reach the dunes.

Dune damages observed post-storm

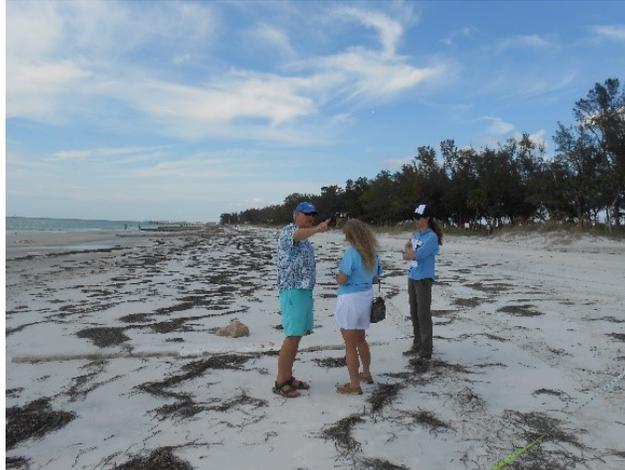
The Coquina Beach project area, located south of the Central Beach project, and adjacent to Longboat Pass, was inundated with high water levels as evidenced by distribution of wrack on the upper berm. The project area lost approximately 47,000 cy due to the storm. Generally, losses occurred on the seaward portion of the beach, while the dunes only sustained isolated impacts.

Post-storm assessment of Coquina Beach

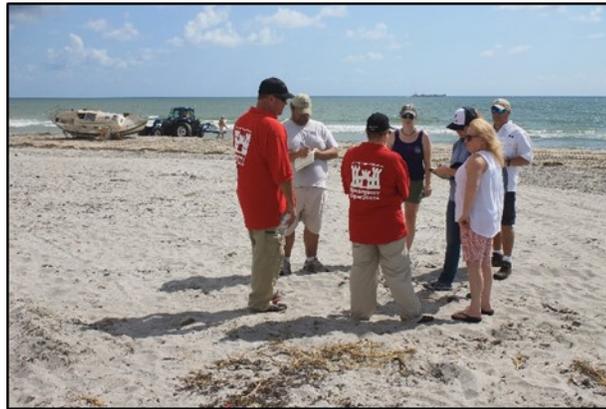
Immediately post-storm, visual observations were made and coordination with project sponsors began. A joint beach assessment was conducted by the City of Delray Beach, Palm Beach County, FDEP, USACE and APTIM on September 16th. Post-storm, the beach was in a deflated condition and had lost substantial beach width based on pre-storm and post-storm observations. The high water mark indicated that the beach was overtopped, but was high and wide enough to prevent loss of dunes or damage to upland development.

Post-storm assessment of Delray Beach

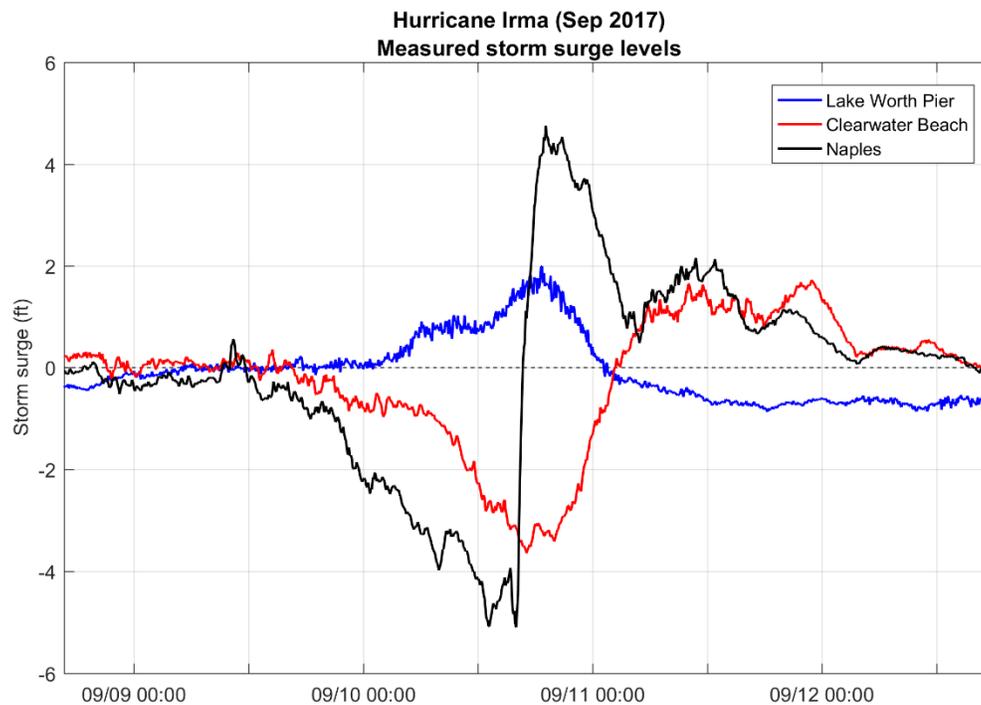
Measured storm surge levels

- In a broad sense across southwest Florida, storm surge level and wave height were those of a fairly low return interval storm (common), while other parameters such as currents and tidal fluctuations were a much higher return interval storm (rare).

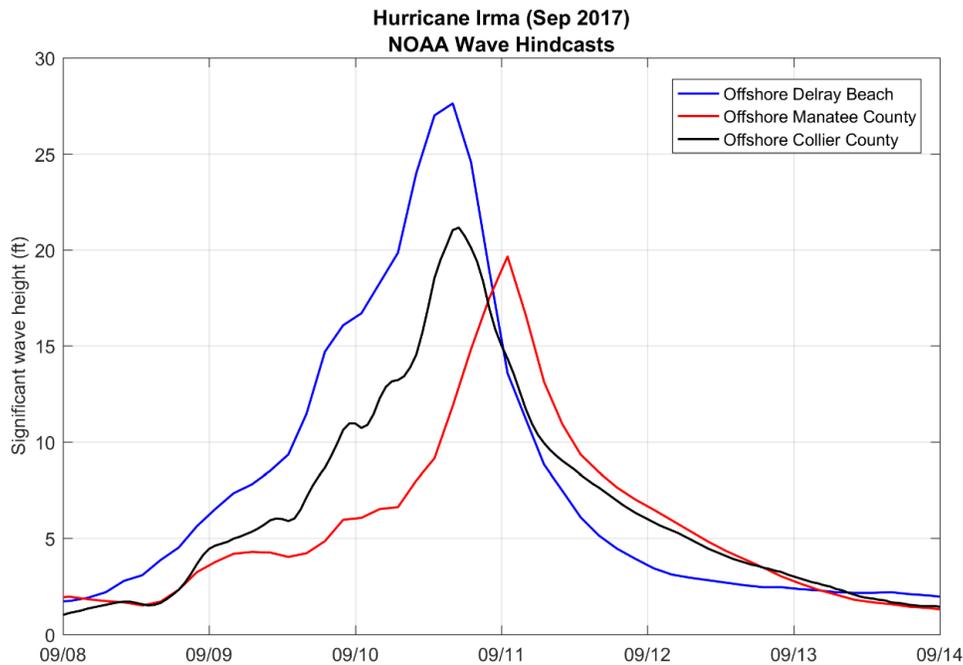
Significant wave heights

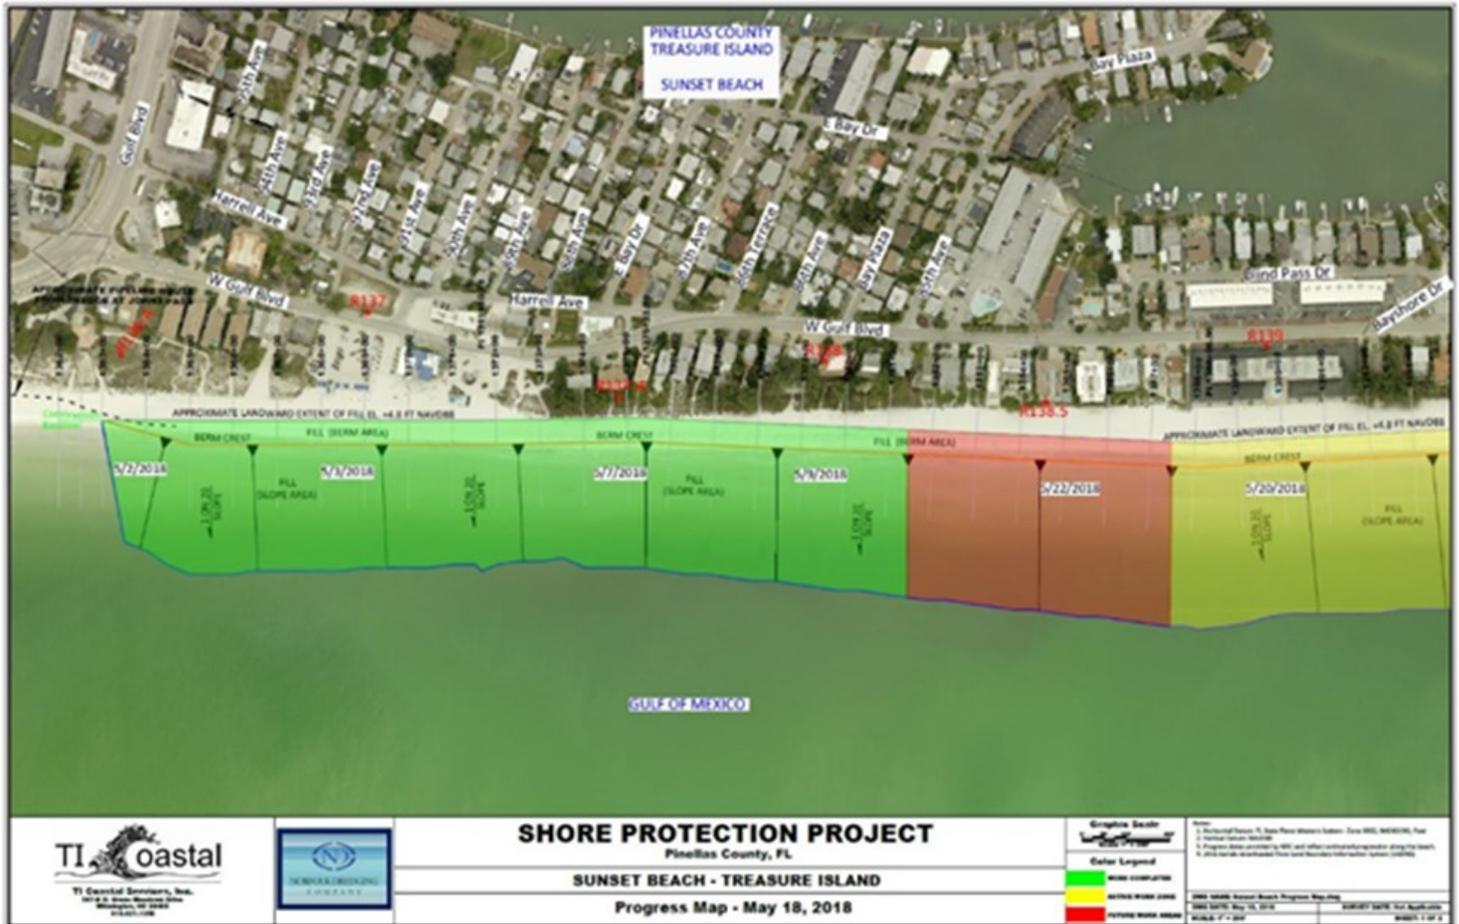
The Pinellas County Shore Protection Project consists of 21.8 miles of shoreline along the west coast of Florida. There are three authorized segments (Sand Key, Treasure Island, and Long Key) that are maintained by the federal government in a cost share agreement with Pinellas County. Sand Key is the northern most segment of the project and consists of 14.2 miles of beach. Treasure Island is the oldest segment of the Pinellas County Shore Protection Project and has been renourished a total of 11 times since its authorization in 1966. Treasure Island is 3.5 miles long and is the shortest segment. Long Key is the southernmost segment and consists of 4.1 miles of shoreline.

The contract for the 2018 Pinellas County Beach Renourishment was awarded on 27 September 2017 to Norfolk Dredging Company for \$36,569,582.00. Norfolk will renourish critically eroded shoreline in Pinellas County using dredge material from Egmont Shoals and Johns Pass.

The work was divided into a base and four options and the award included Options A and B. Norfolk is expected to place a total of approximately 1,000,000 cubic yards of beach-quality material on Sand Key and approximately 63,000 cubic yards of material on Treasure Island at Sunshine Beach.

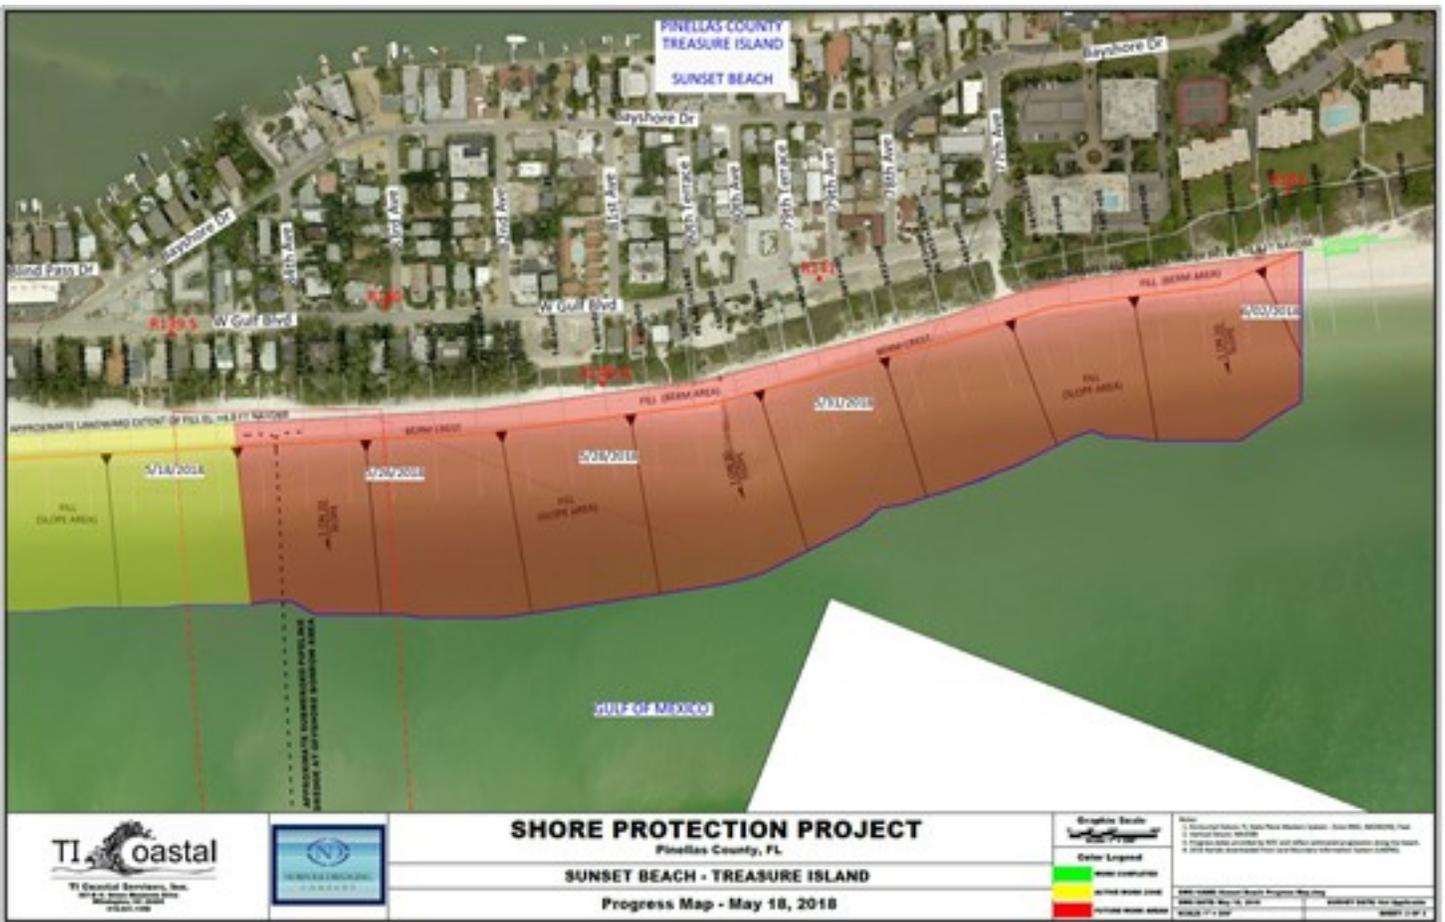
Construction of 2018 Renourishment commenced in April 2018 and is expected to continue until October 2018. The latest released progress map (Figure 1 below) shows the extent of the work completed on Treasure Island on 18 May. Construction on Treasure Island is expected to be completed in early June. Afterwards, the contractor will shift their focus to Sand Key for the remainder of the project.
