# DRONE TECHNOLOGY AND RUBBLE MOUND STRUCTURES

## ST. LUCIE INLET SOUTH JETTY CASE STUDY

Presented By: Andrew Wycklendt, P.E.

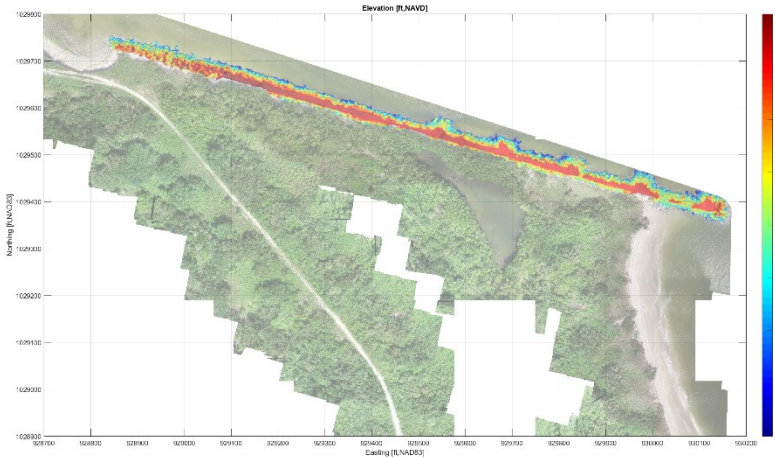
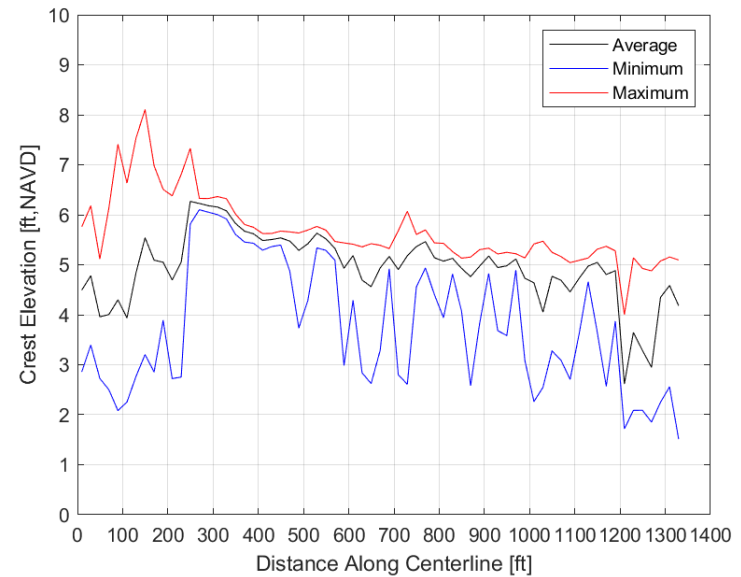
# JETTY CREST ELEVATION

› Minimum, maximum, and average crest elevations were calculated for each 20-foot segment along the jetty.

Face	Min	Max	Avg
Crest	1.5	8.1	4.9

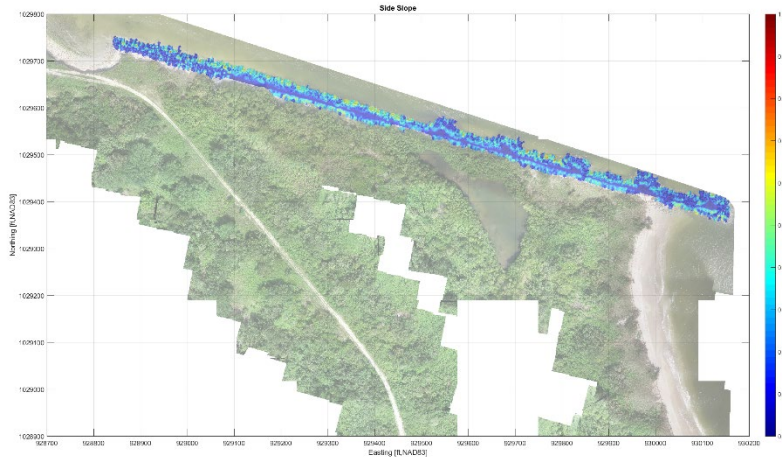
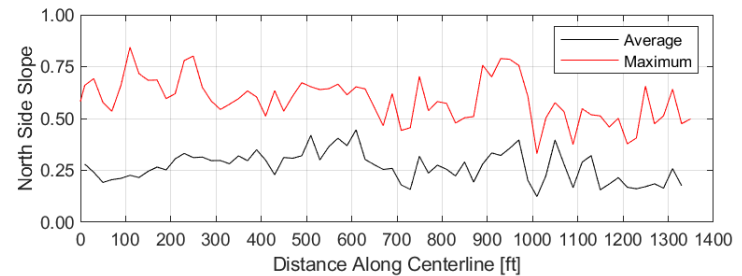
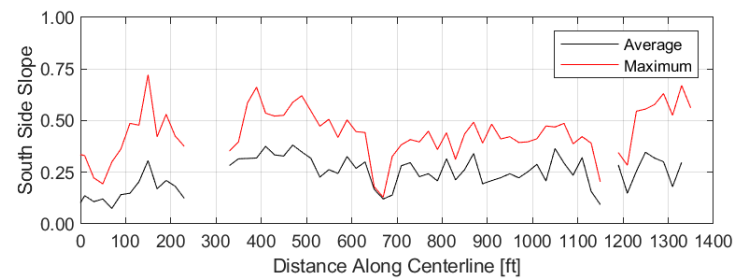
# JETTY SIDE SLOPES

Face	Min	Max	Avg
North	1V:3.0H	1V:1.2H	1V:3.7H
South	1V:7.7H	1V:1.4H	1V:4.1H

› Average and maximum side slopes were calculated for each 20-foot segment along the north and south jetty faces.

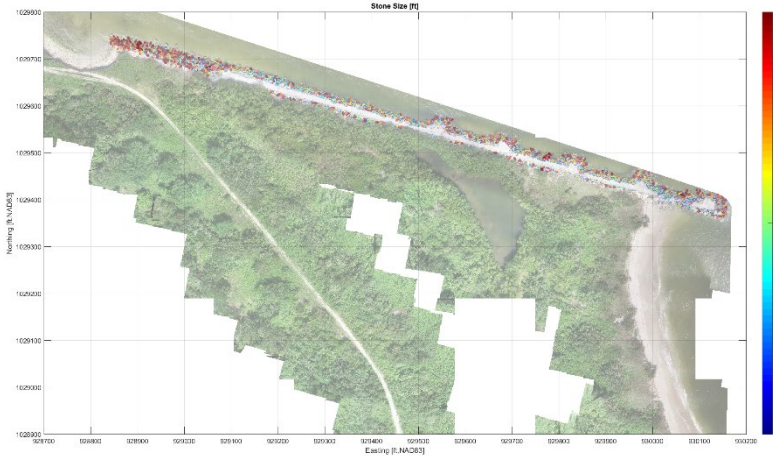
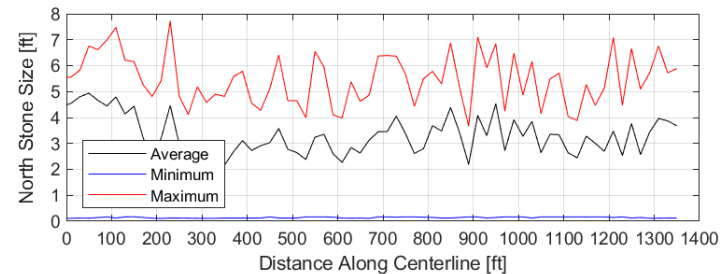
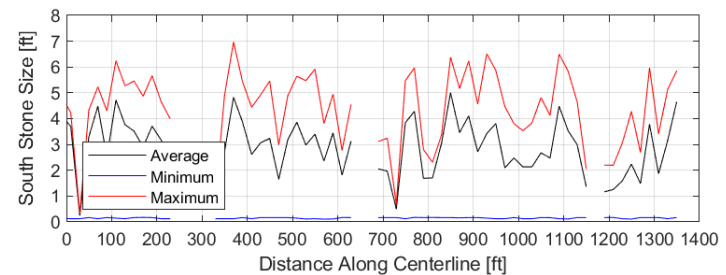
# JETTY STONE SIZES

Face	Min	Max	Avg
North	1.8	4.8	3.1
South	0.5	6.1	2.9

- Minimum, maximum, and average stone sizes were calculated for each 20-foot segment along the north and south jetty faces.

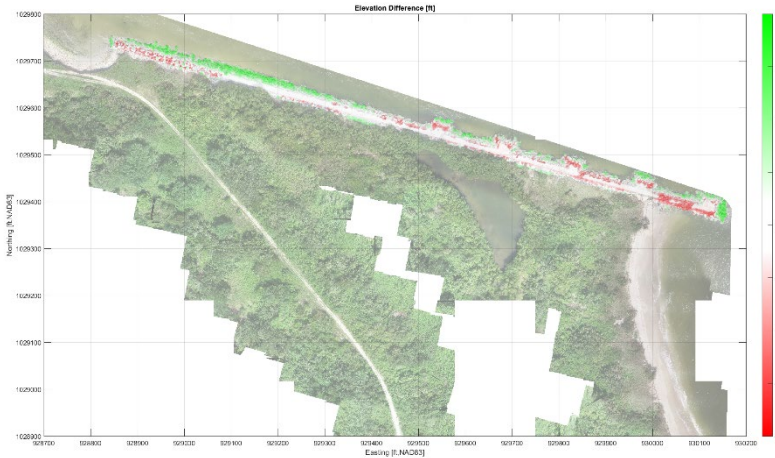
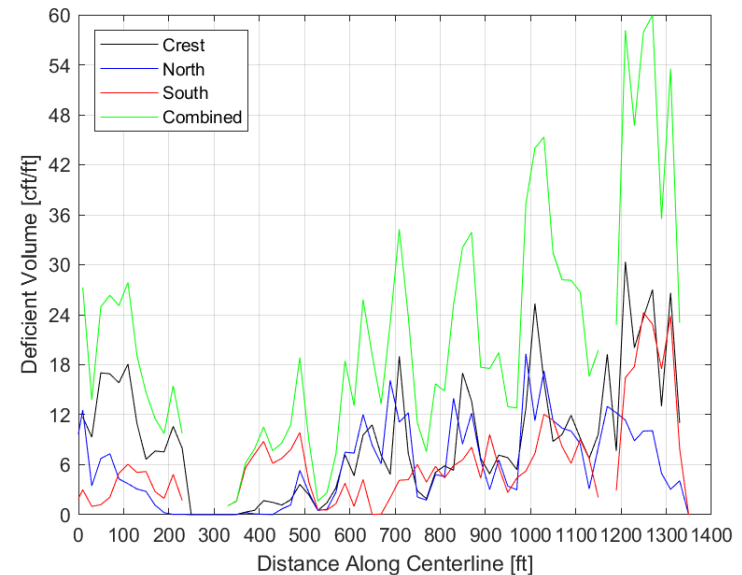
# JETTY VOLUME COMPARISONS

› Volumetric requirements were calculated for each 20-foot segment along the jetty.

Face	Volume (cft)	Weight (tons)
Crest	12,450	1,030
North	7,940	650
South	8,480	700
<b>Total</b>	<b>28,870</b>	<b>2,380</b>
