# Vibrations & Excitations

## ...what The Beach Boys didn't tell you

Florida Shore & Beach Preservation Association

Palm Beach County

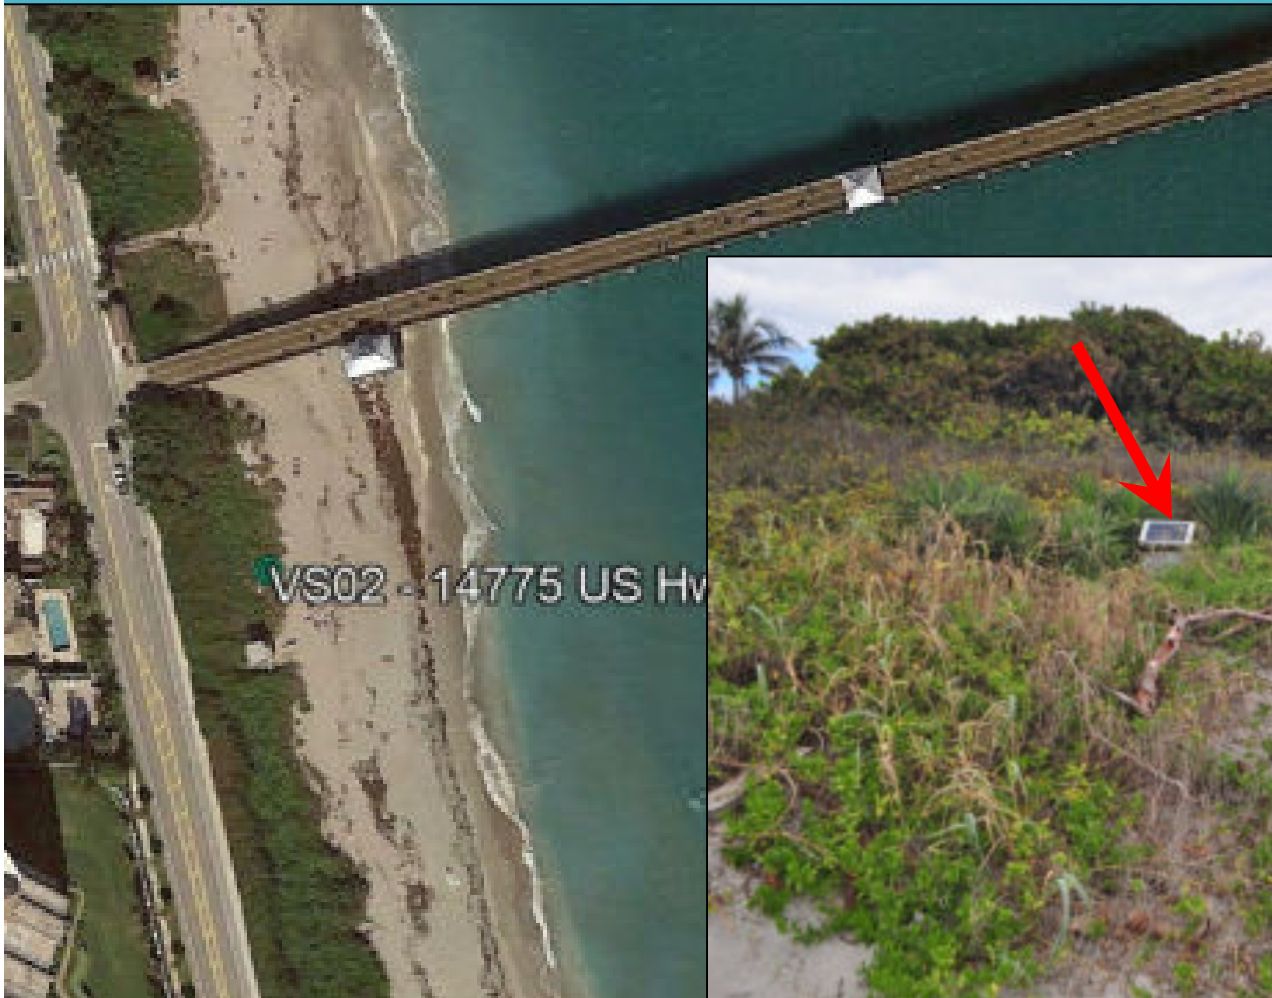
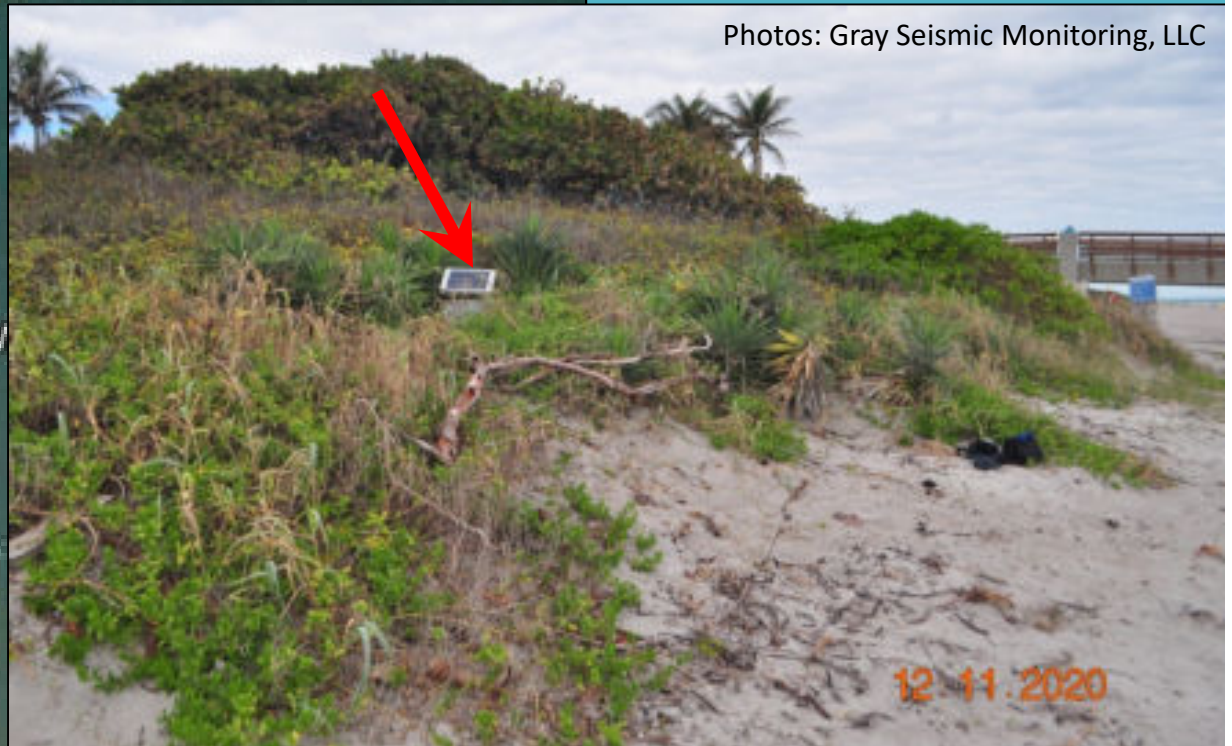
- **Beach Nourishments**

*NCCSPP Segment I (2021/22)*

*NCCSPP Segment III (2020/21)*

Photos: Gray Seismic Monitoring, LLC

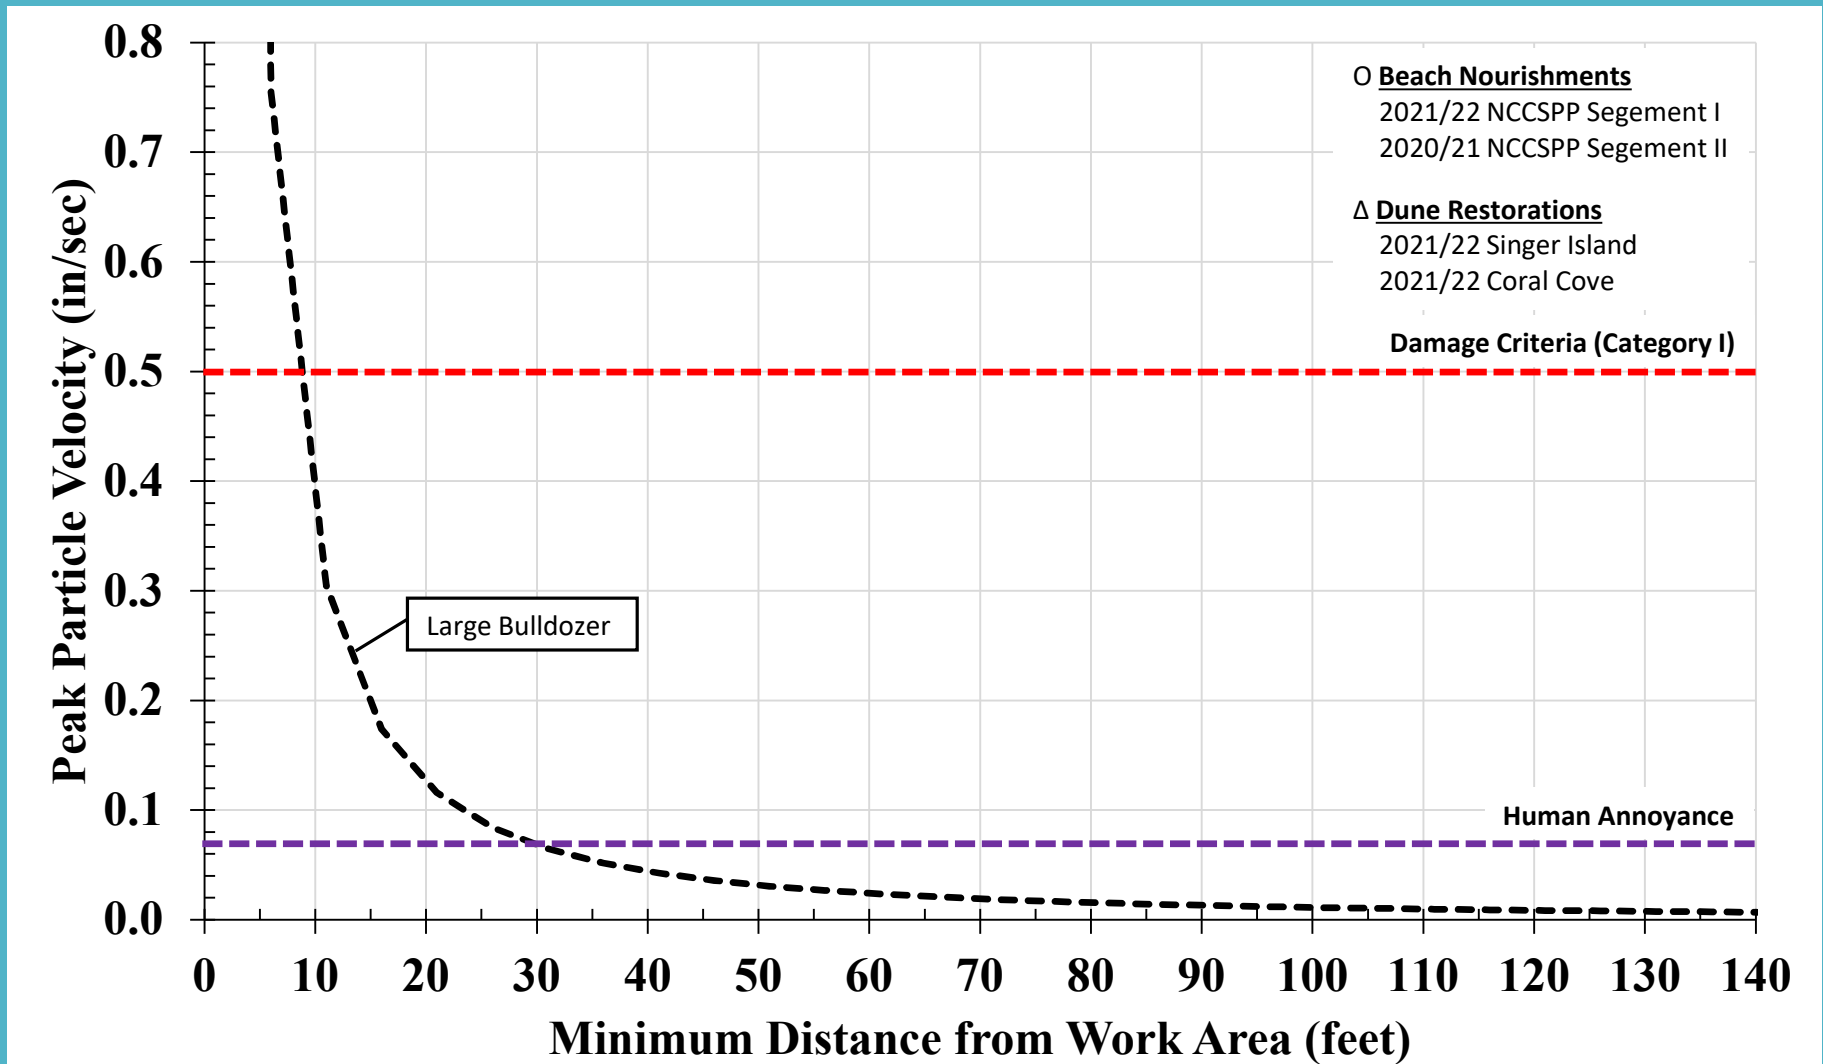
- **PBC County Vibration Monitoring**

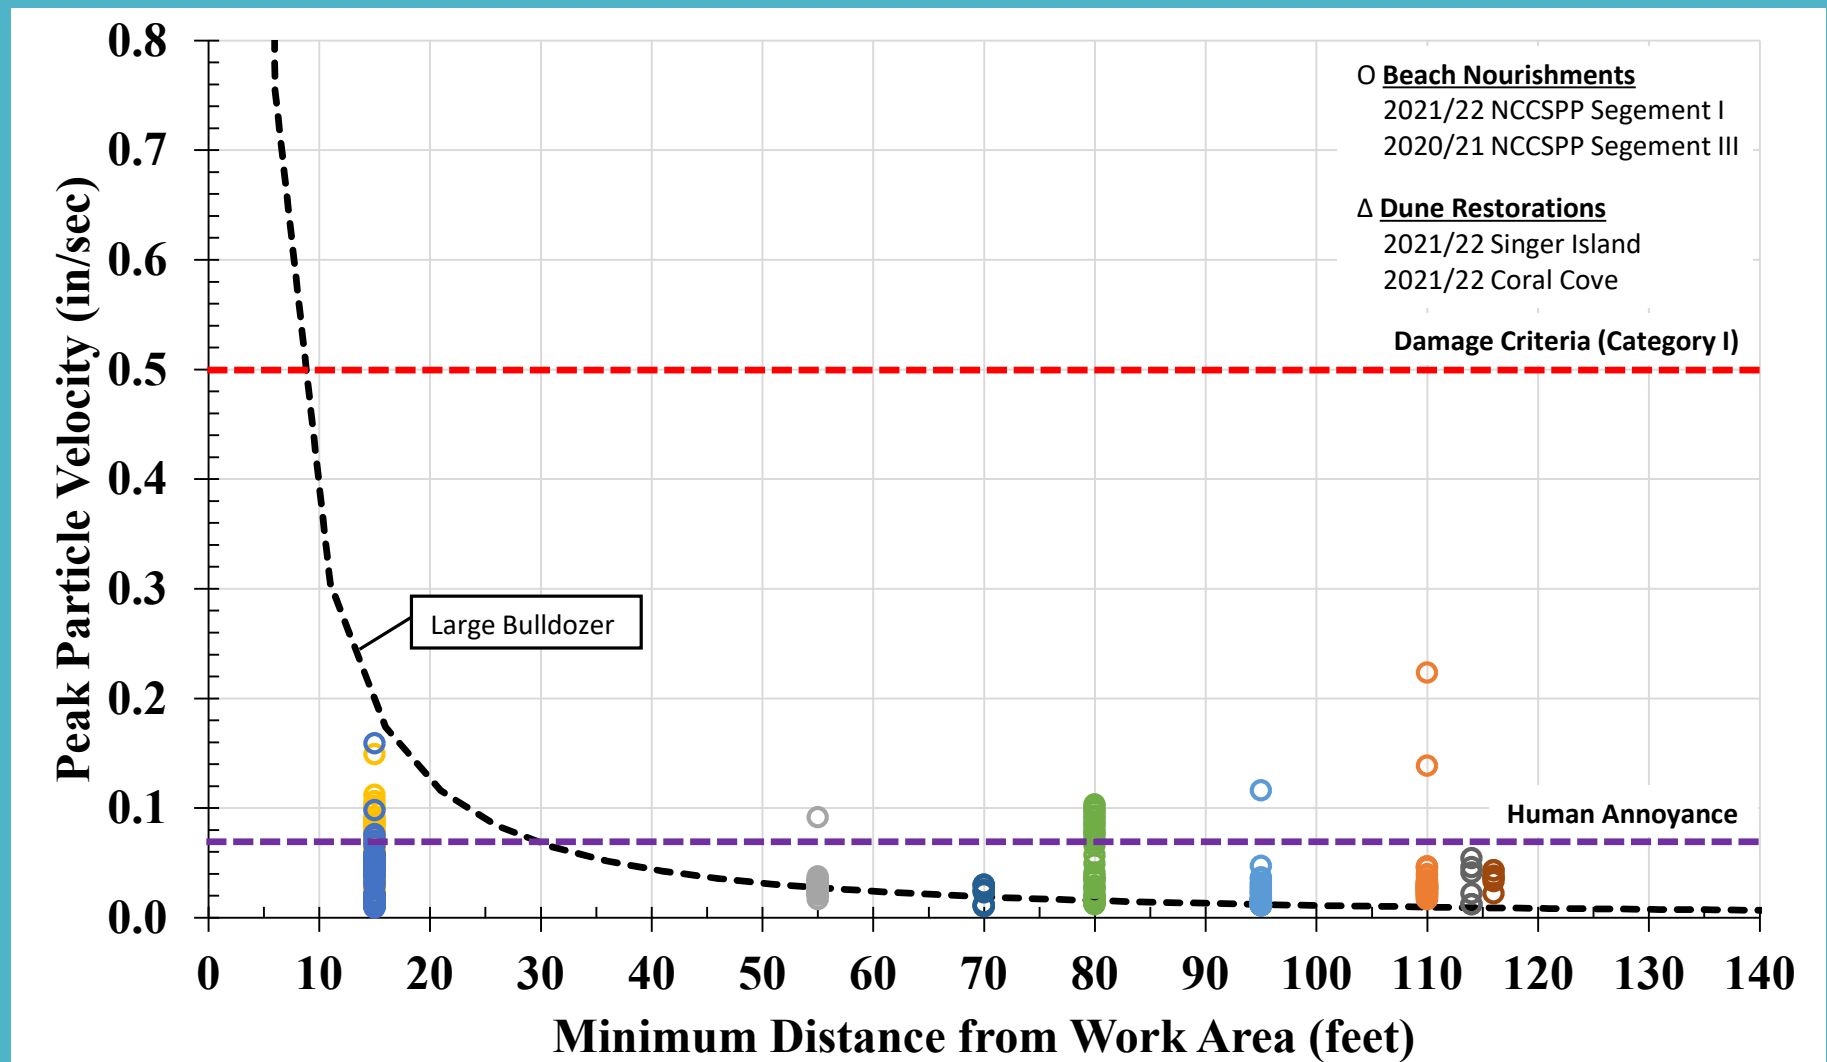
- County Projects: Beach Nourishments

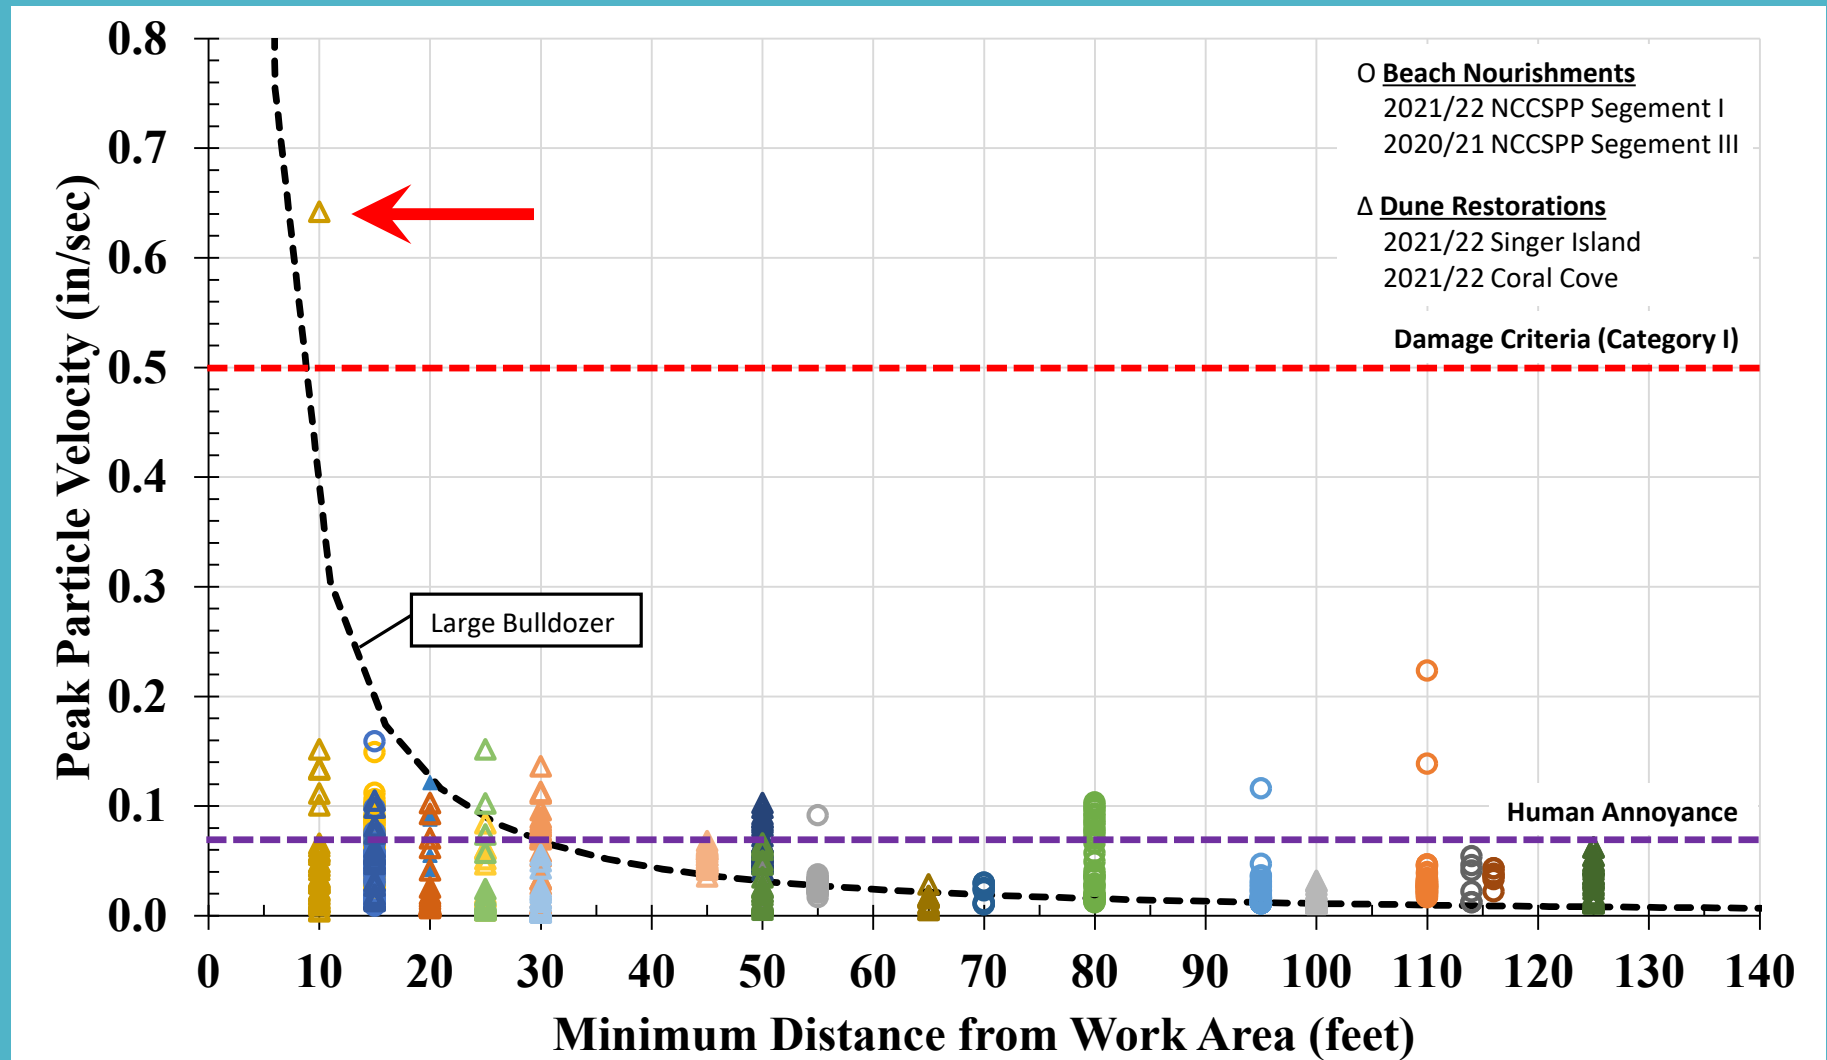
- County Projects: Beach Nourishments + Dune Restorations

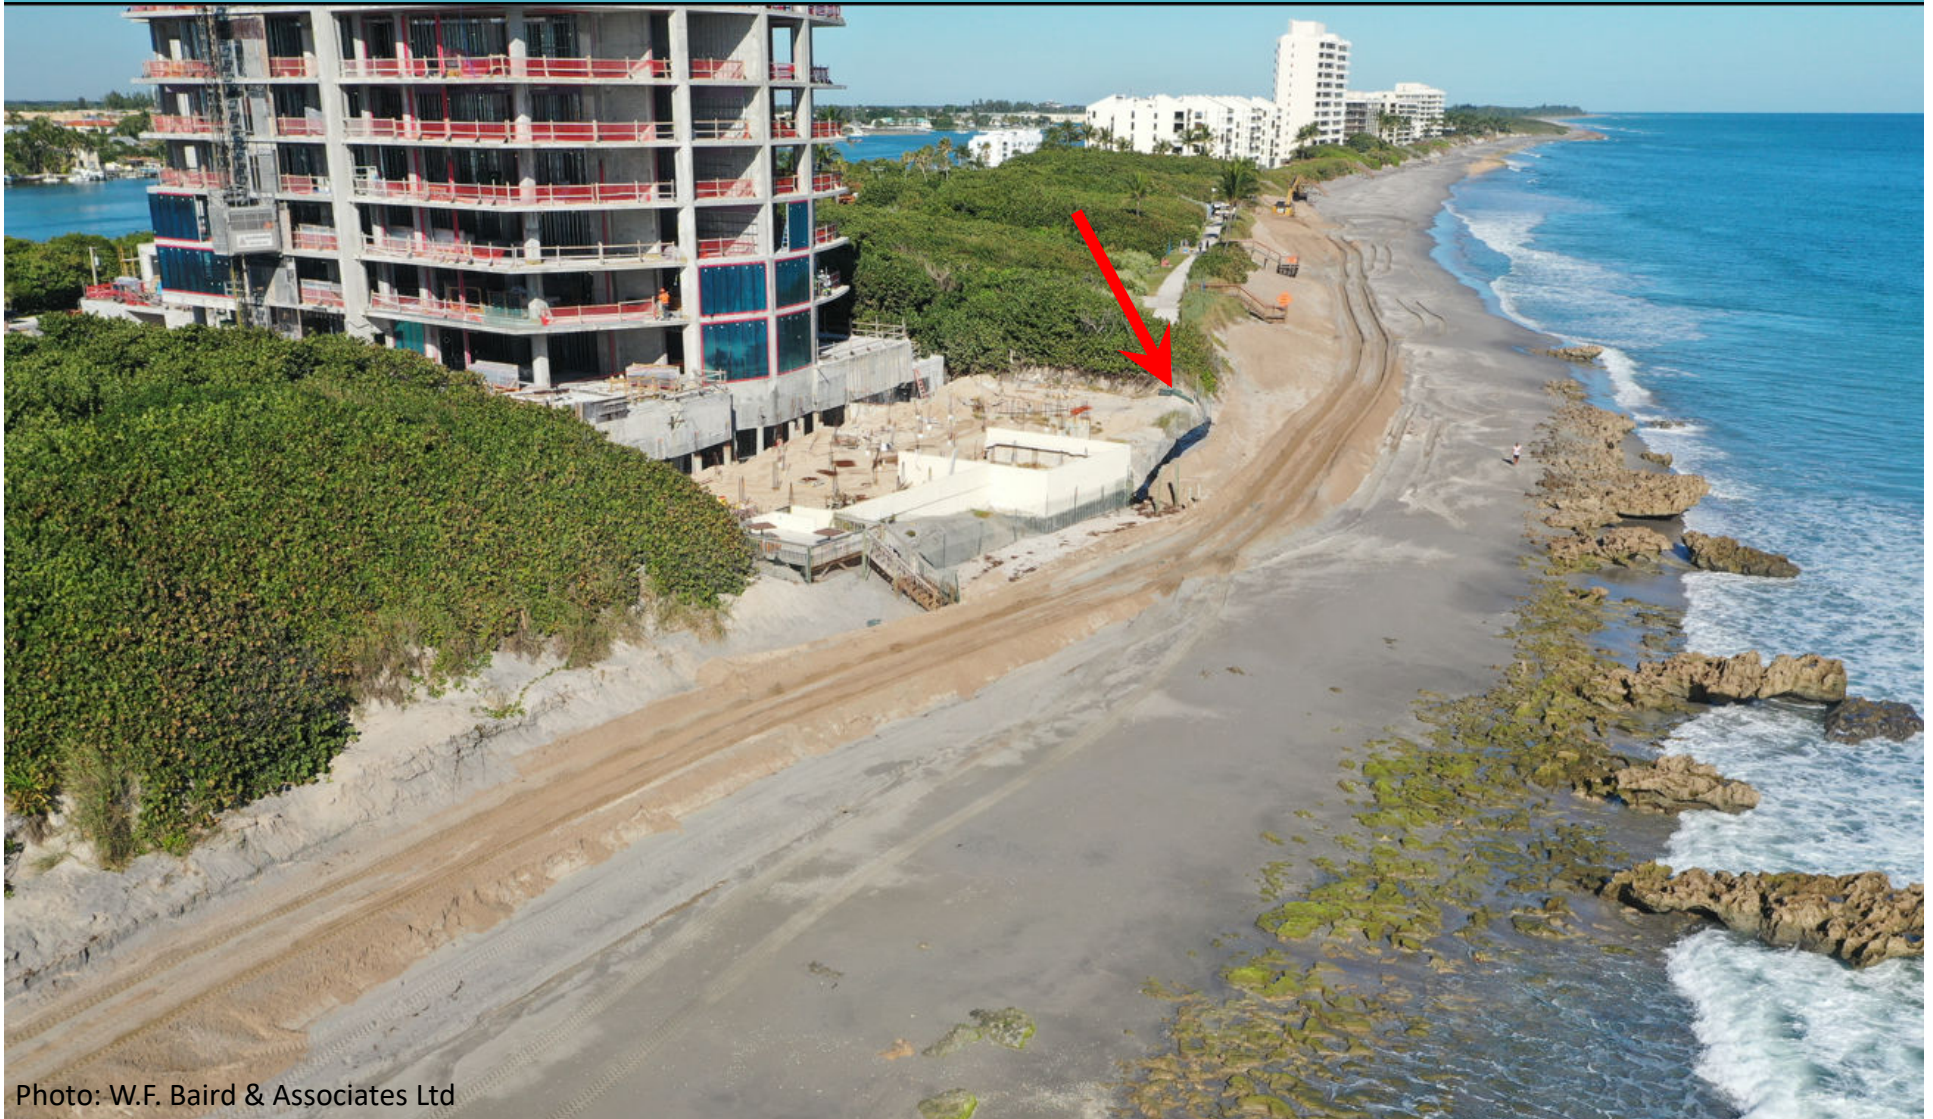
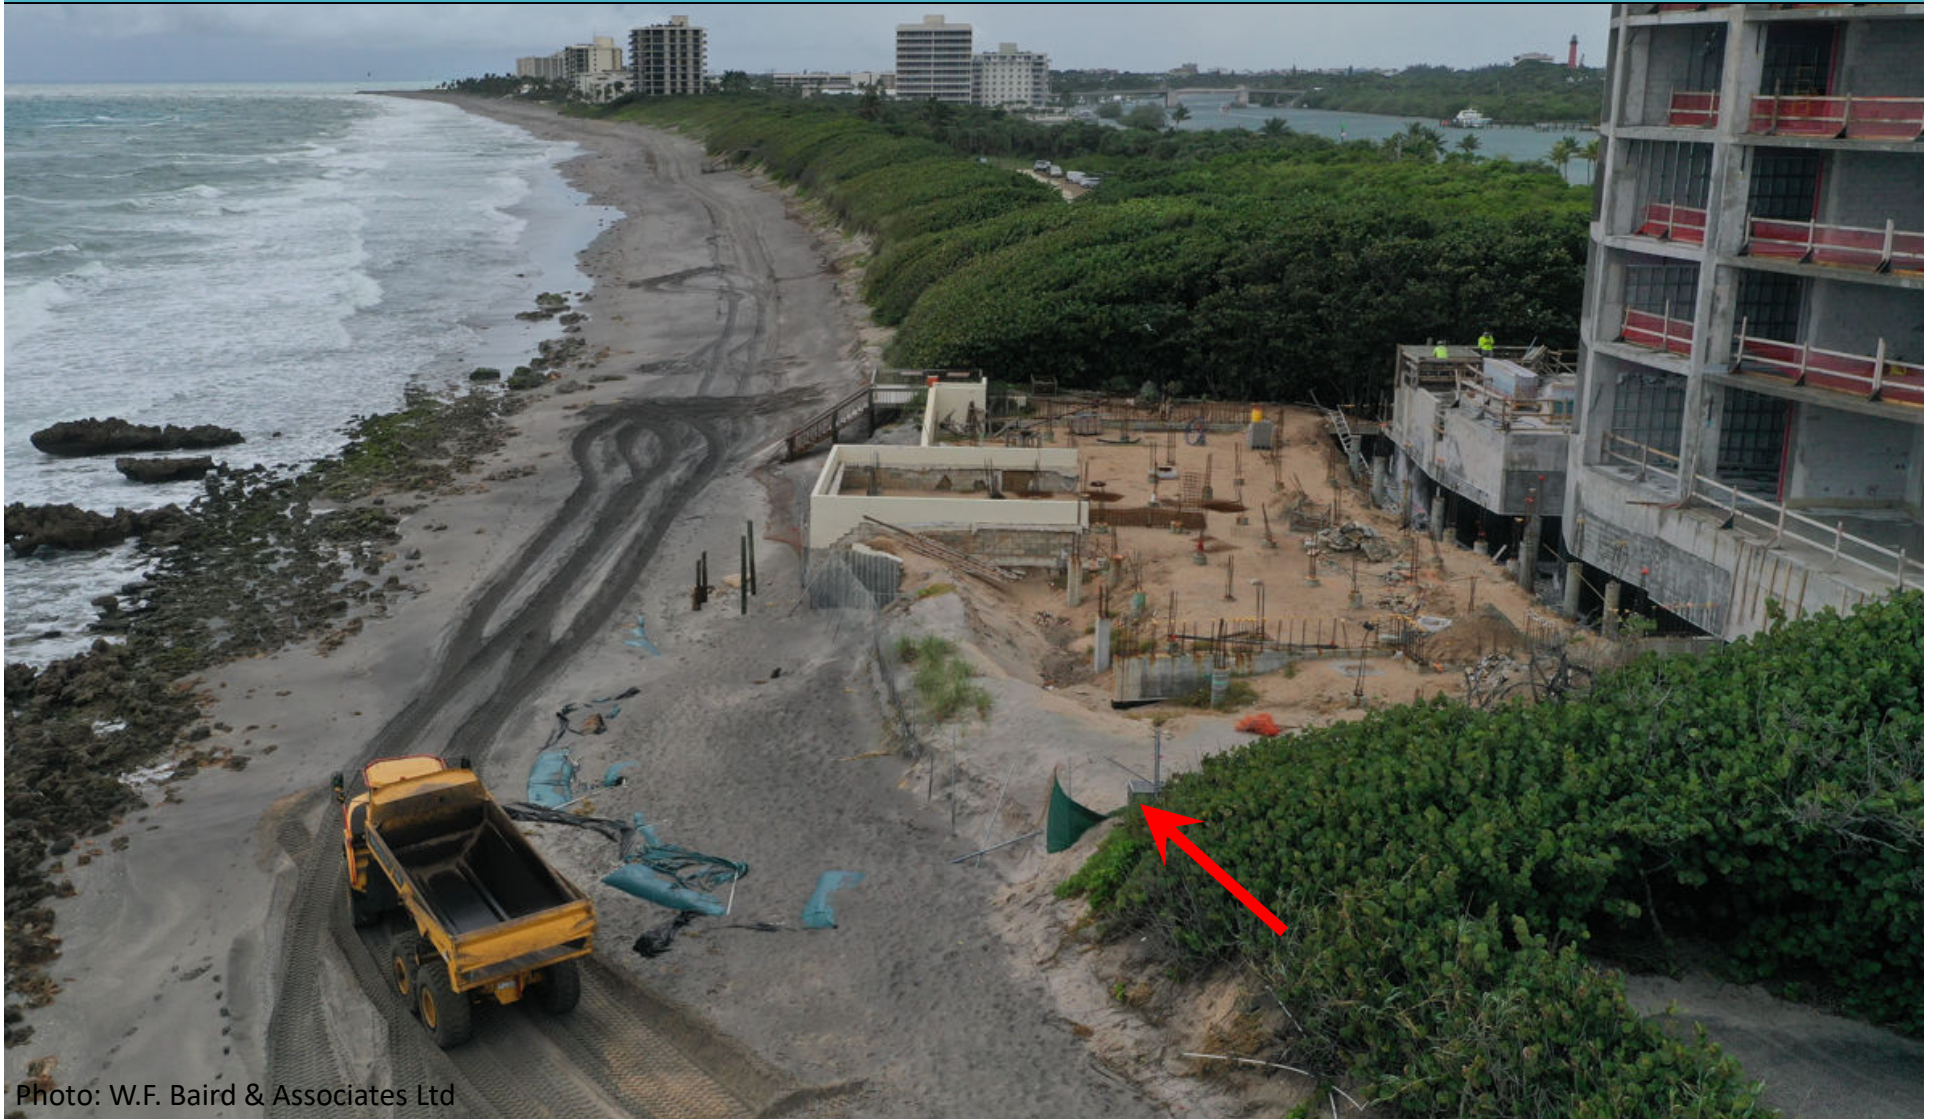
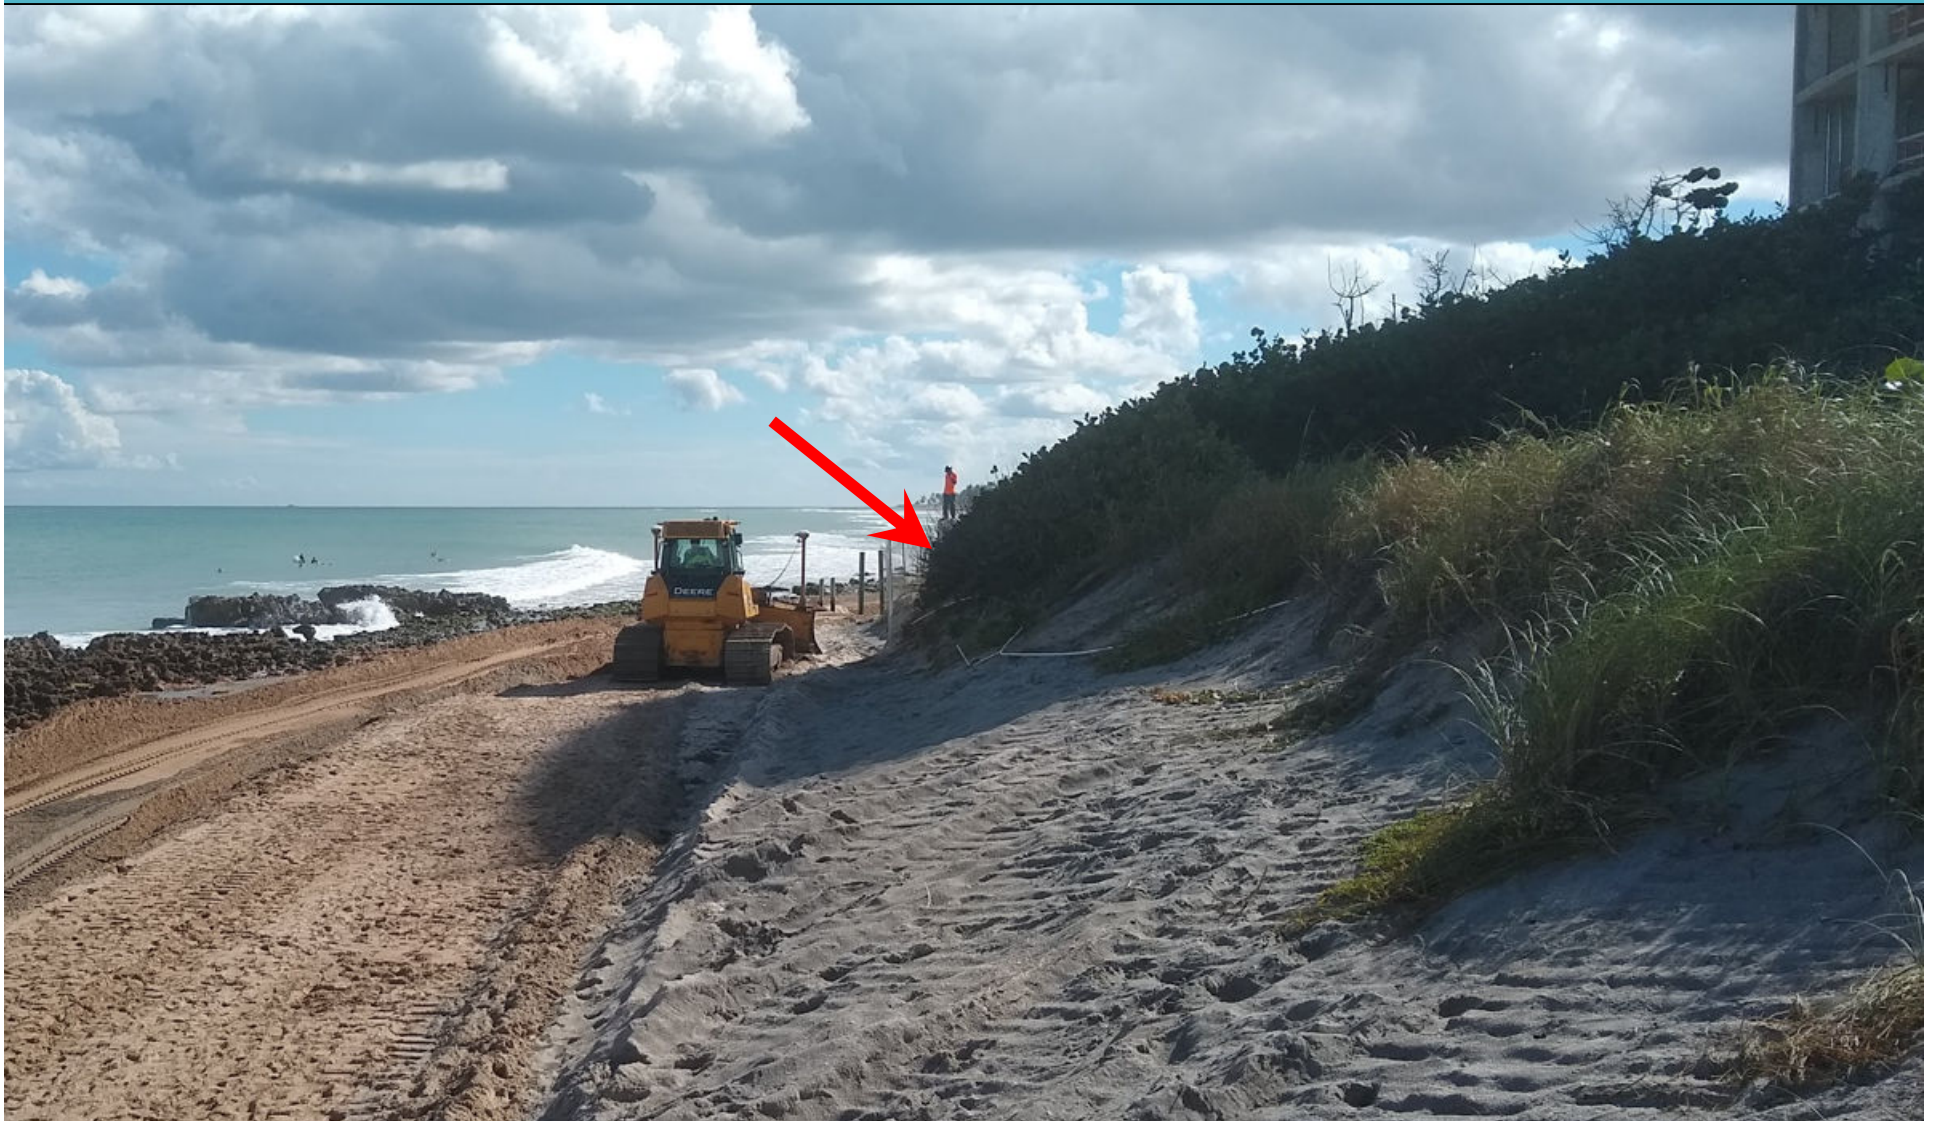
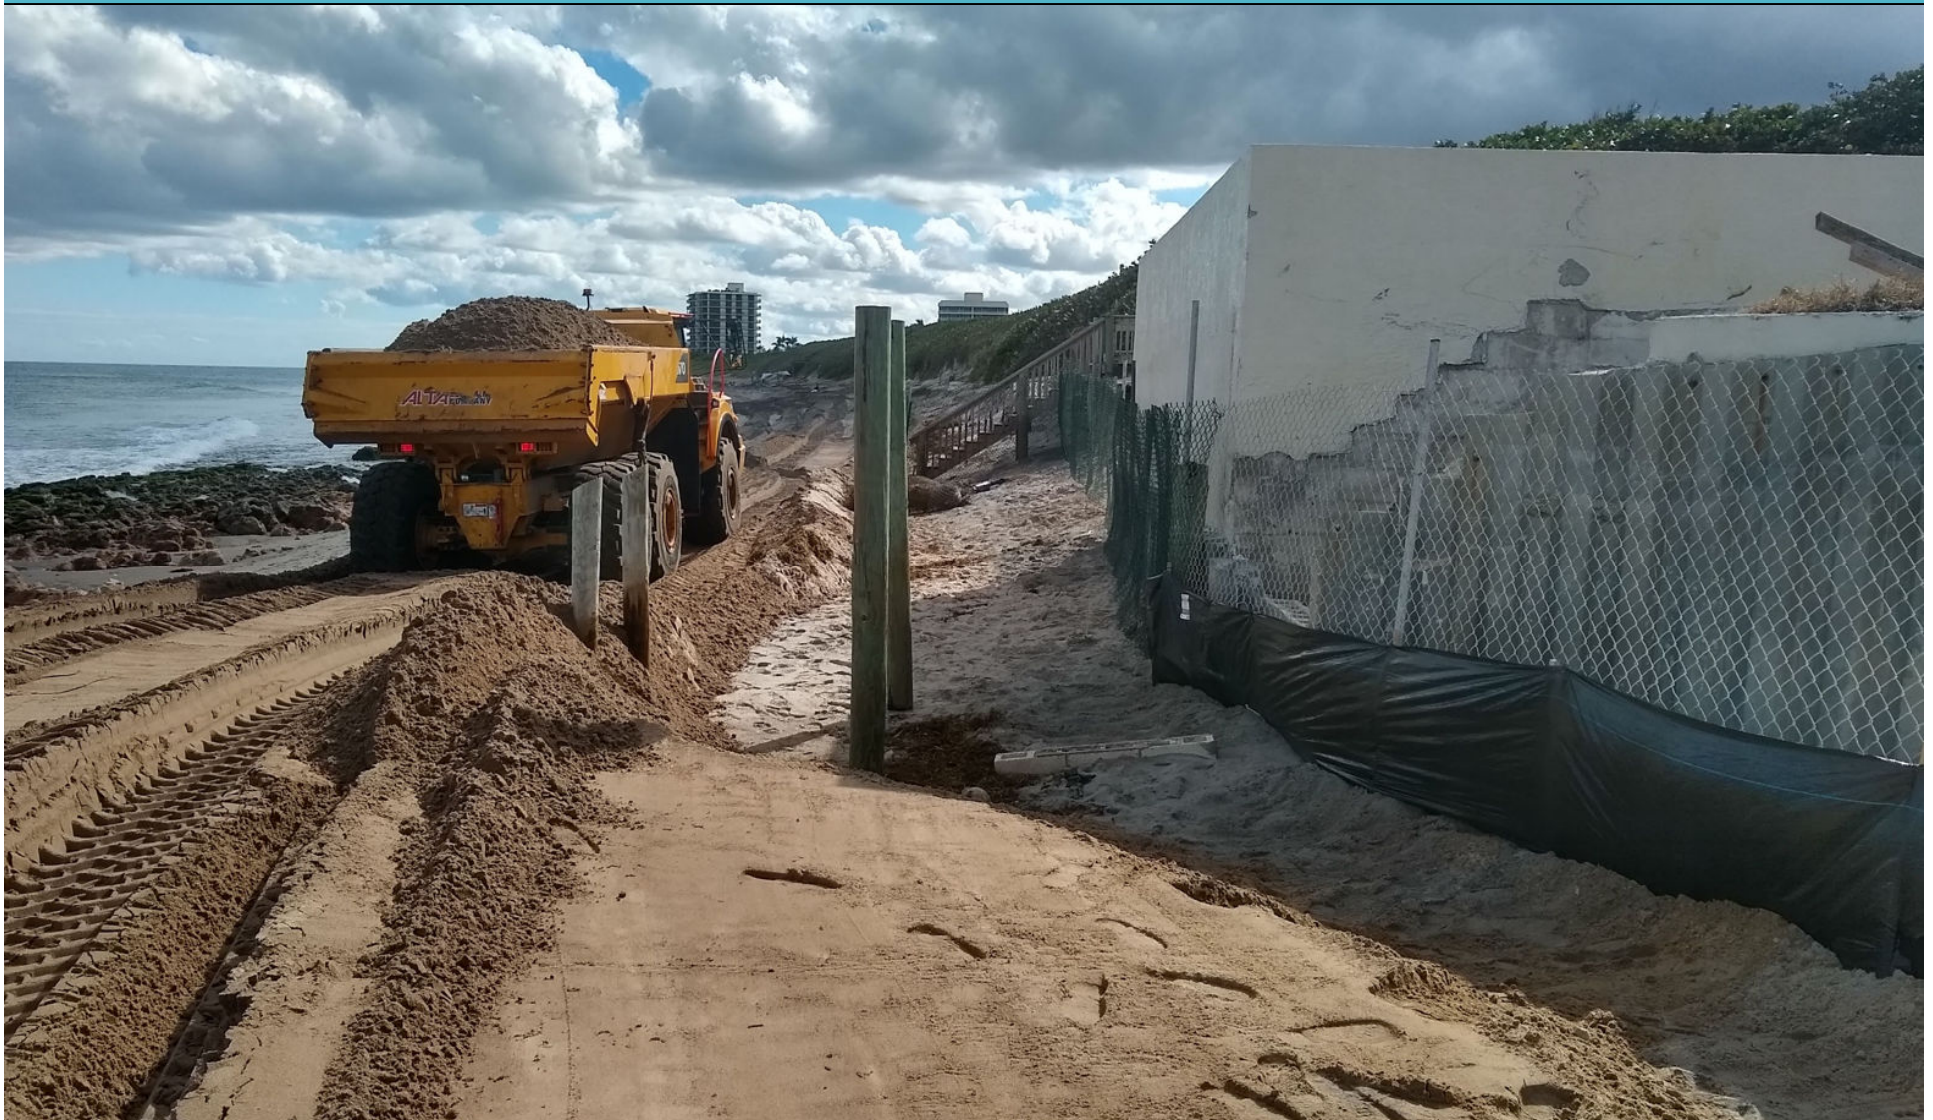
- Dune Restoration...Coral Cove

- **Four County beach and dune projects... vibration monitoring resulted in one instance of the FTA damage criteria being exceeded.**
- **Exceedance during the Coral Cove Dune Restoration Project.**
  - **The parcel was under major redevelopment, which included structural rehabilitation of the condominium, promenade, and fronting seawall.**
  - **County's construction activities were within ~10 feet of the monitoring station. Activities included the use of bulldozers and offroad dump trucks.**
  - **Real-time monitoring allowed the County's contractor to be notified and to adjust operations. No damage reported.**
