# Low Impact Secant-Pile Seawall for protecting SR-A1A along Lower Flagler & Upper Volusia Co.

*Low Impact Secant-Pile Seawall for protecting SR-A1A along Lower Flagler & Upper Volusia Co.: Presentation #39 (Thursday, February 8, at 1:40 pm in Session B3)*

# Abstract

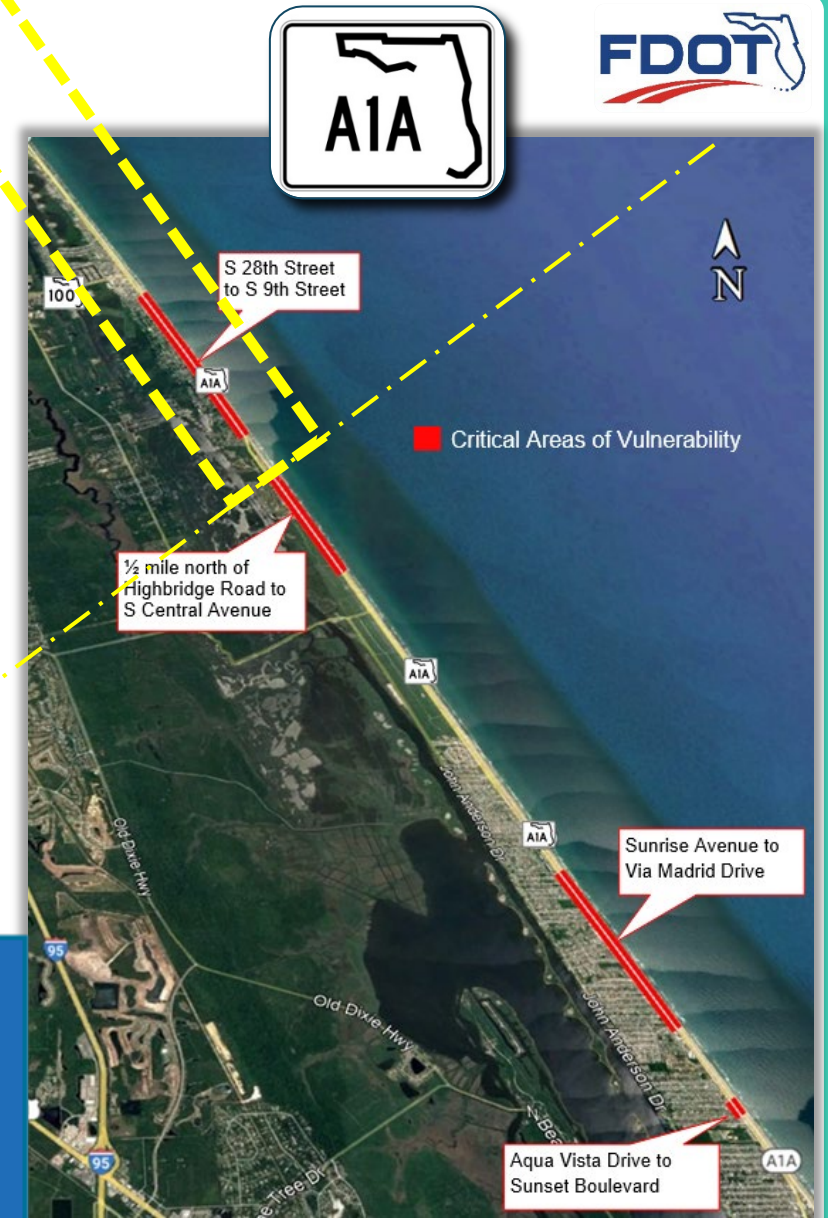
## ➤ 2023-24 PROJECT LOCATION (Segment 2 & 3):

- Studied 6.1 miles of beach along East Flagler Beach – from Volusia County Line north (includes previous secant-pile section in Segment 3)
- See redline “Critical Areas of Vulnerability” for secant-pile seawall (South 9<sup>th</sup> Street to South 28<sup>th</sup> Street ~ 1 mile)

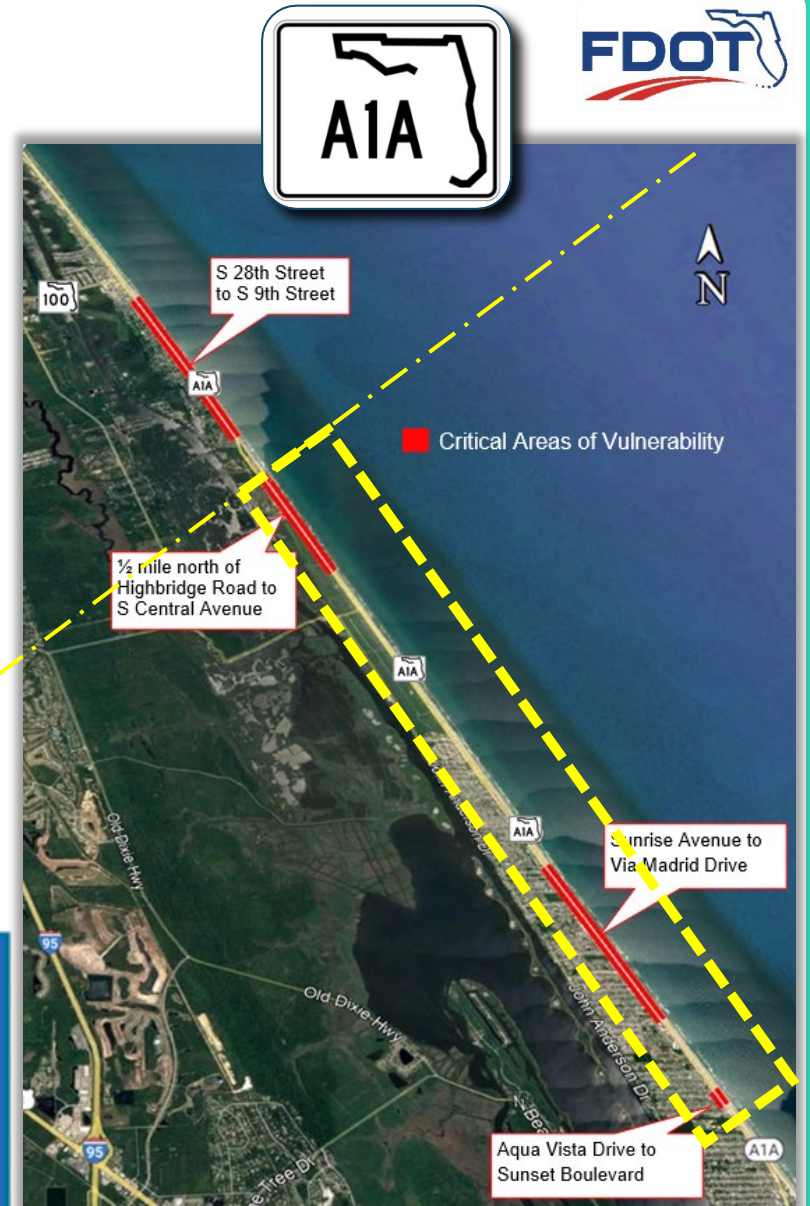
## ➤➤ 2024-25 PROJECT LOCATION (*Segment 1*):

- Studied 7 miles of beach along Ormond-by-The-Sea (Volusia County) - Roberta Rd to Flagler County Line
- See redline “Critical Areas of Vulnerability” for secant-pile seawall (~2 x 1 mile)

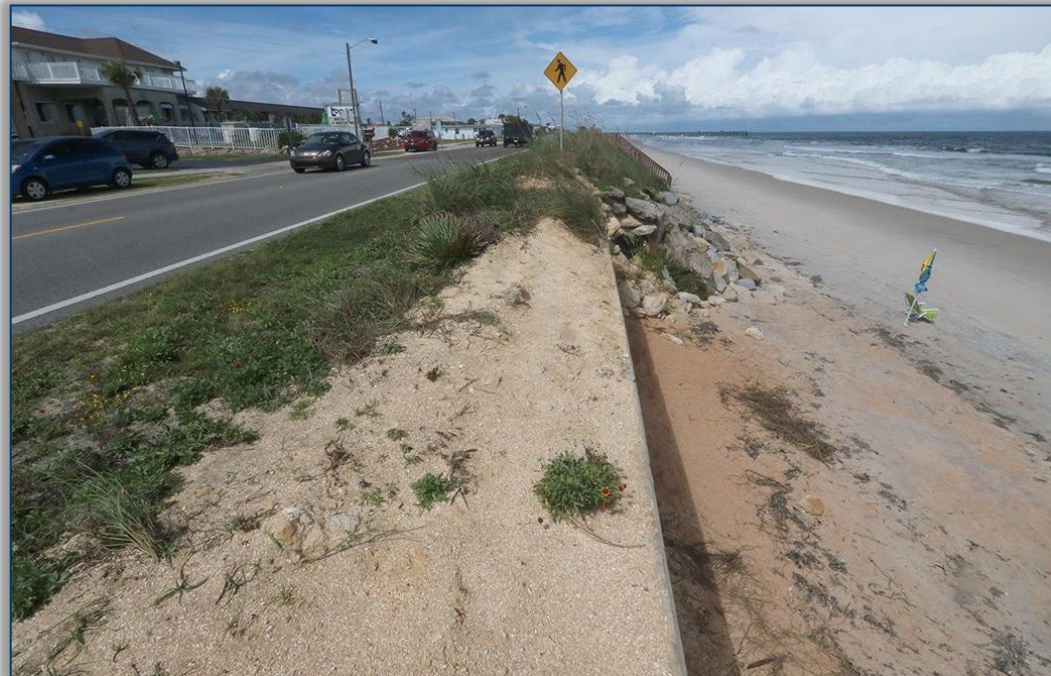
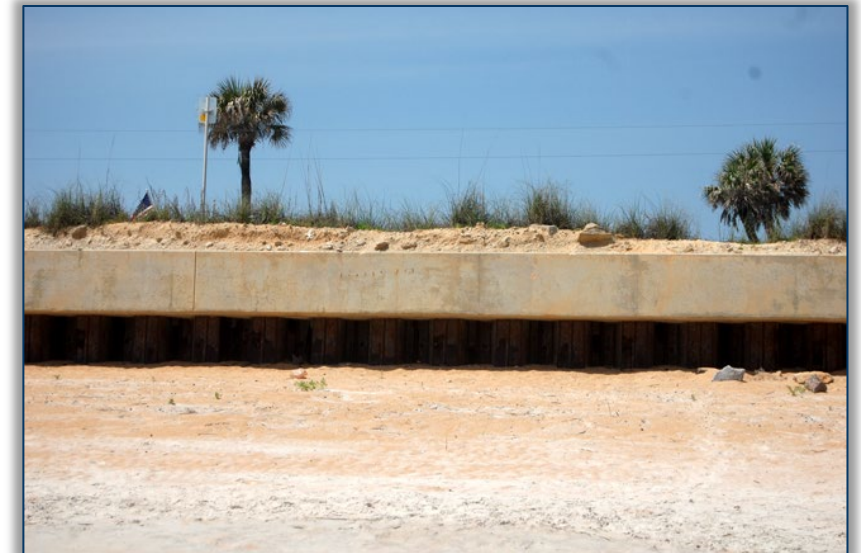
## ➤ 2006 EMERGENCY CONTRACT WALL (*Partial Segment 2*):

- In response to storm damage and roadway undermining.
- Steel Sheet Pile Wall with deadman tie-backs.

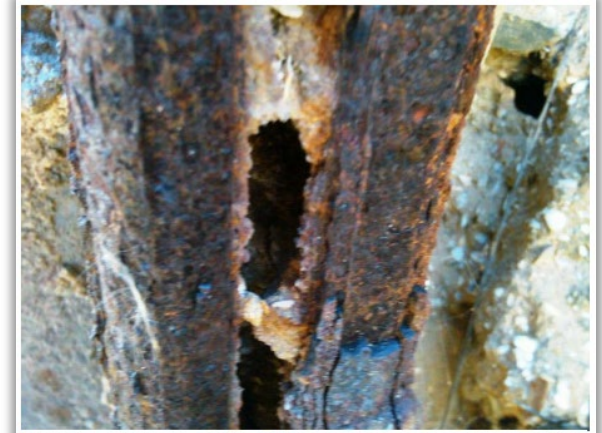
Figure 3 - Corrosion at the joint between two sheet piles showing complete section loss.

- Wall Thickness Evaluation Protocol of A1A Sheet Pile Retaining Wall at Flagler Beach (*Report Date: Jan 8, 2016*).
- “...If the corrosion progress at the current rate, by the next 3 years many piles will start losing the sacrificial steel and no piles will have any sacrificial steel left by the next 7 years.”
- Average Section loss up to 13 mils/year > 2 times **SDG 3.1** rate.

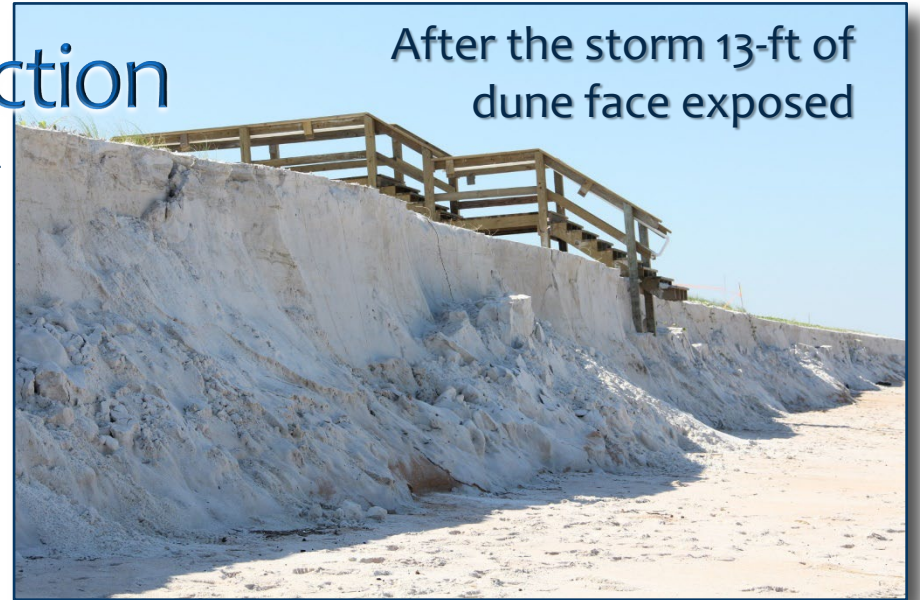
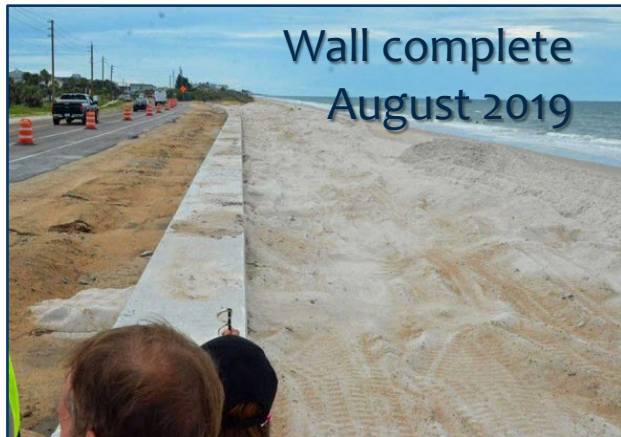
## ➤ SEPT. 2019 – HURRICANE DORIAN:

- **Segment 3** - Significant Beach Erosion, but no highway damage or wall exposure)

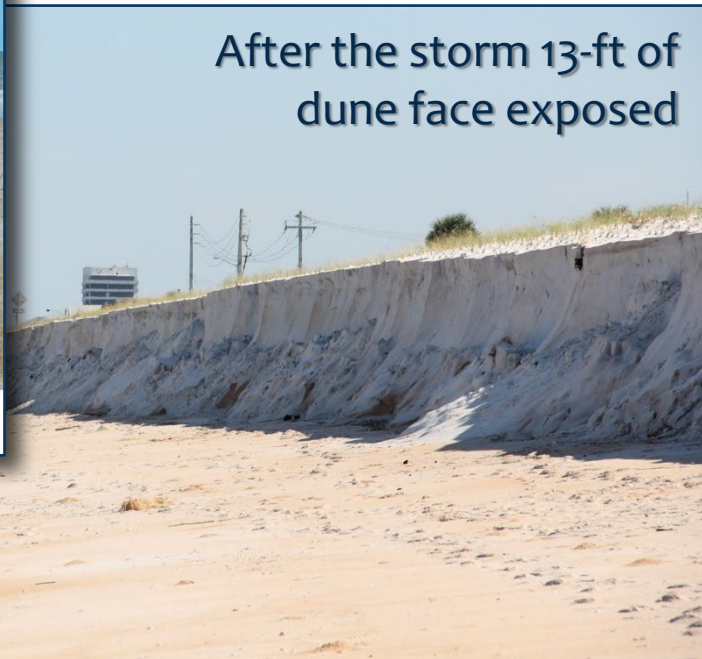
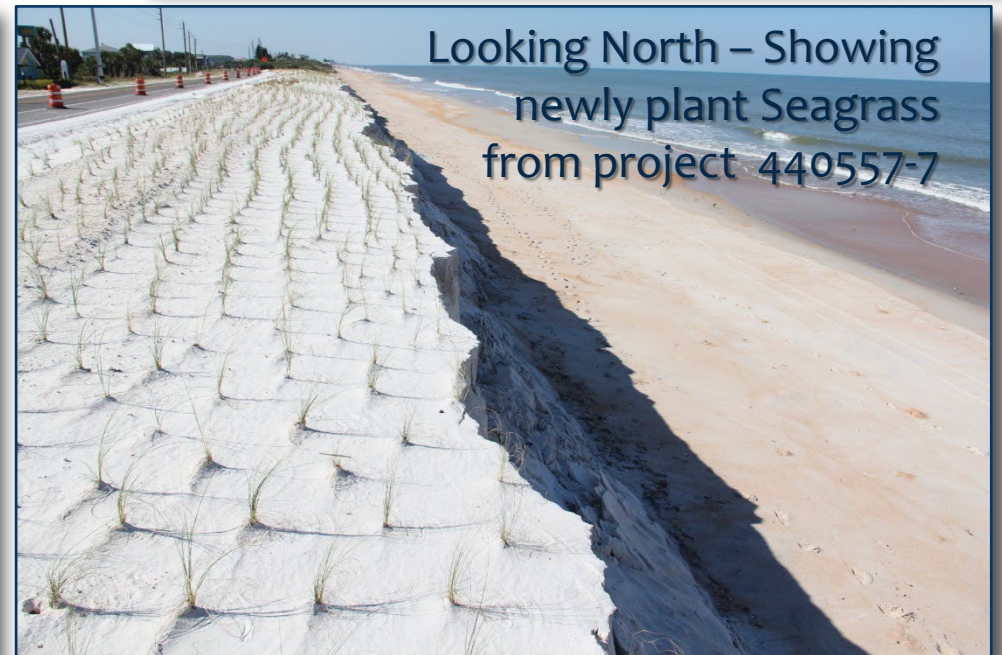
Department of Transportation's covered sea wall project nearing completion on Aug. 1, 2019. (© FlaglerLive)

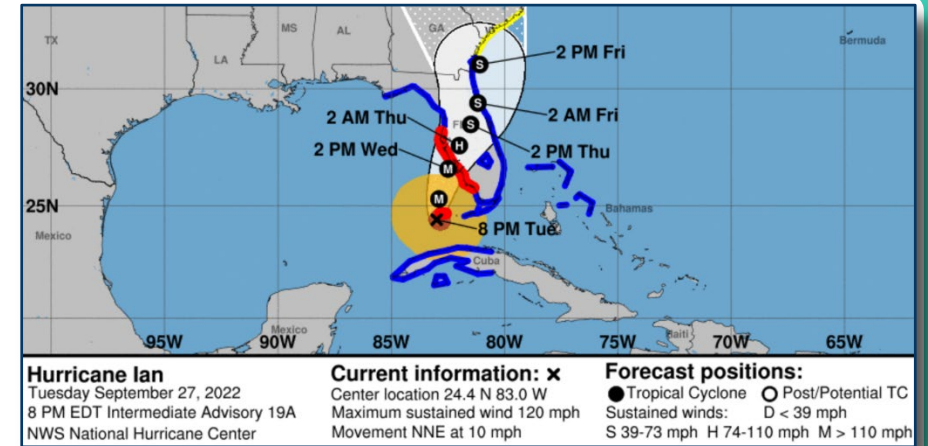
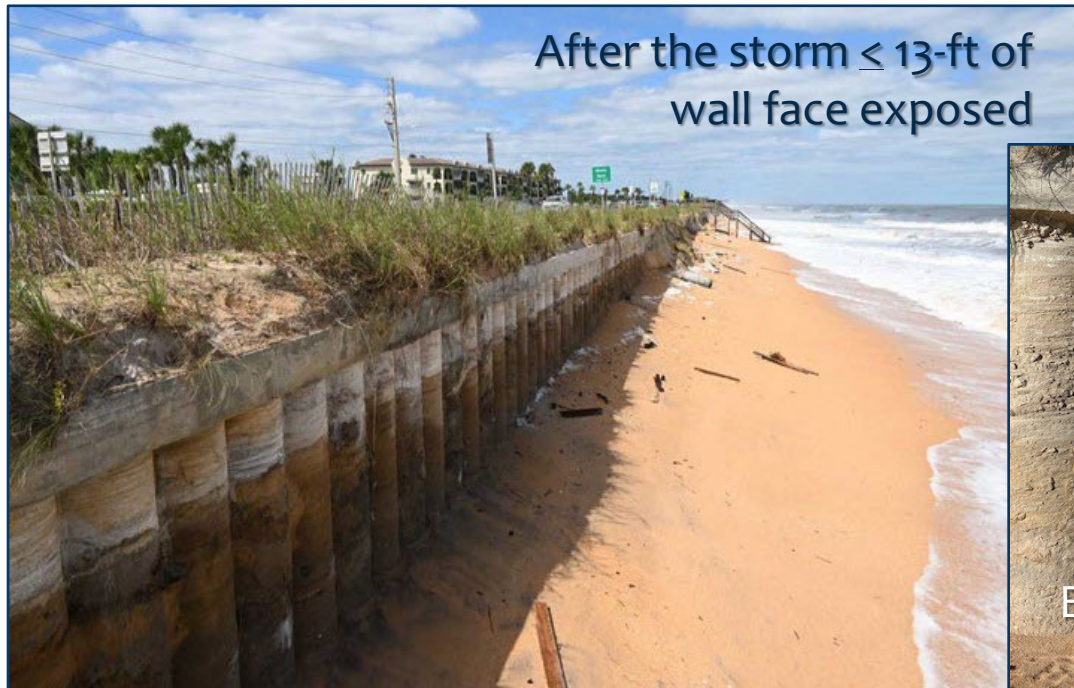
## SEPT. 2022 – HURRICANE IAN:

- **Segment 3** - Significant Beach Erosion, seawall exposure up to 13-foot at face, but no damage to SR-A1A.

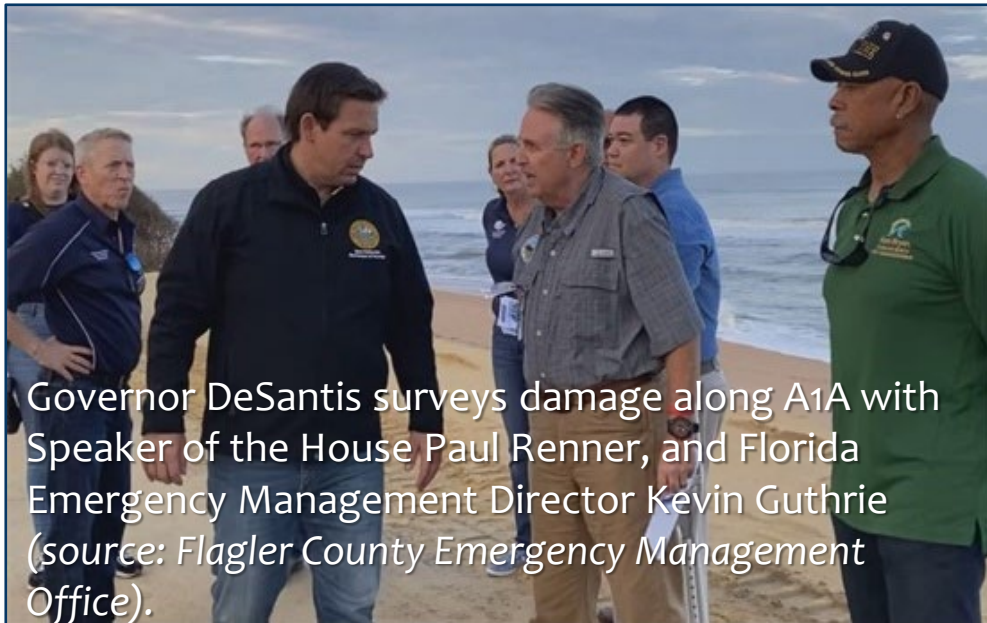
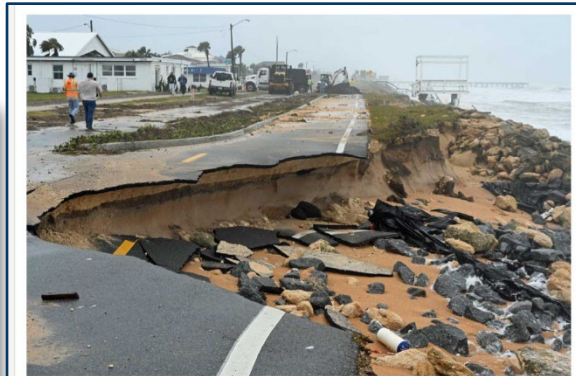
## ➤ OCT. 2022 – HURRICANE NICOLE:

- Segment 1 & 2 - Significant highway damage north and south of seawall.

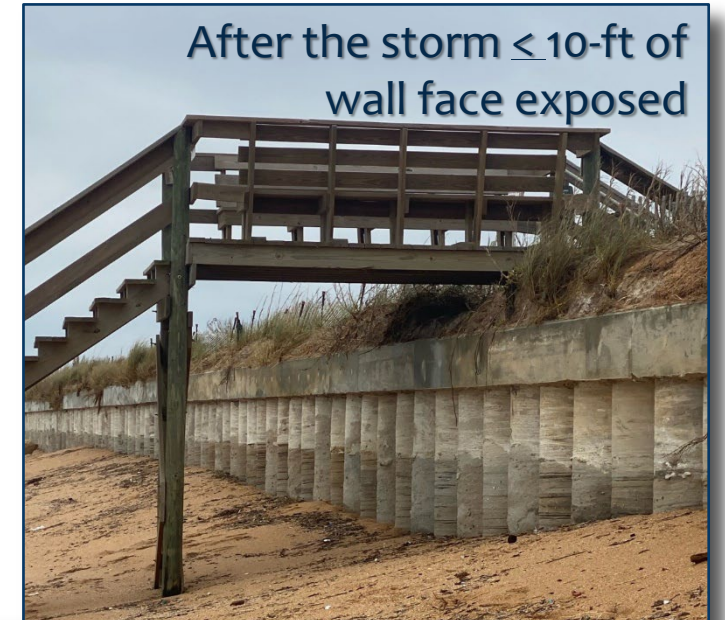
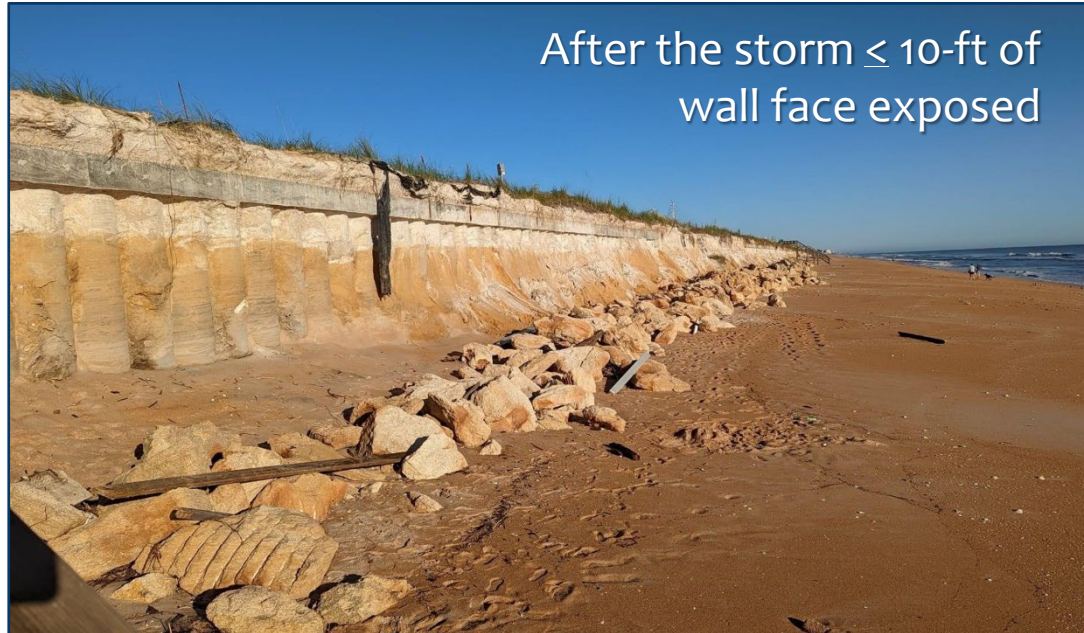
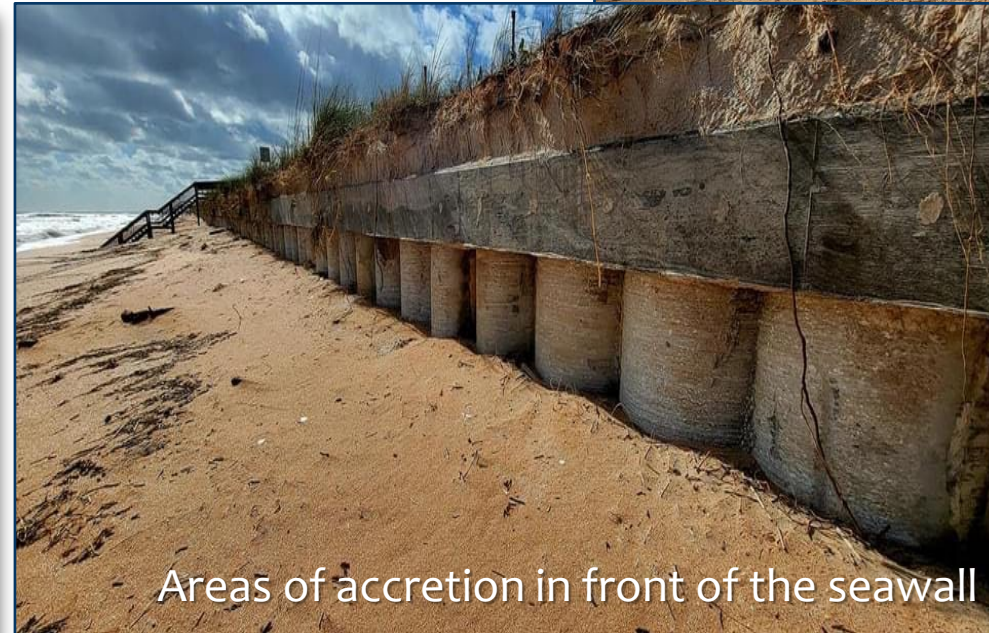
## » OCT. 2022 – HURRICANE NICOLE:

- **Segment 3** - Additional sections of wall exposed but some accretion from littoral drift, but no damage to SR-A1A behind the seawall.

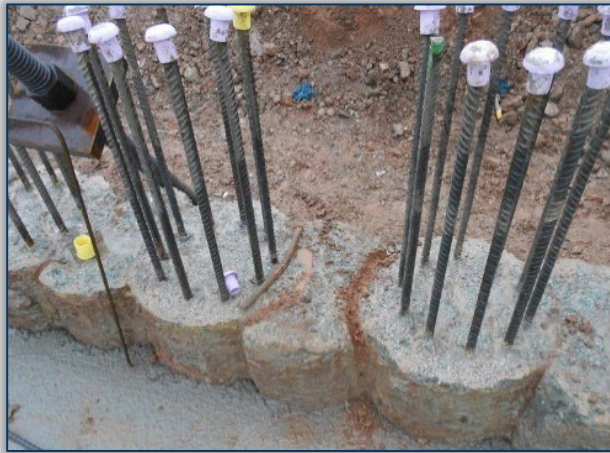
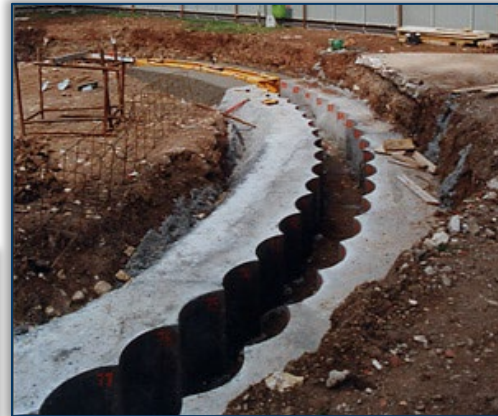
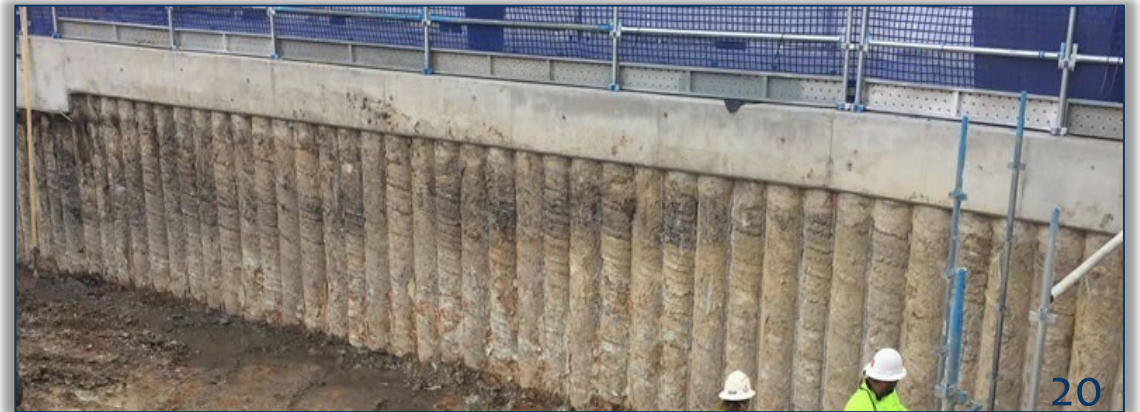
# Secant Pile Wall Technology

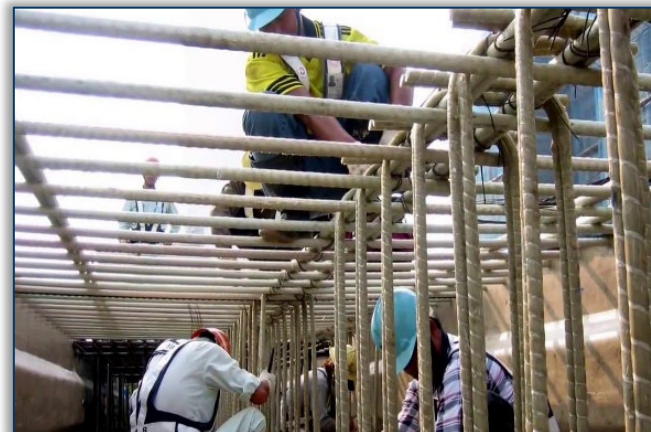
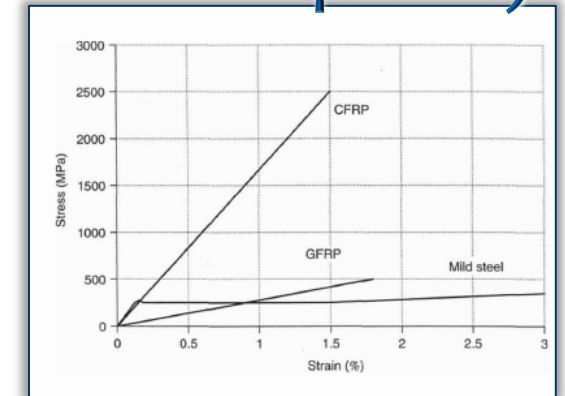
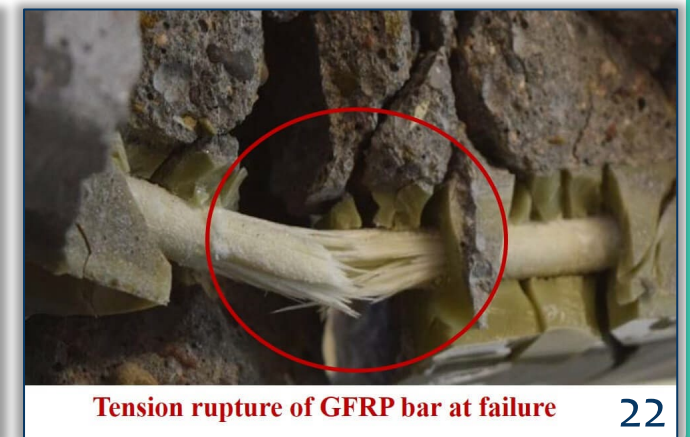
- Largest ASTM D7957-17 bar size #10 Bar. *(FDOT added #11's in 2024)*
- Variable surface to concrete bond capacity.
- Bends only ~60% strength of straight bar.
- No yield (warning) before failure but extensive concrete cracking visible.

Tension rupture of GFRP bar at failure

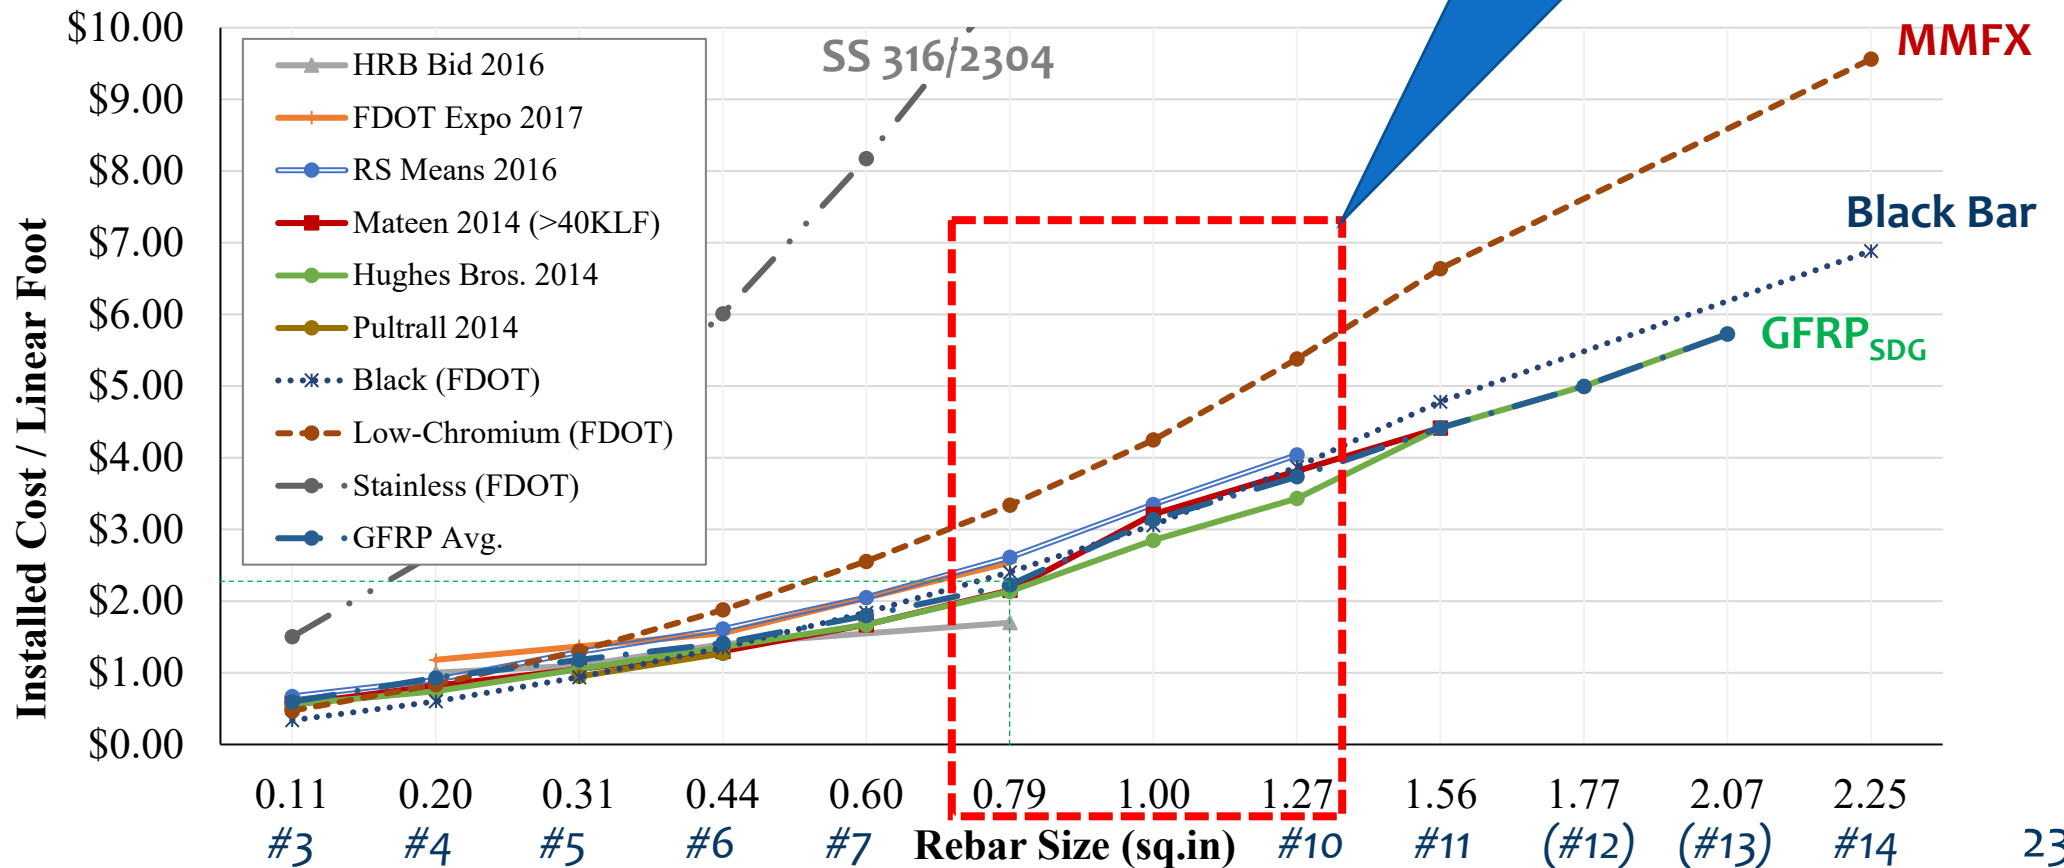
- Cost Comparison (Published and FDOT Bid Estimates)

#8's to #10's typical for Secant-Piles  
(needs to be updated using 2024 bids)

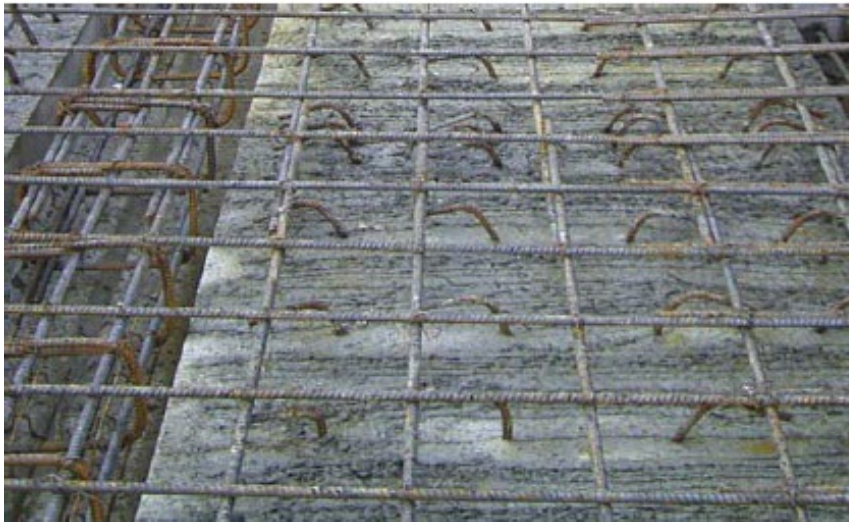
Steel Bars

#8 Steel Rebar (@\$1.05/lb) = \$2.80/ft

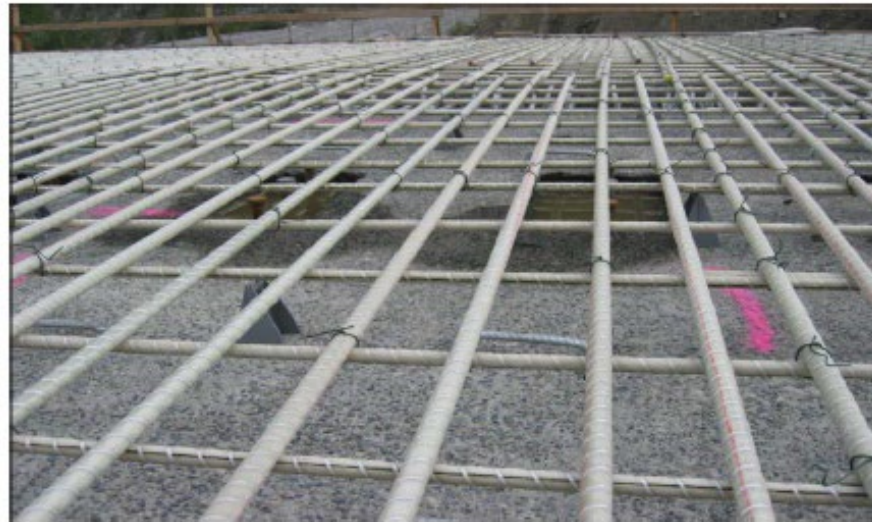
GFRP Bars

#8 GFRP Rebar: \$2.25/ft + testing

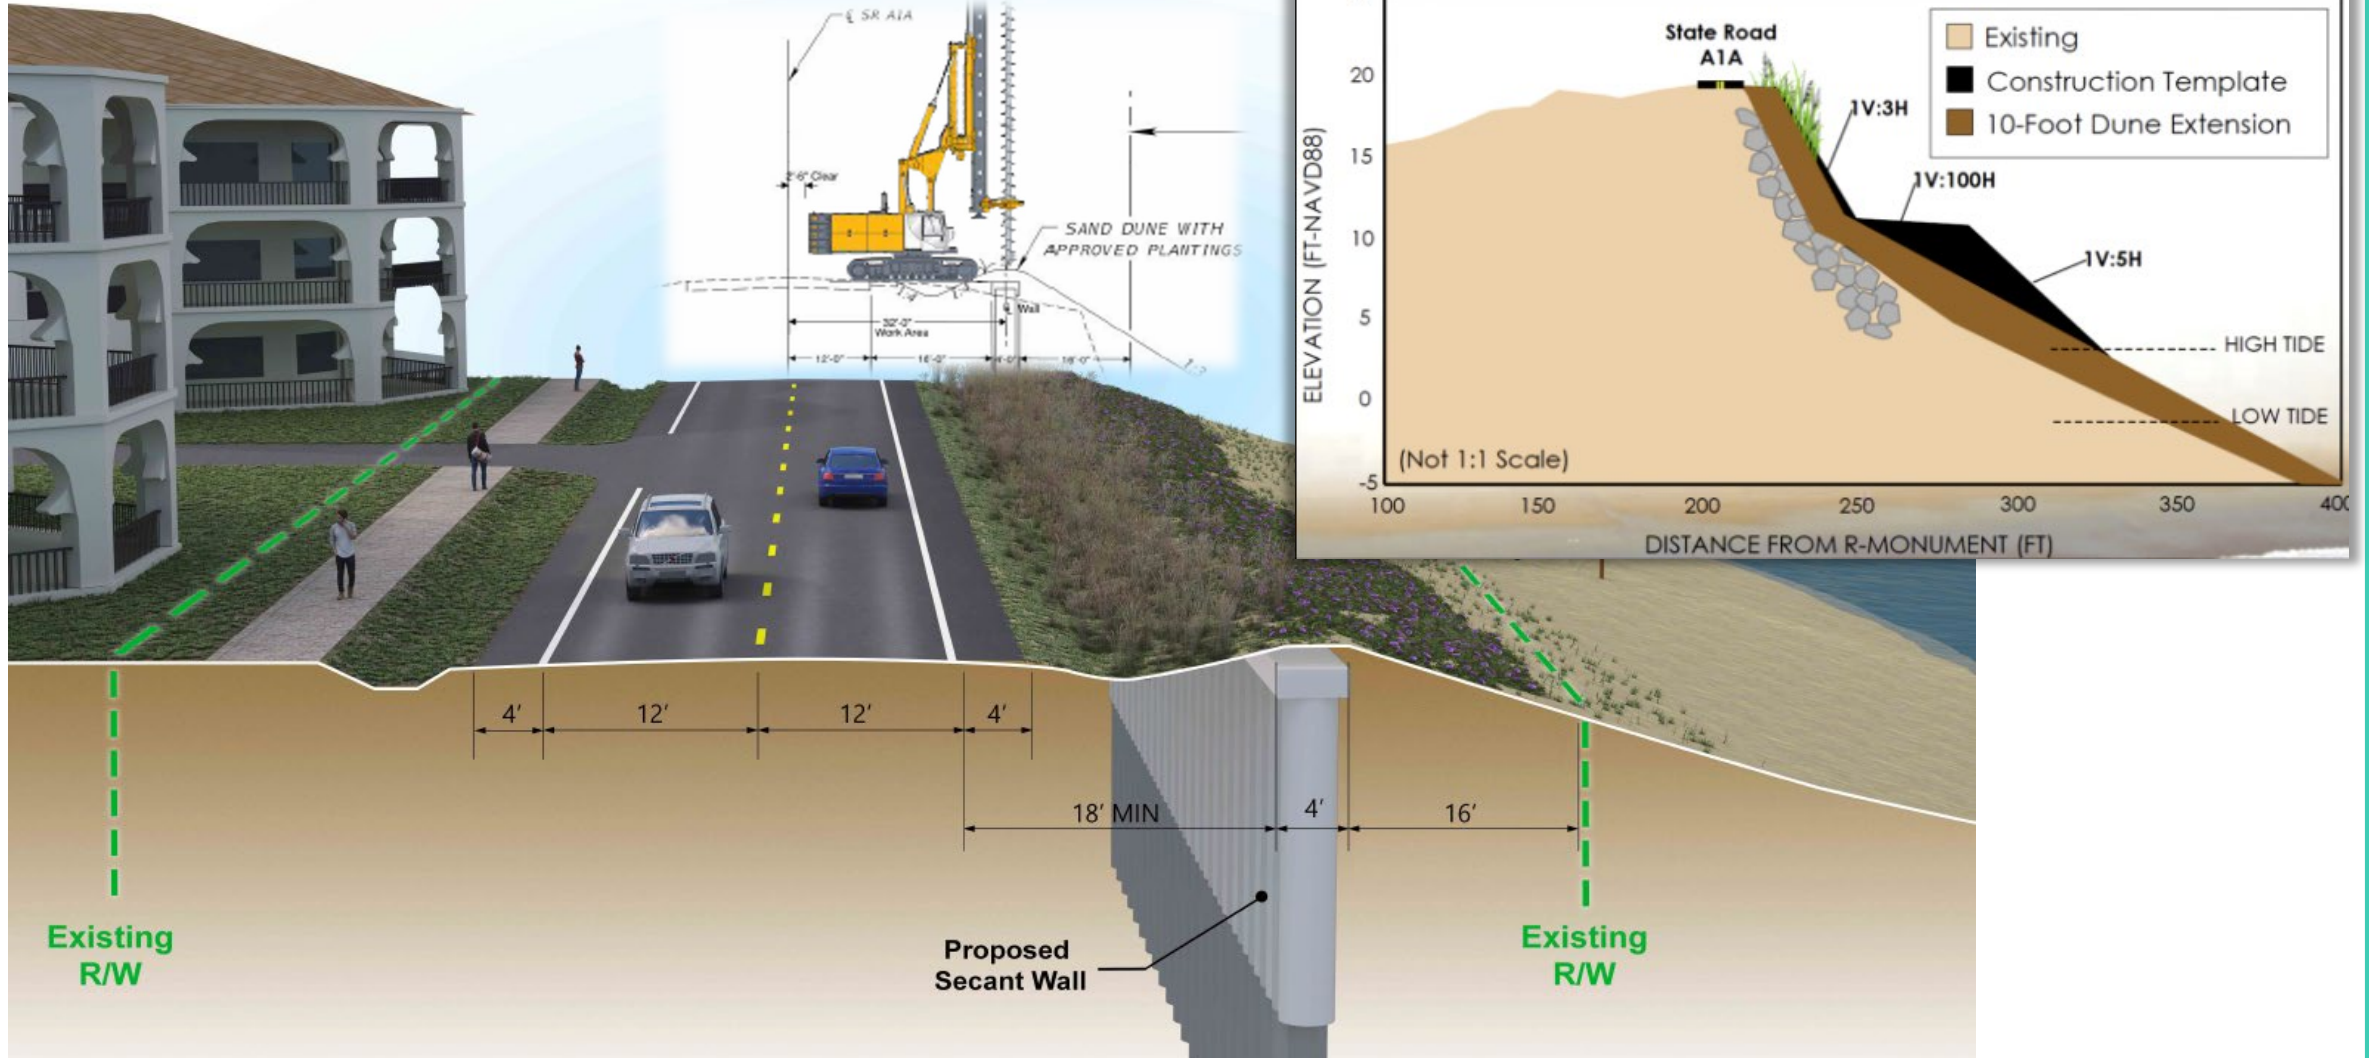
# Flagler Beach #1, 3 & 4: SR-A1A Wall Design (2019 & 2024)

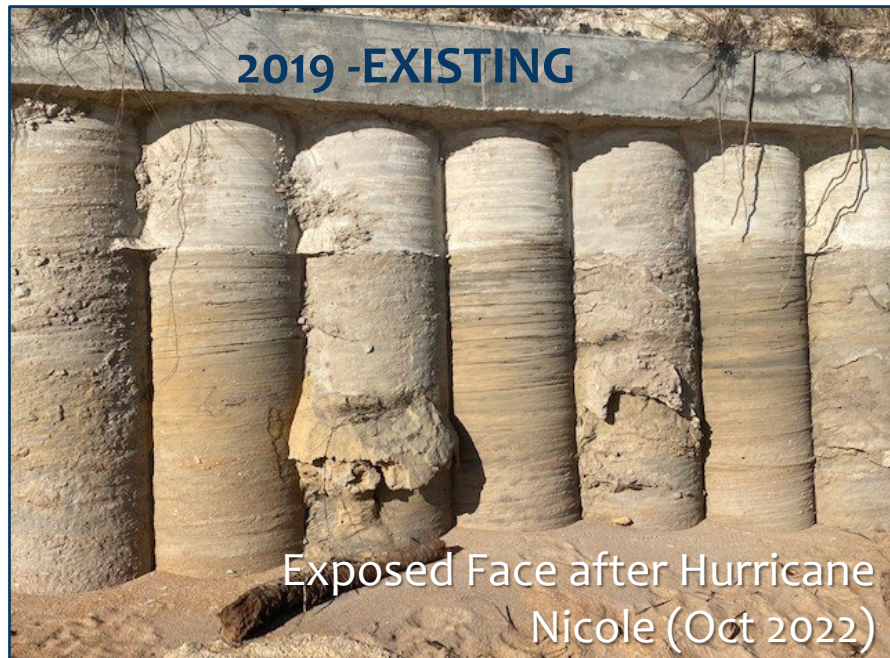
Hex-Tube  
and/or  
SEAHIVE  
facing

- Seawater/Marine concrete using Hex-Tube/SEAHIVE.
- Open capped topping possibilities.

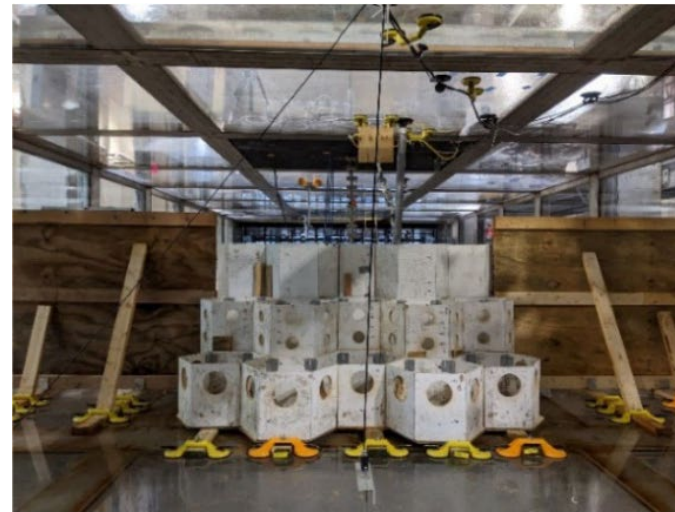
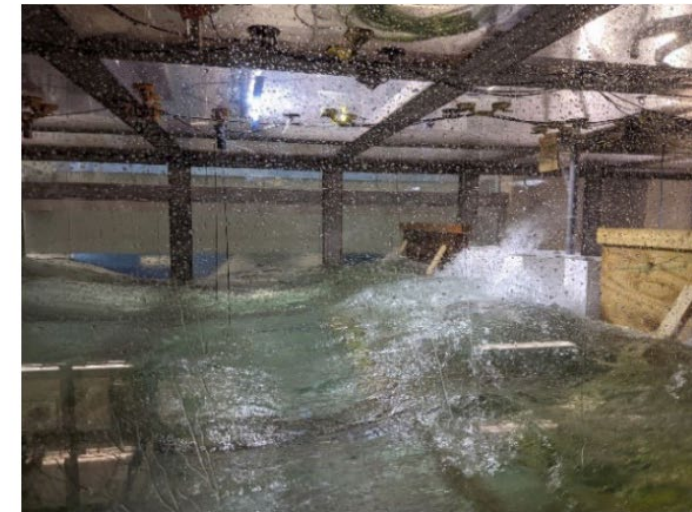
FIGURE 11 Semi-perforated SEAHIVE system model configuration in SUSTAIN.

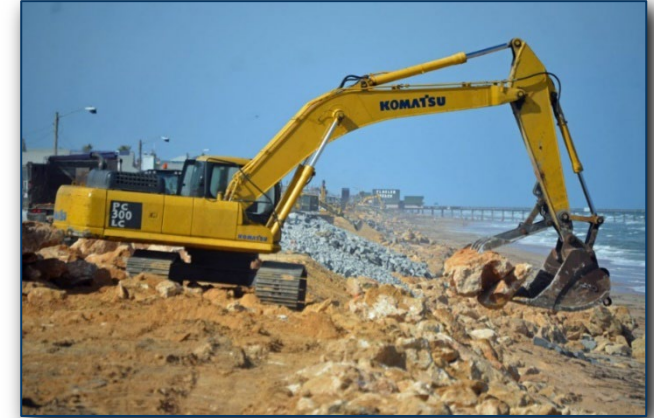
## ▪ AFTER STORM EMERGENCY REPAIRS INSTALLED:

- ✓ *Project let and completed shortly after Hurricane Nicole.*
- ✓ *Repaired dunes, Placed revetment/rip rap, rebuilt/repaved damaged highway sections.*

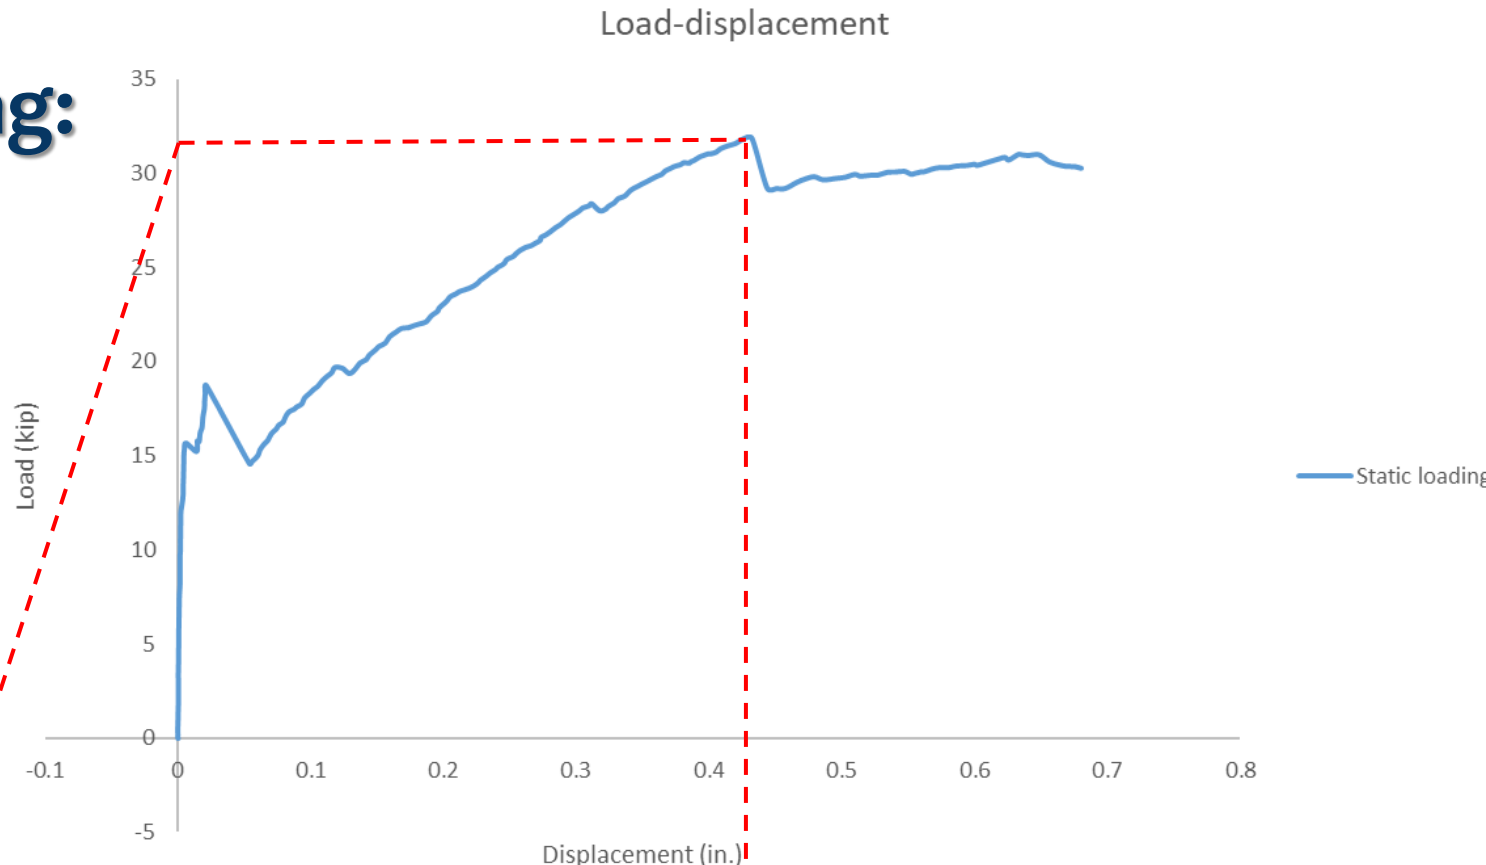
# Results of the statical compressive load on SEAHIVE element

Loading condition	Maximum Load (kips)	Displacement at maximum load (in.)	Load at first drop (kips)
<b>Static</b>	<b>31.86</b>	<b>0.43</b>	<b>16.07</b>

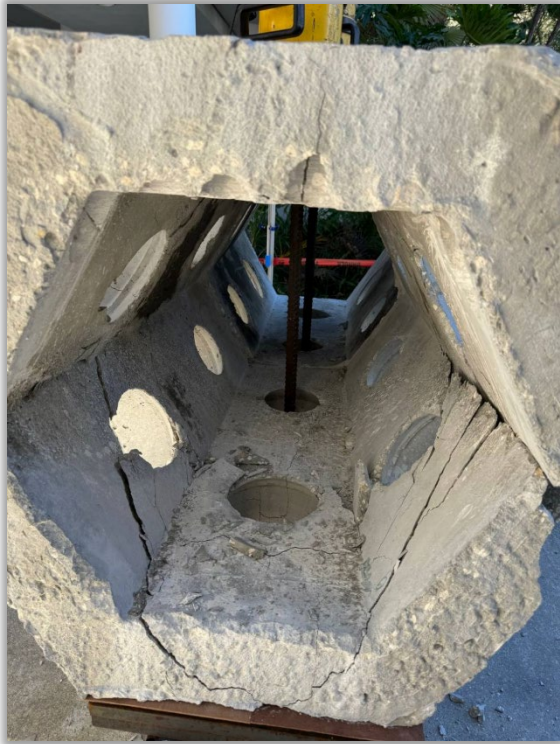
**Cross-section View**

# Results of the Flexural loading on SEAHIVE element

Cracks started to initiate at **17 kips**. Moreover, the ultimate load is **60 kips**. It should be noted that both loads represent the total load of two jacks.
