Adaptability During Design and Construction of Large Scale Coastal Restoration Projects in Louisiana

*27th Annual National Conference on
Beach Preservation Technology
February 13, 2014*

*Presented by:
Michael Poff, P.E.*

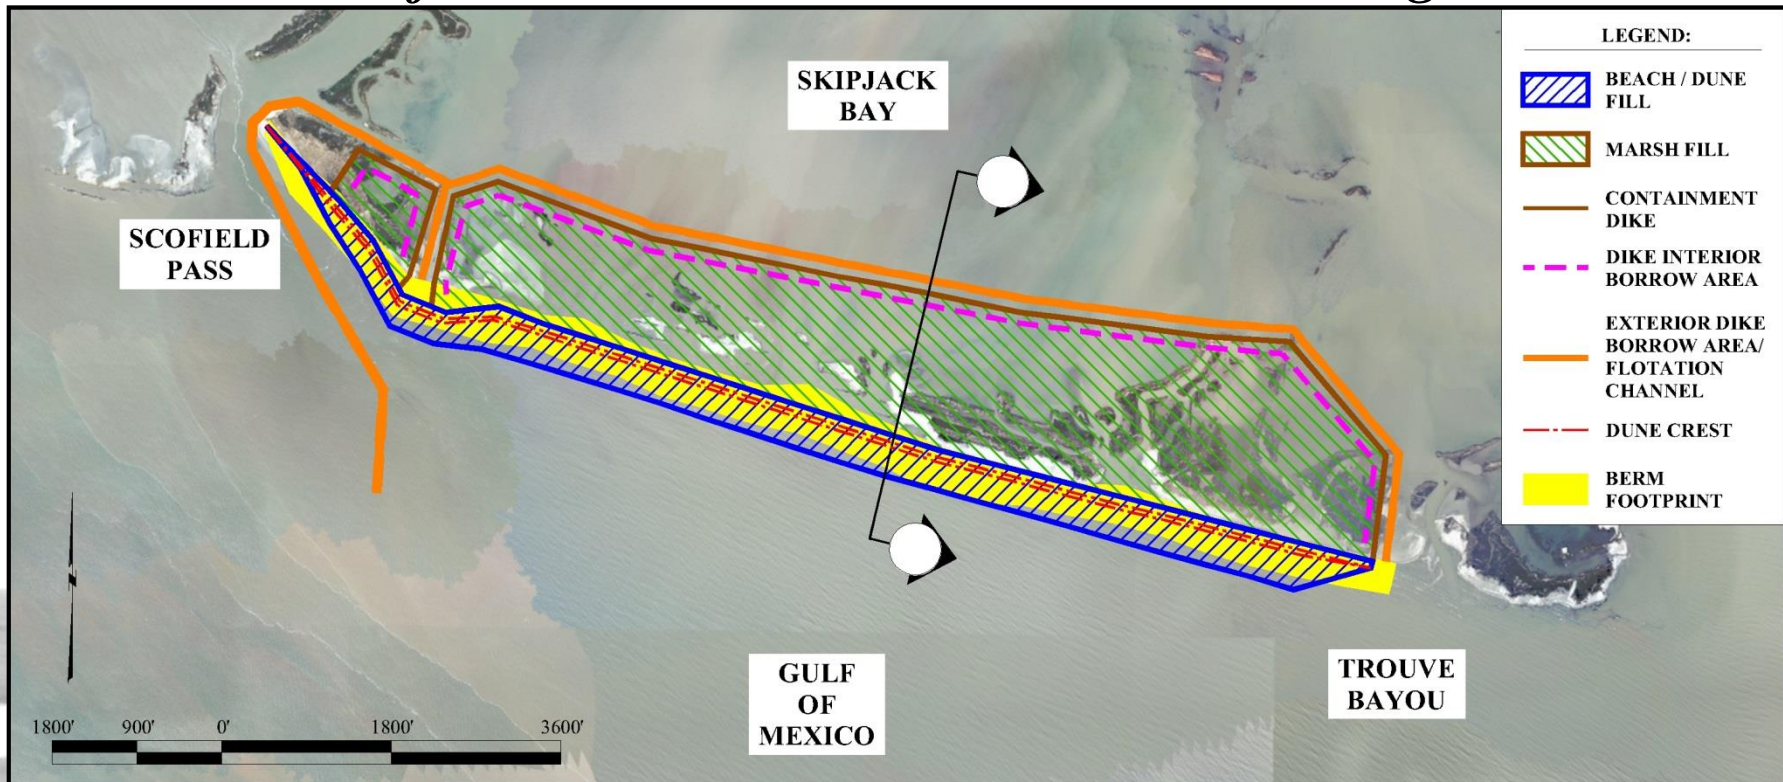
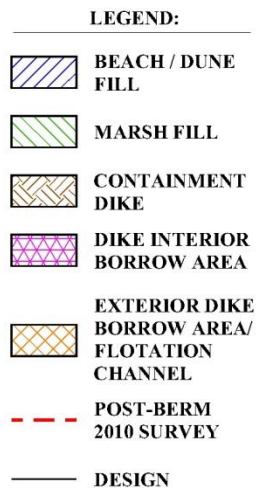
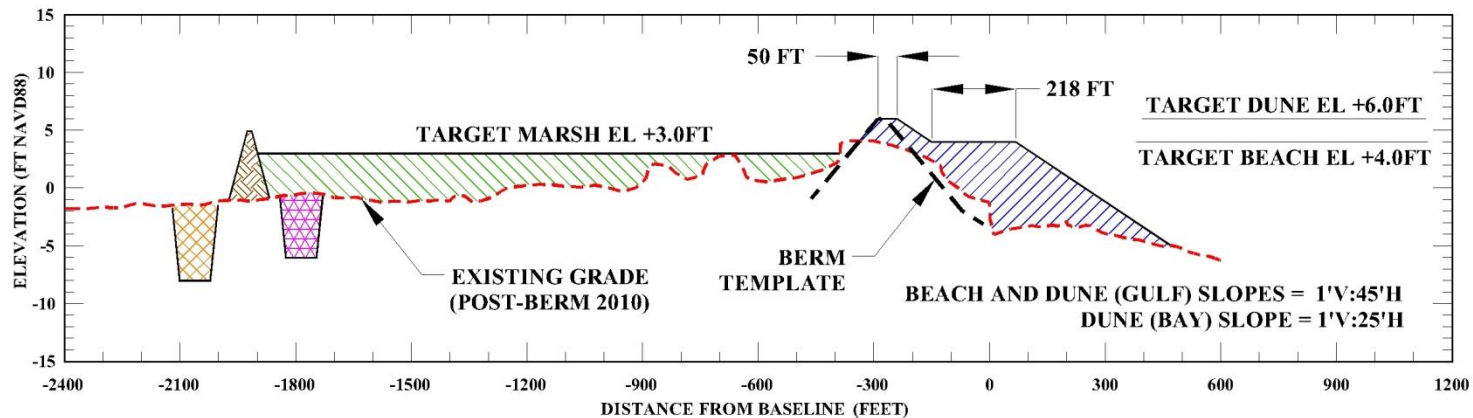
Scofield Island - Final Construction Design

POST-BERM GULFWARD TEMPLATE - FINAL CONSTRUCTION TEMPLATE

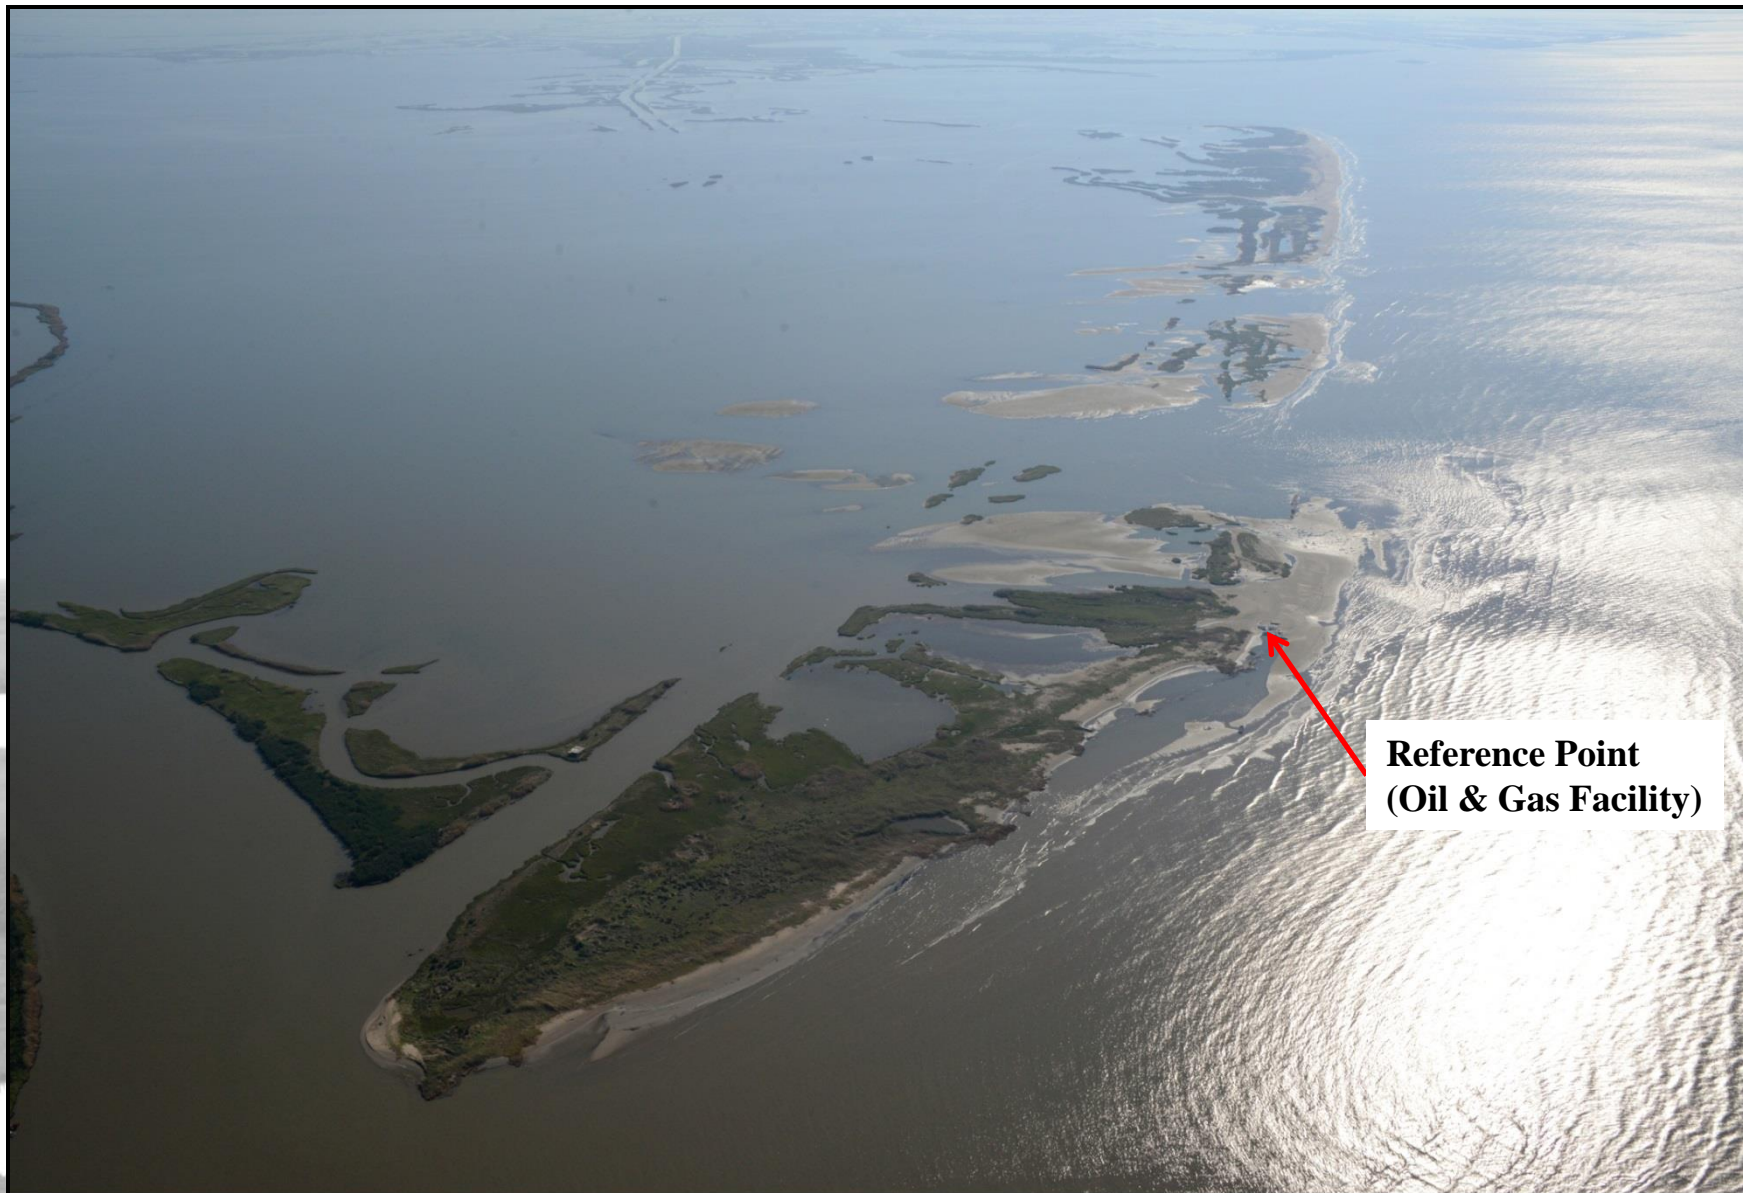
Post – Hurricane Isaac

Scofield Island

Image # 121002 6049
Date 10.02.12

Hurricane Isaac Impacts

Hurricane Impacts

Beach and Dune

- 257,310 cy (-15.8%)

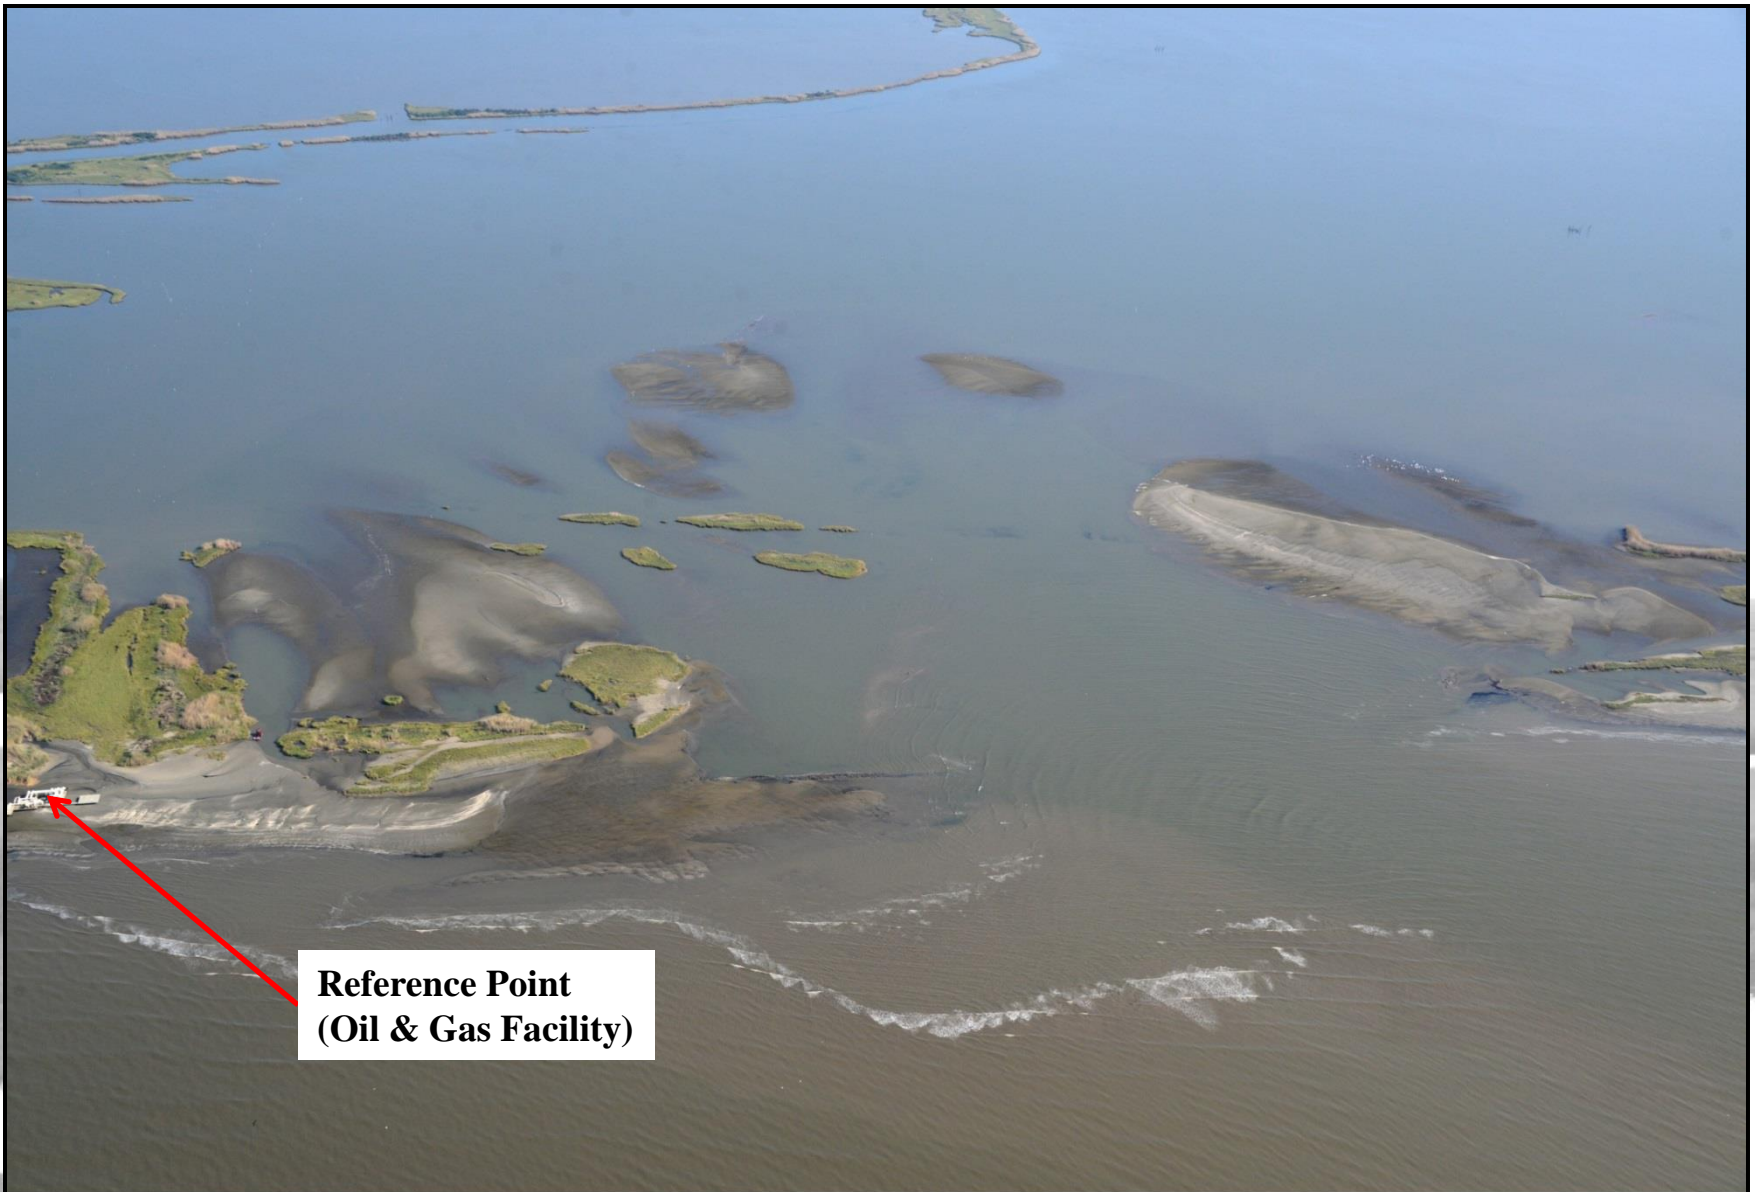
Post – Hurricane Isaac Breach

**Reference Point
(Oil & Gas Facility)**

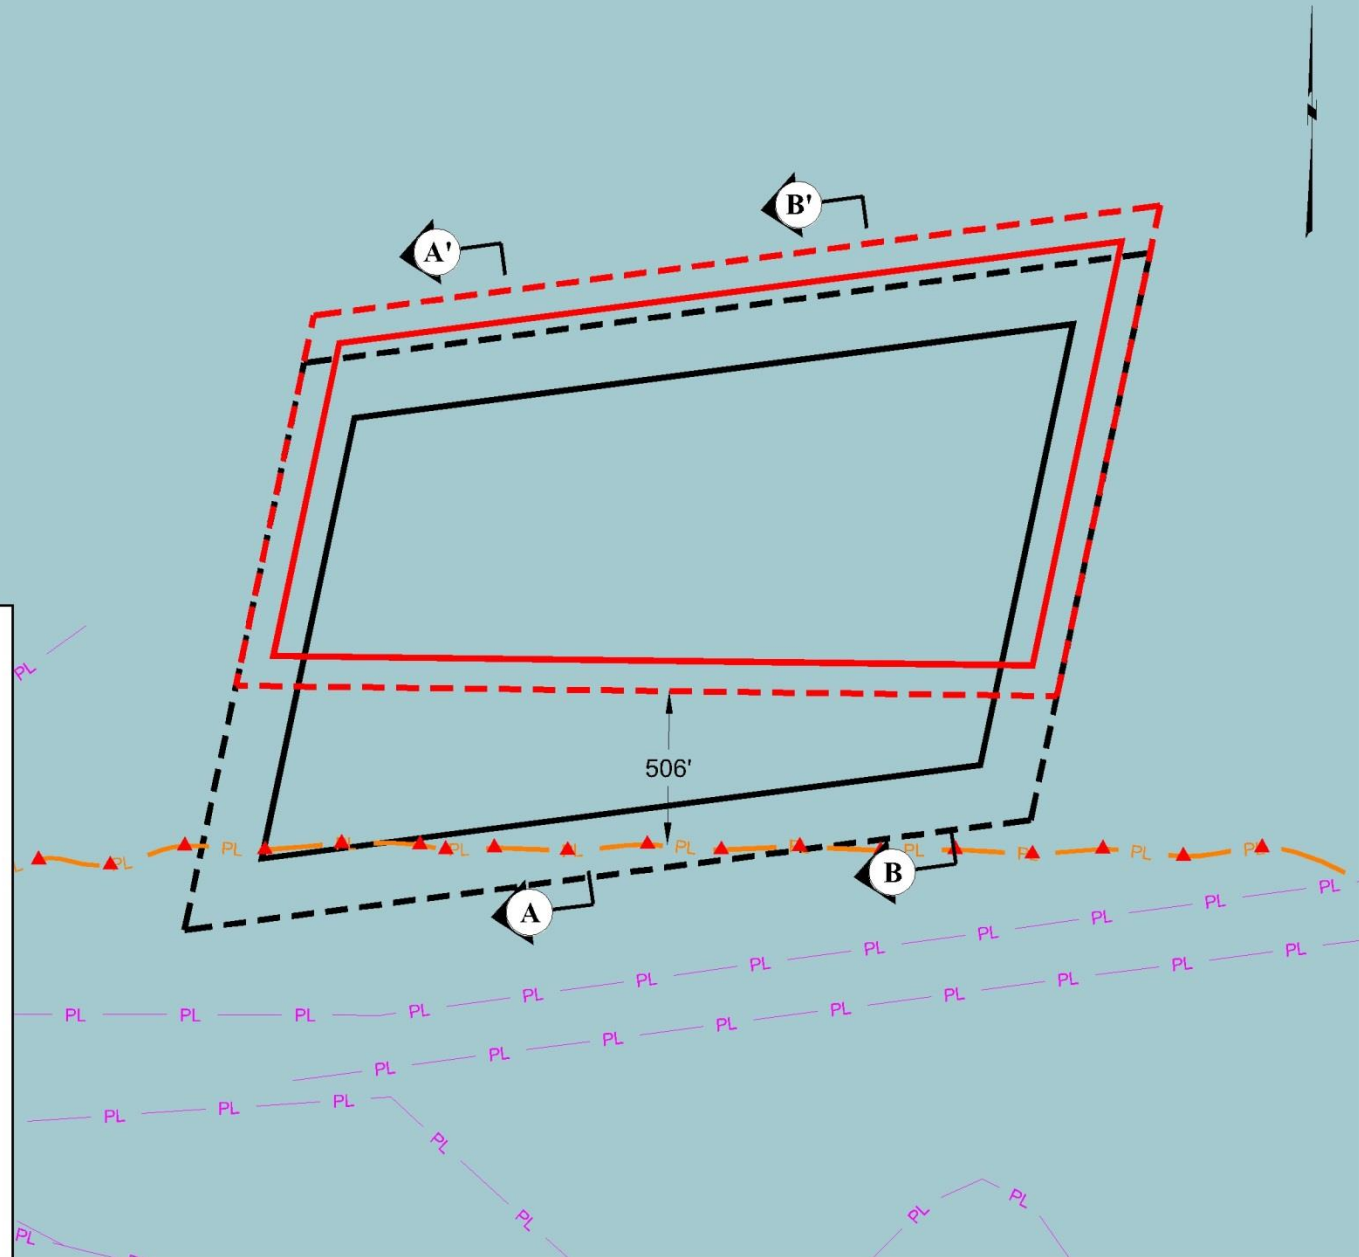
Scofield Offshore Borrow Area Redesign

ORIGINAL BORROW AREA PARAMETERS

BORROW AREA LENGTH	2,800 FT
BORROW AREA WIDTH	1,900 FT
BORROW AREA CUT DEPTH	-40 FT
BORROW AREA VOLUME (-40' NAVD88)	3.30 MCY

REVISED BORROW AREA PARAMETERS

BORROW AREA LENGTH	2,810 FT
BORROW AREA WIDTH	1,650 FT
BORROW AREA CUT DEPTH	-42 FT
BORROW AREA VOLUME (-42' NAVD88)	3.02 MCY

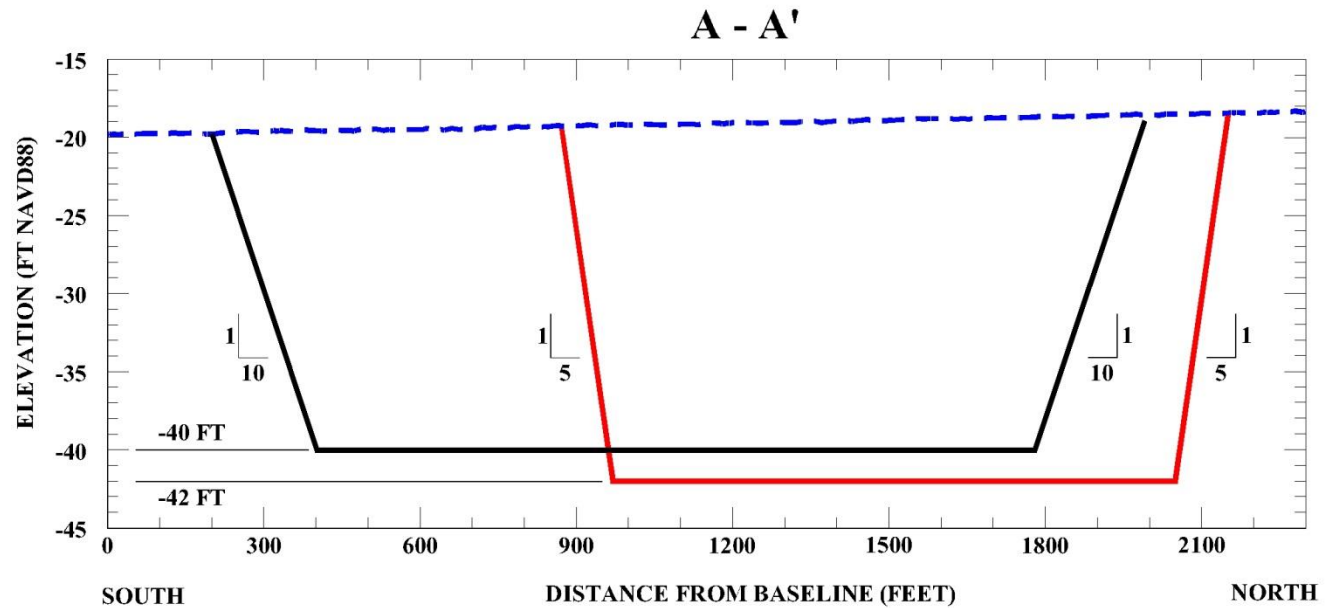
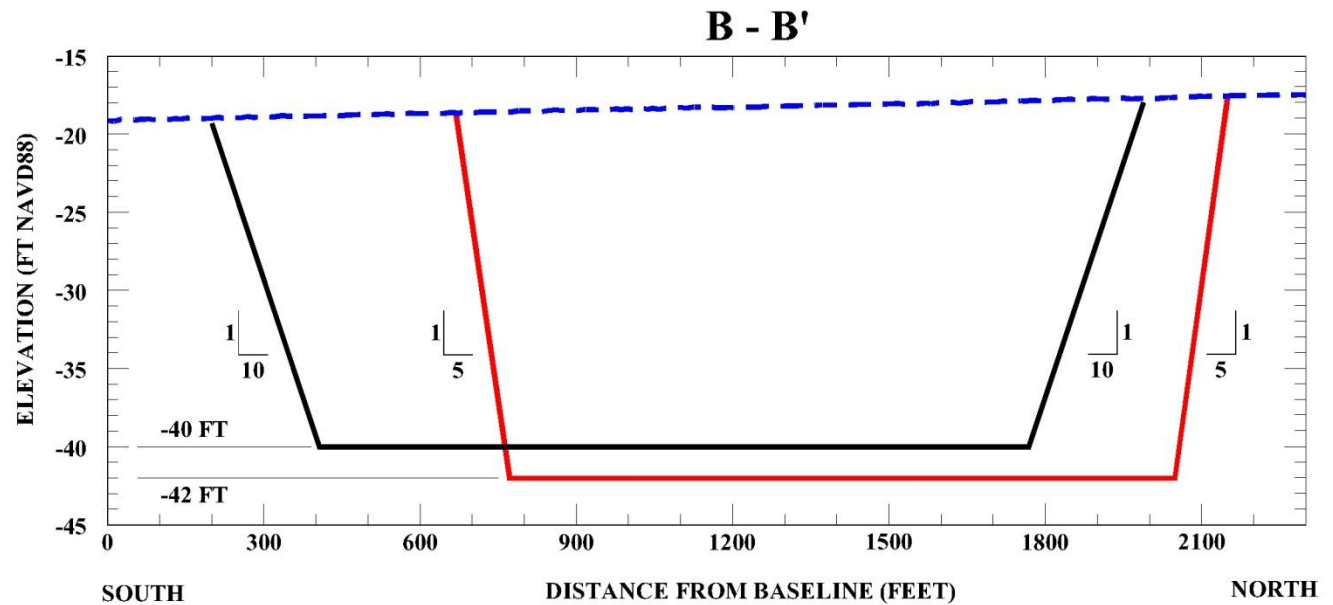
Scofield Offshore Borrow Area Redesign

- EXISTING GRADE
- ORIGINAL BORROW AREA DESIGN
- REVISED BORROW AREA DESIGN

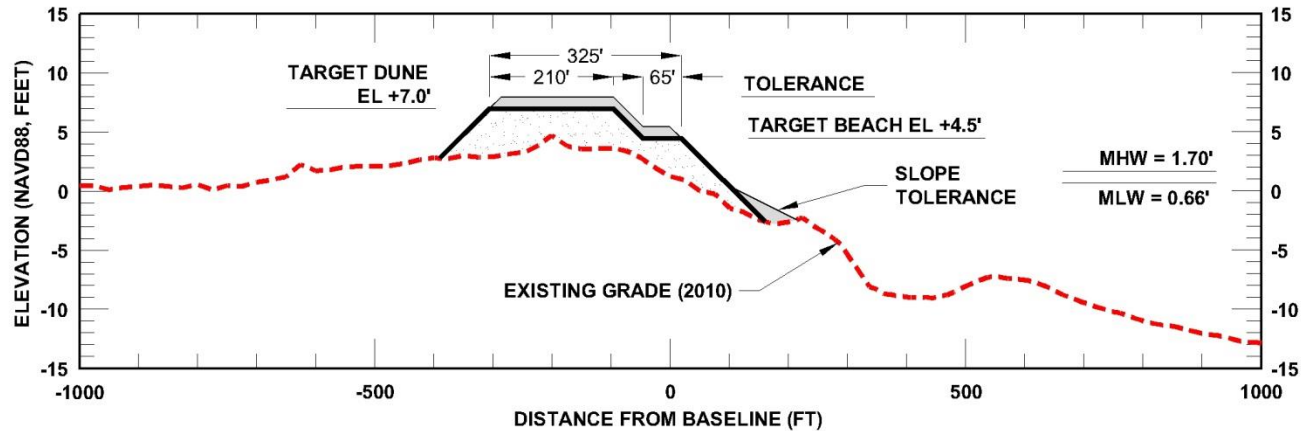
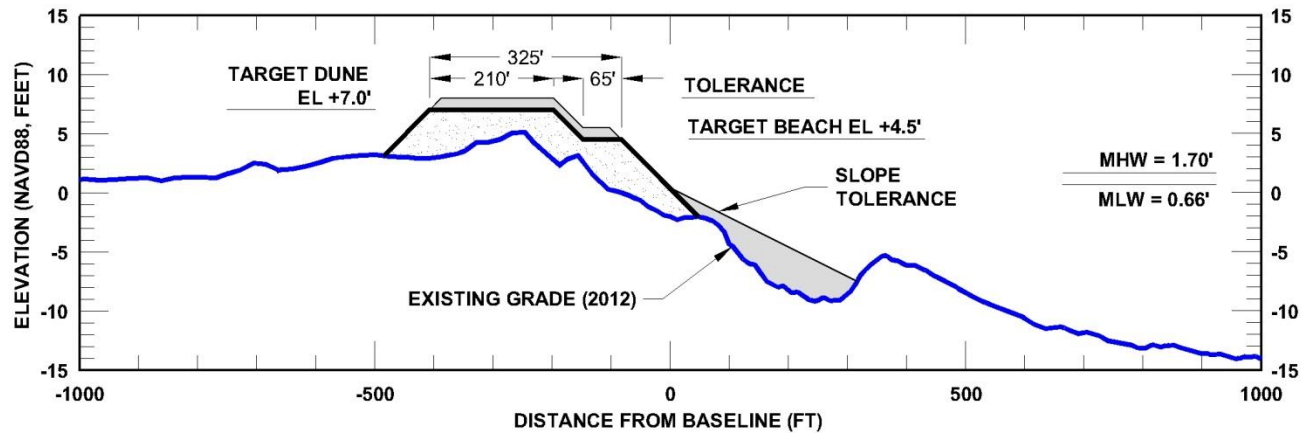
Post- Hurricane Typical Design Template Adjustment

SCALE:
H: 1" = 300'
V: 1" = 15'

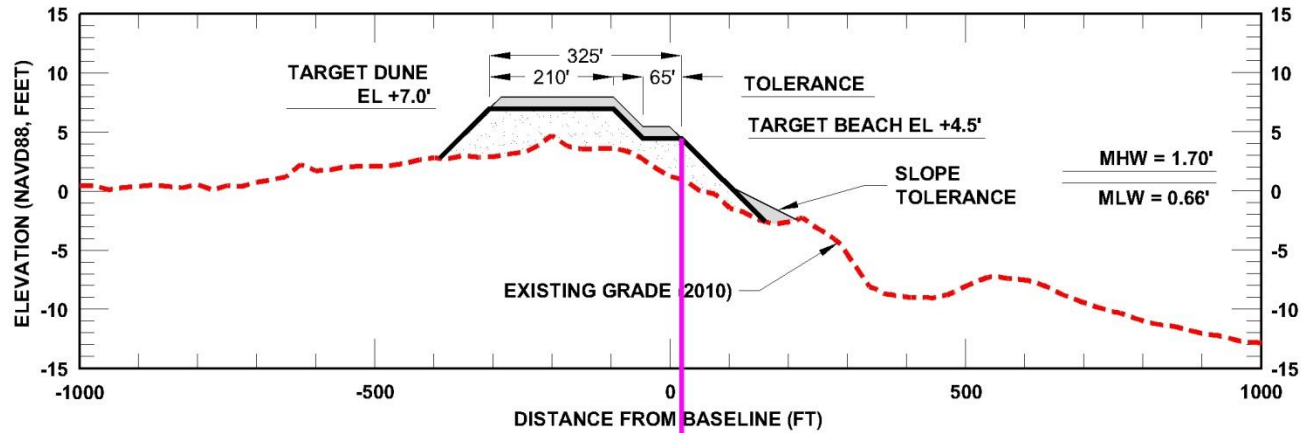
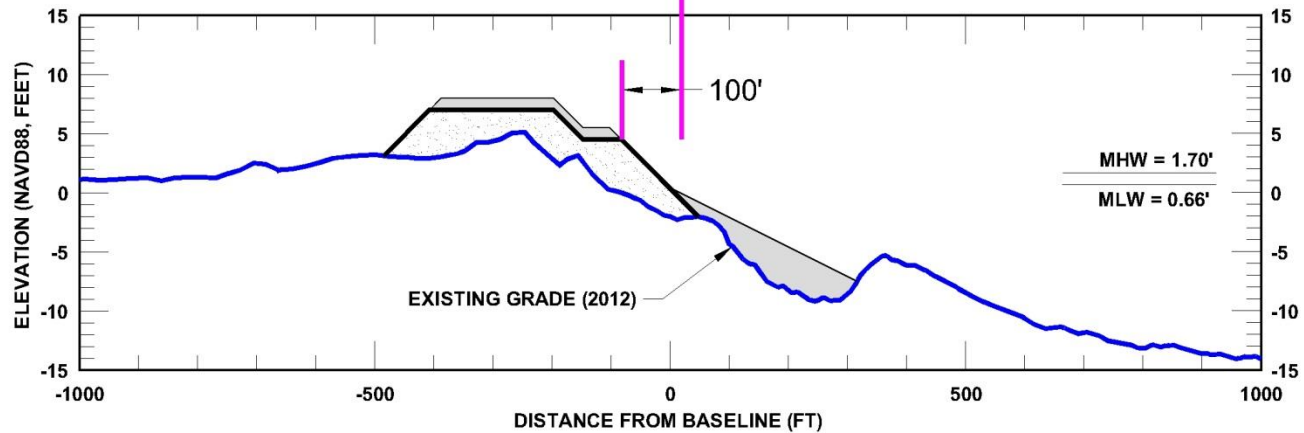
Post- Hurricane Typical Design Template Offset

SCALE:
H: 1" = 300'
V: 1" = 15'

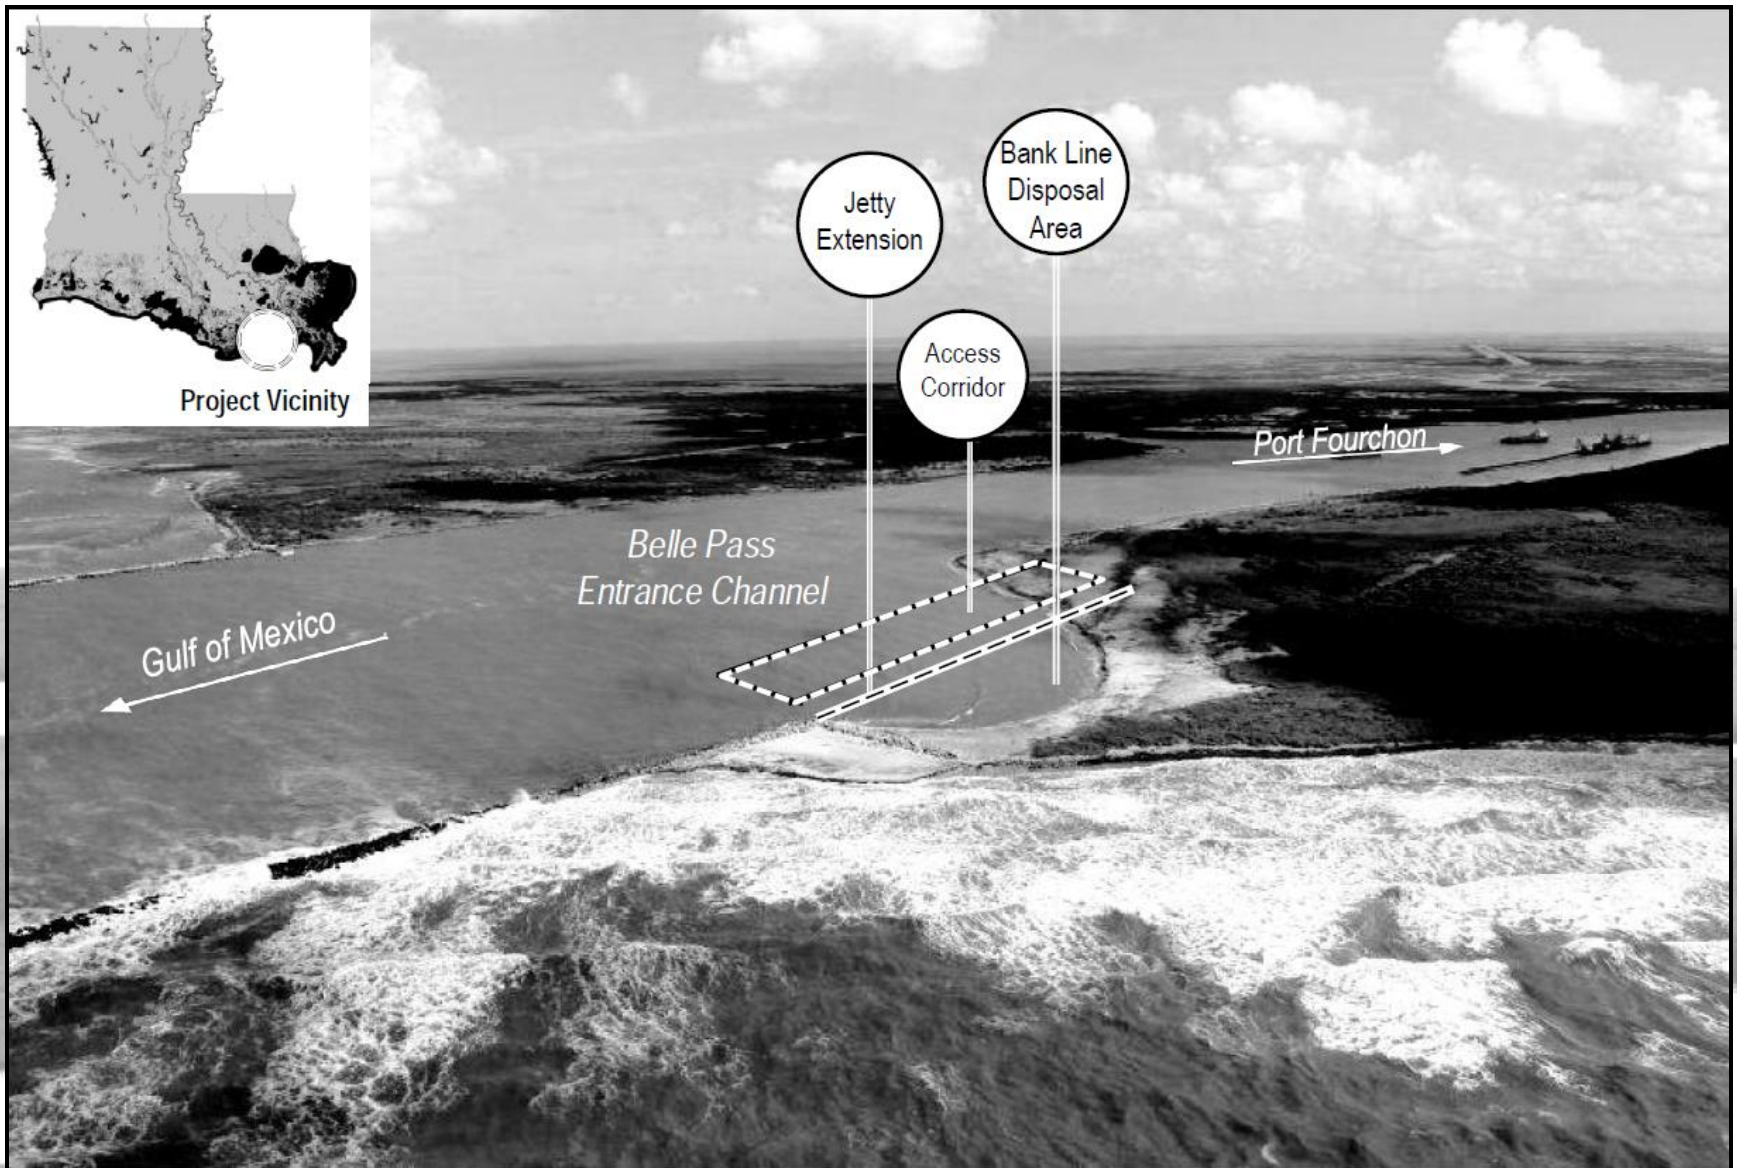
Figure 1. Project vicinity & overview. The jetty extension would tie the existing jetty to a natural high ridge along the bank line, crossing an area of shallow open water and beach. Equipment would access the construction site from Belle Pass. Dredged material excavated to provide equipment access would be temporarily stockpiled within the access corridor for later use as construction backfill, and/or placed beneficially in a shallow cove to rebuild a portion of the eroded bank line.

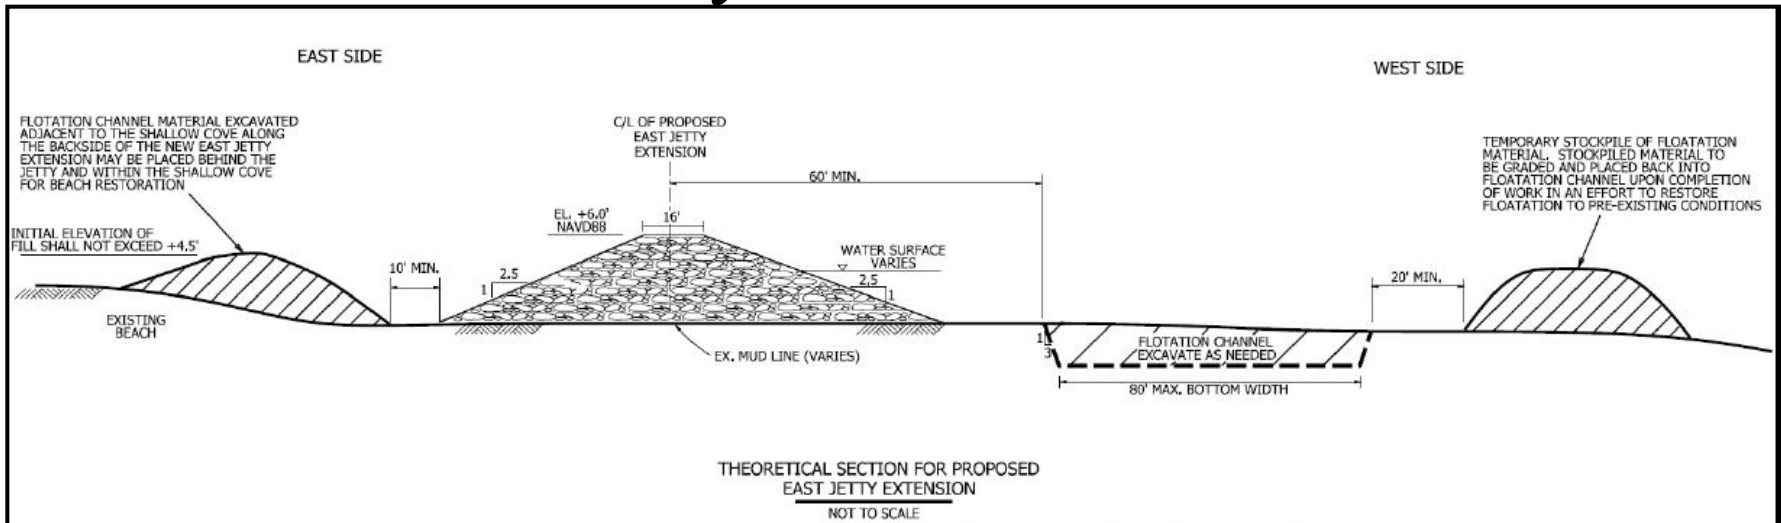
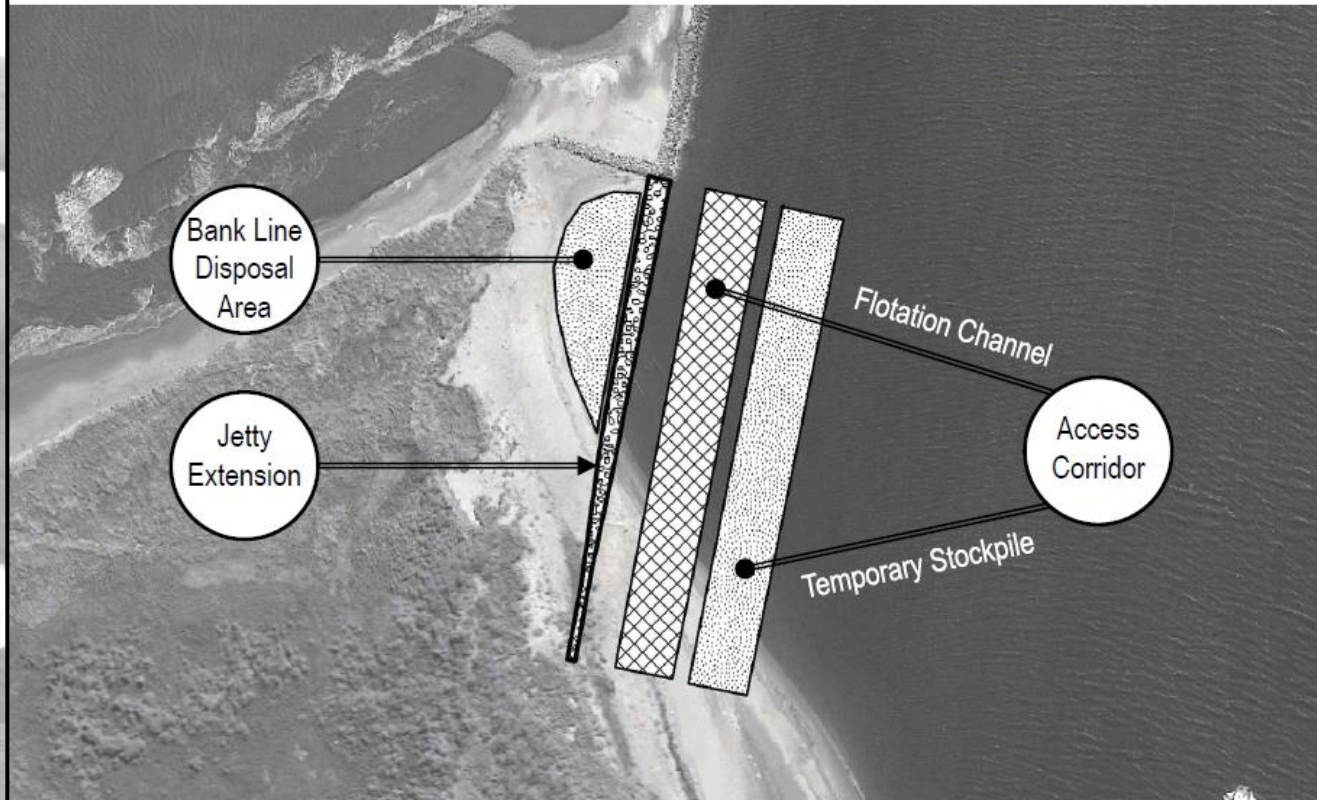
Figures 2 and 3. Theoretical cross-section (above) and plan view (left) of the jetty extension, flotation channel, temporary stockpile area, and bank line disposal area.

The jetty extension would tie the existing jetty to a natural high ridge along the bank line.

A flotation channel would be excavated to provide equipment access for construction of the jetty extension. Dredged material would be temporarily stockpiled adjacent to the channel for later use as backfill, and placed beneficially in the bank line disposal area to restore an eroded section of the bank line.

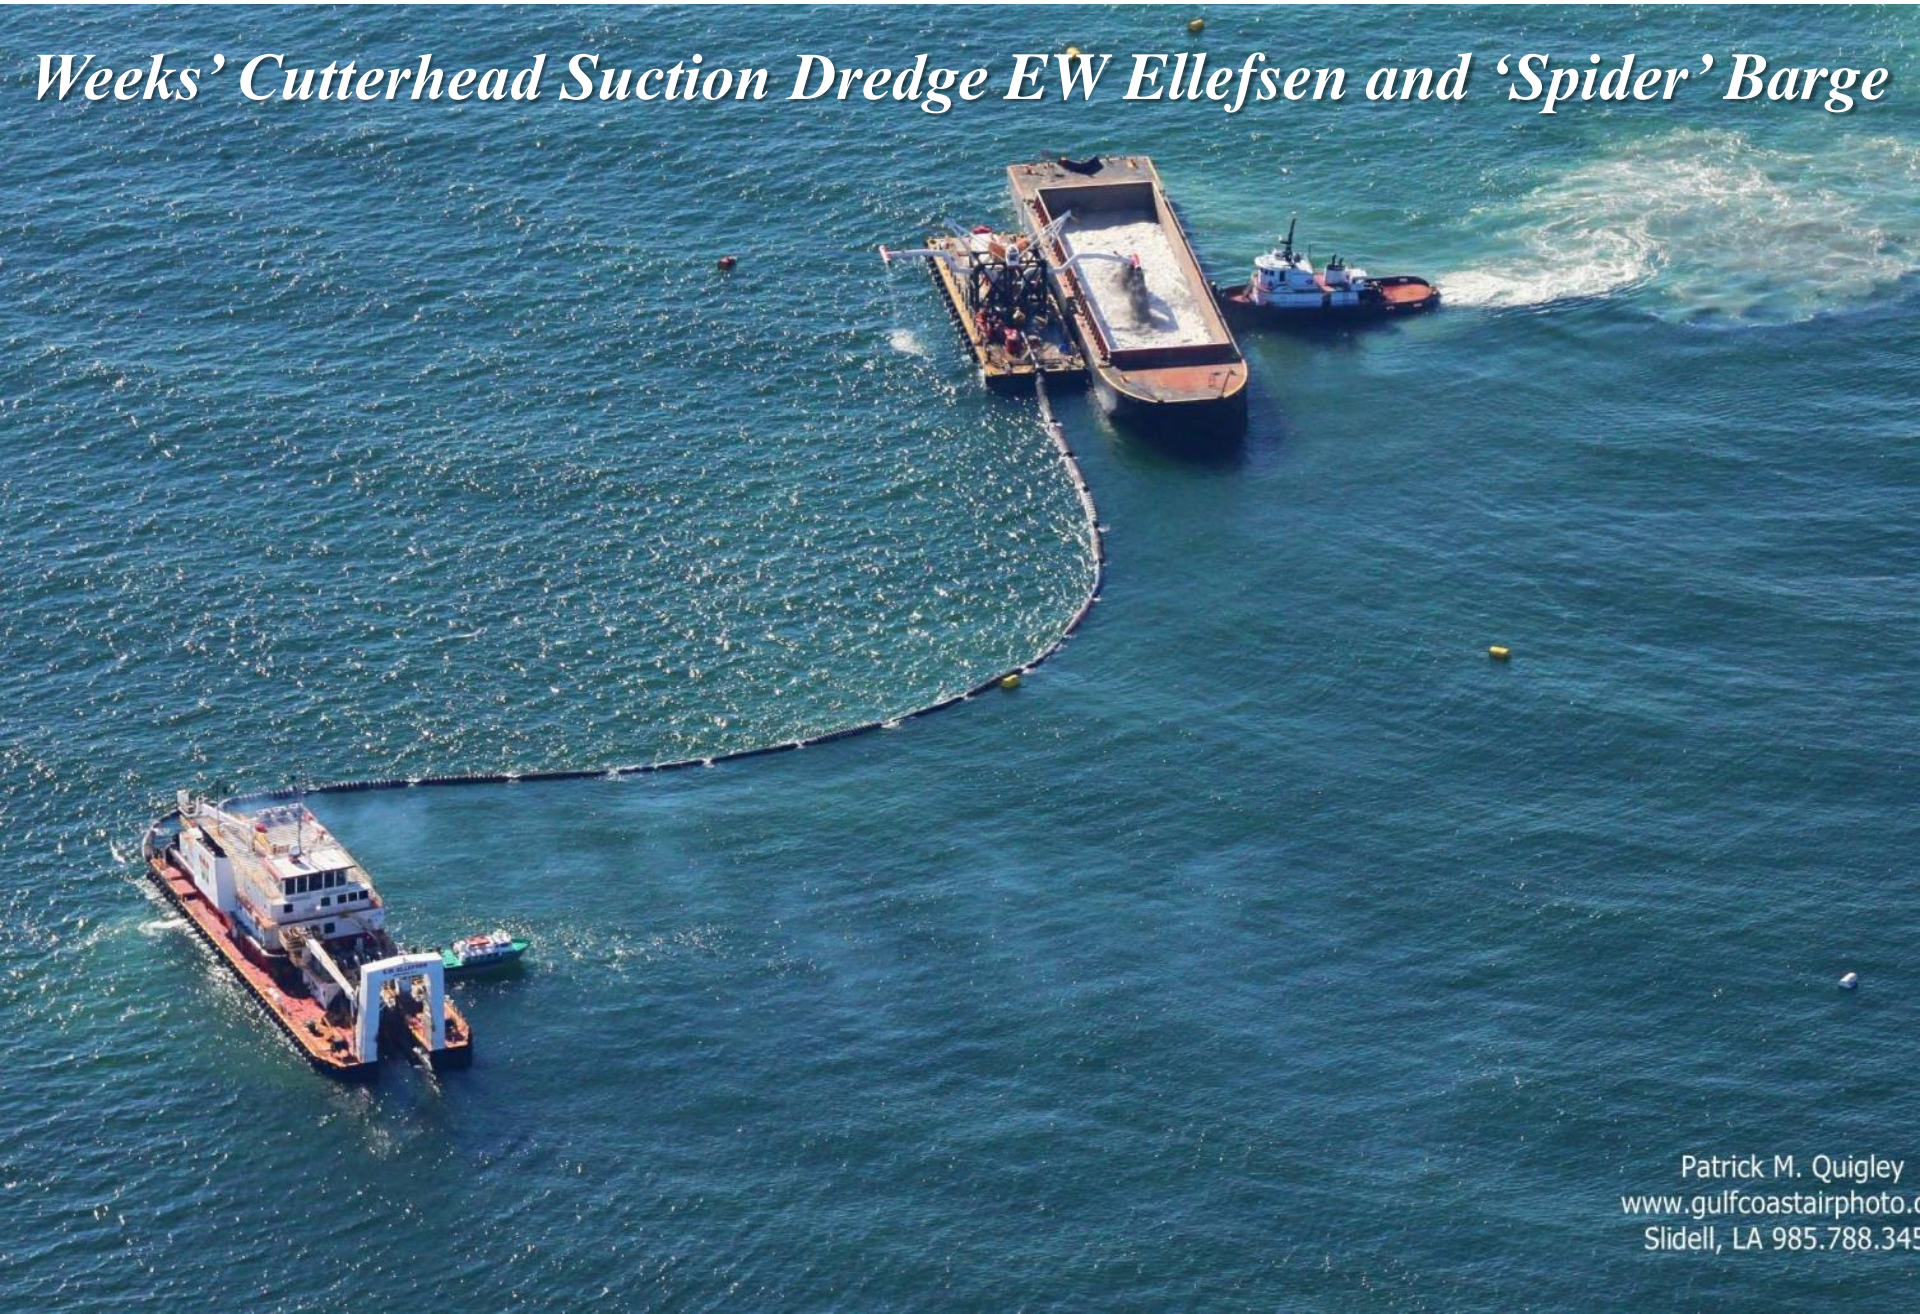
Weeks’ Cutterhead Suction Dredge EW Ellefsen and ‘Spider’ Barge

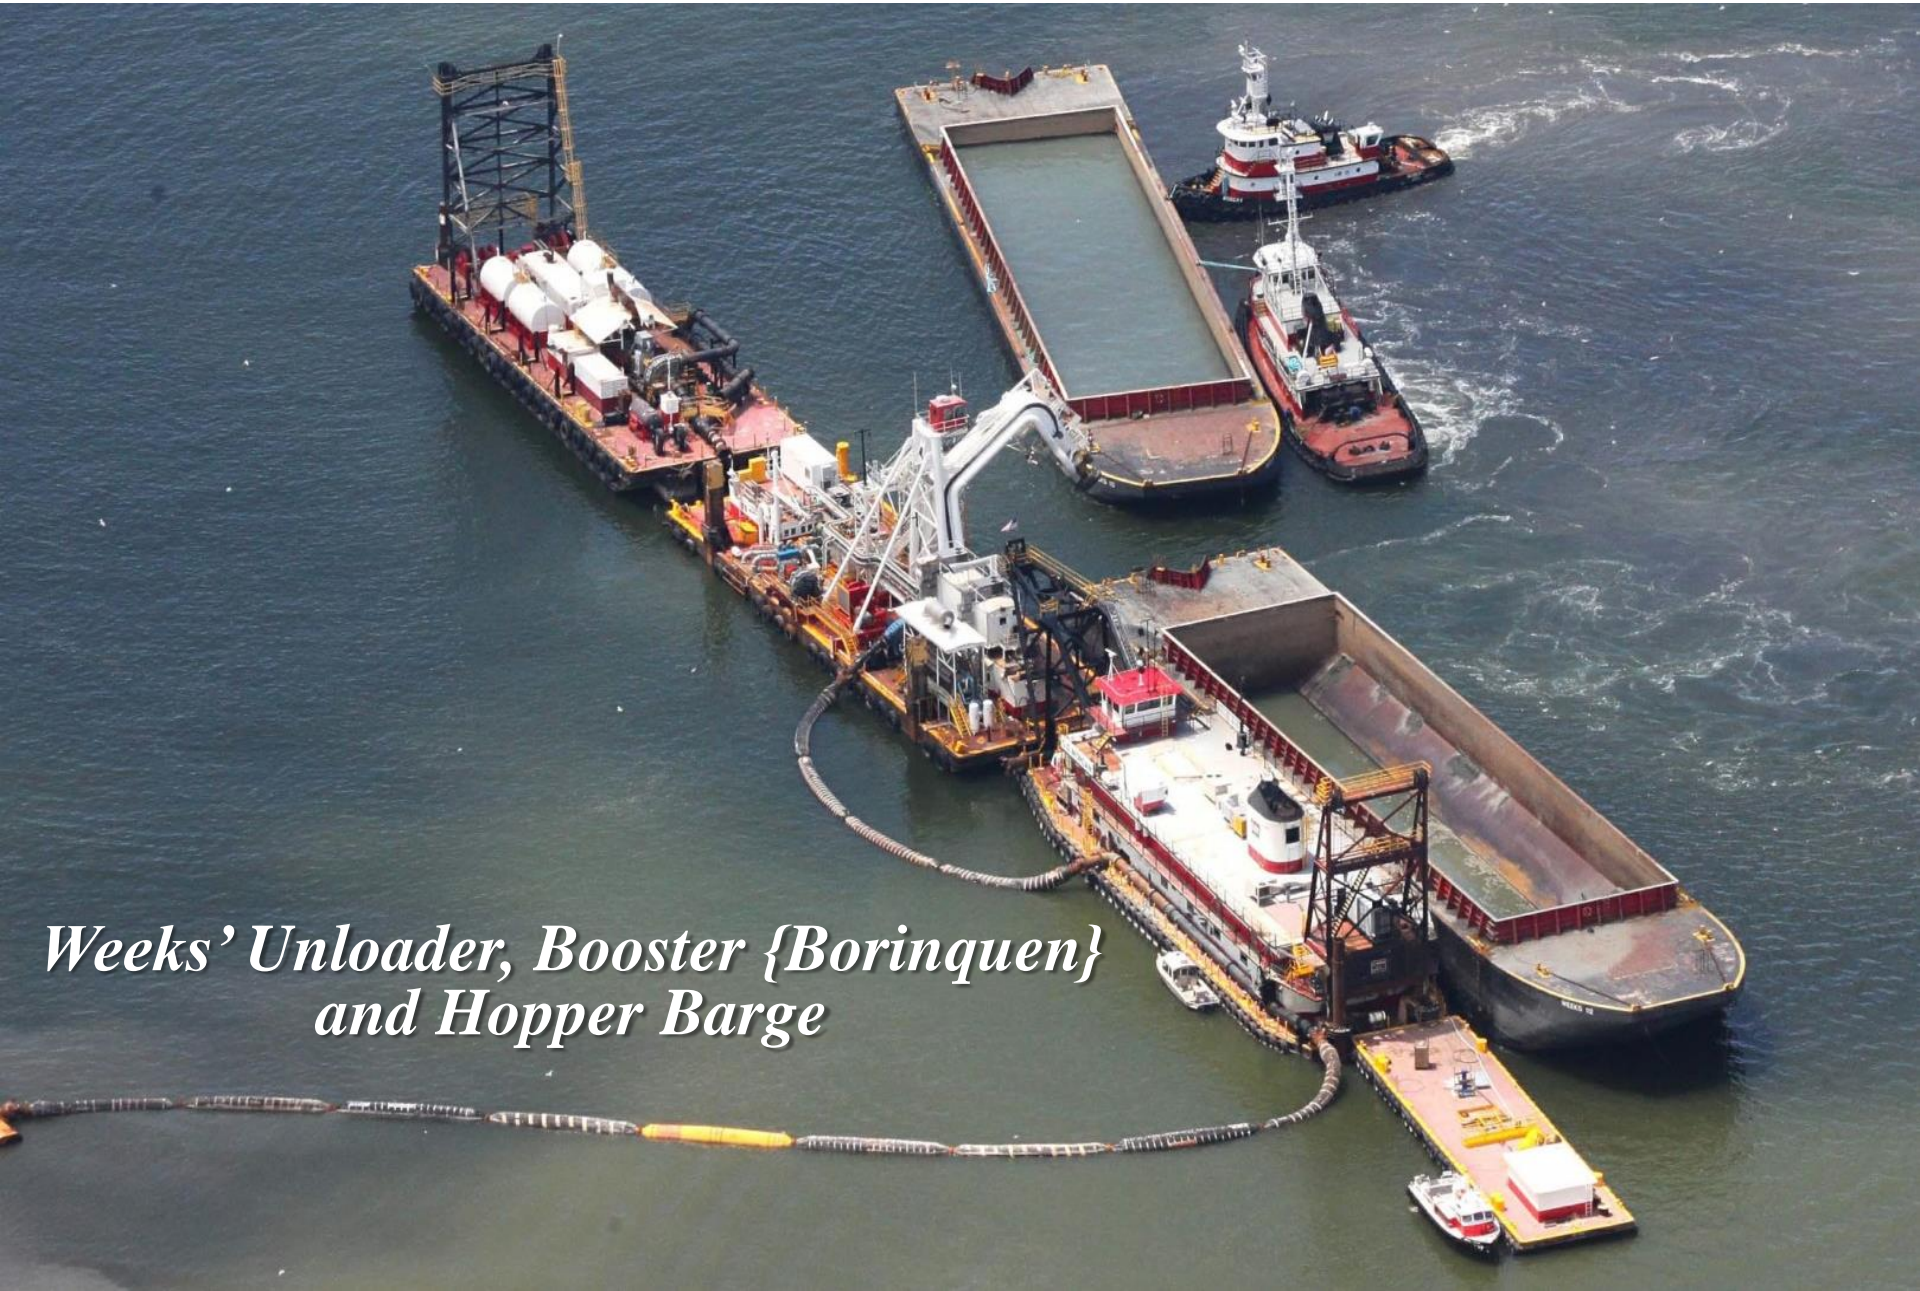
*Weeks’ Unloader, Booster {Borinquen}
and Hopper Barge*
