# PAST, PRESENT AND FUTURE OF MEXICO BEACH, THE UNFORGETTABLE COAST

**Michael R. Dombrowski, P.E., President, MRD Associates, Inc.**  
Caroline MacLeod, E.I., Coastal Engineer, Coastal Protection Engineering

**FSBPA 38<sup>th</sup> Annual National Conference on Beach Preservation Technology**  
**February 2025, Panama City Beach, Florida**

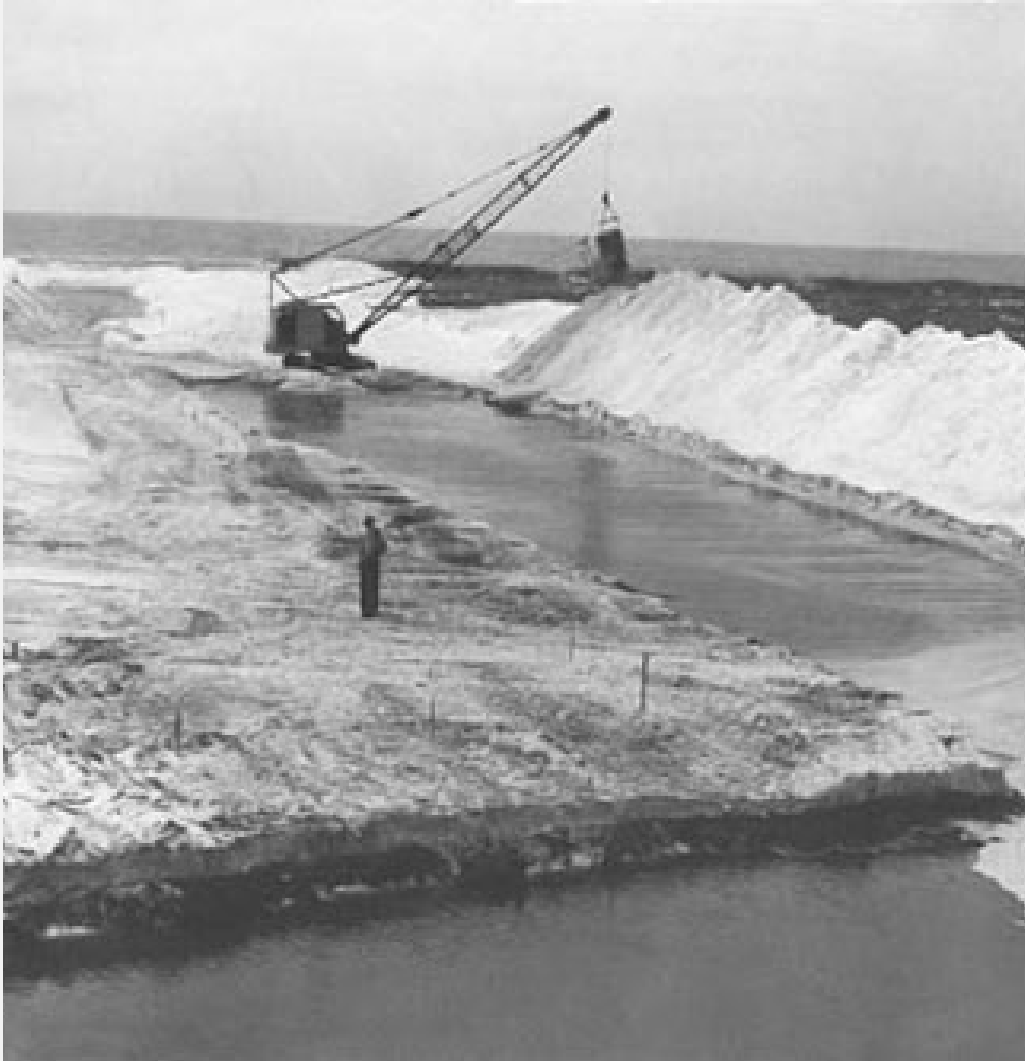
# MEXICO BEACH INLET HISTORY

- Inlet located at the west end.
- Created in the early 1960's.
- Channel follows the historic path of Salt Creek.
- Interior channel along the north side of US 98 and exits 1.9 miles to the east of the inlet channel.
- Supports recreational fishing and diving, and charter boats.
- Maintained by a City owned suction head dredge since 1978.

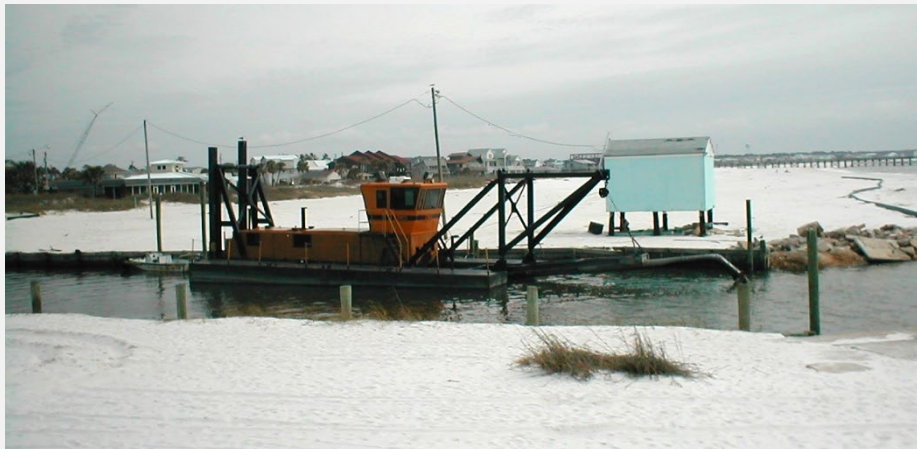
# MEXICO BEACH INLET HISTORY

- 1960 – Initial inlet construction
- 1971 to 1974 – Dragline (100,000 cy)
- 1974 – CERC USACE Truck mounted jet pump field experiment.
- 1975 – State grant to purchase a fixed twin jet pump system.
- 1975 – Hurricane Eloise
- 1976 – City owned jet pump
- 1978 to present - City owned suction head dredge.

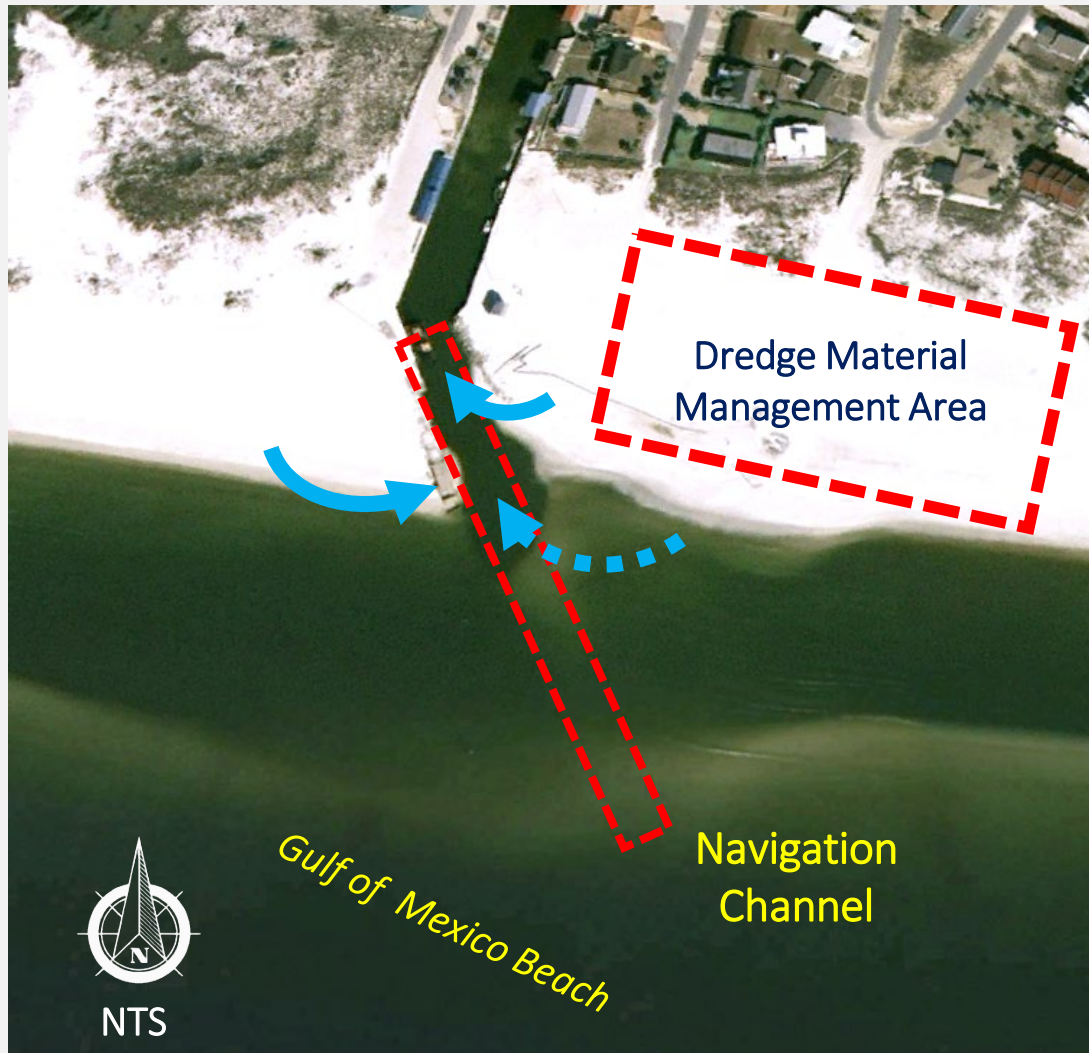
# MEXICO BEACH INLET ISSUES

- Discharge pipe less than 350 feet from the inlet.
- West jetty middle section is not sand tight.
- East jetty is a pile of loose rubble and is not sand tight.
- Deposition from the downdrift shoreline and recycling dredged material back into the inlet.
- Stockpile of dredged material on the downdrift shoreline and not bypassed to the eroding shoreline.

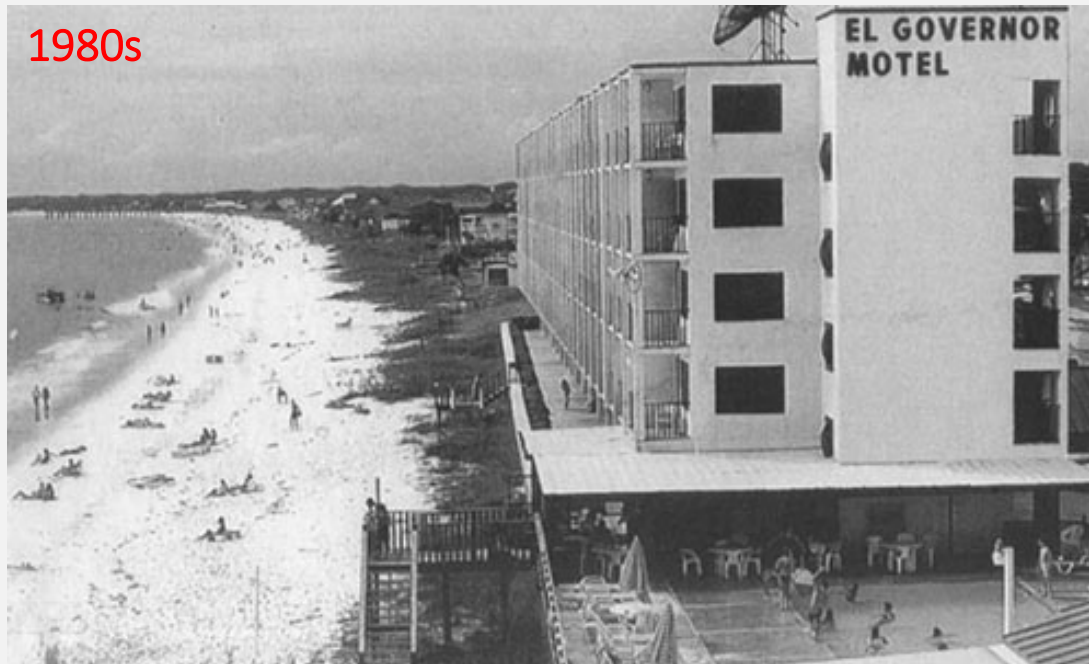
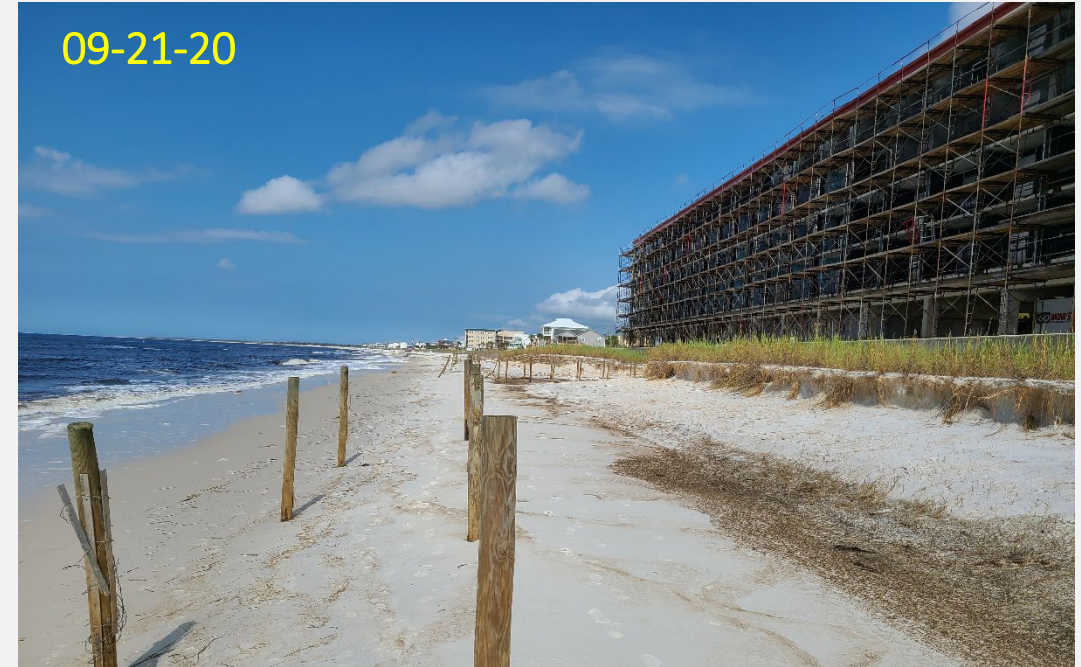
# CRITICALLY ERODED SHORELINE (R-132 to R-137.8)

Pursuant to rule 62B-36.002(5), Florida Administrative Code (F.A.C.), defines “critically eroded shoreline” as, “a segment of the shoreline where natural processes or human activity have caused or contributed to erosion and recession of the beach or dune system to such a degree that upland development, recreational interests, wildlife habitat, or important cultural resources are threatened or lost.”

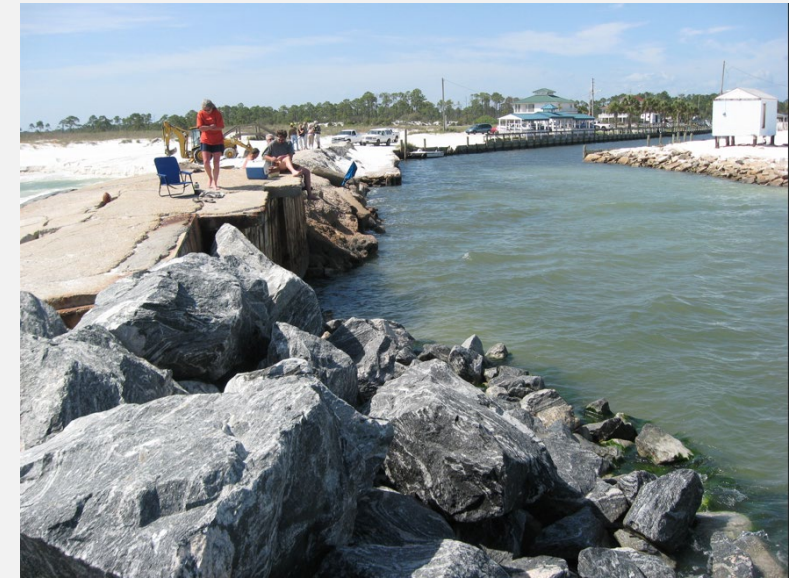
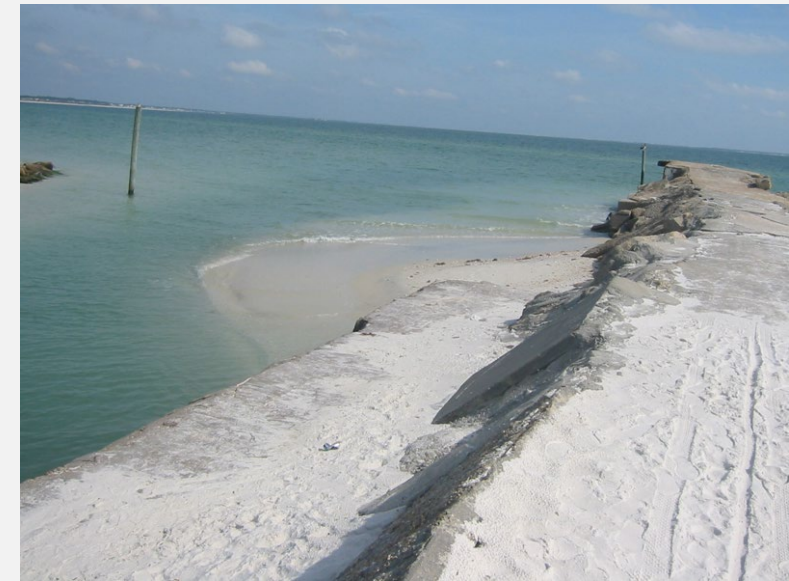
# WEST JETTY IMPROVEMENTS

- Constructed in 2008
- 60-foot extension
- City attempted to sand tighten box culverts

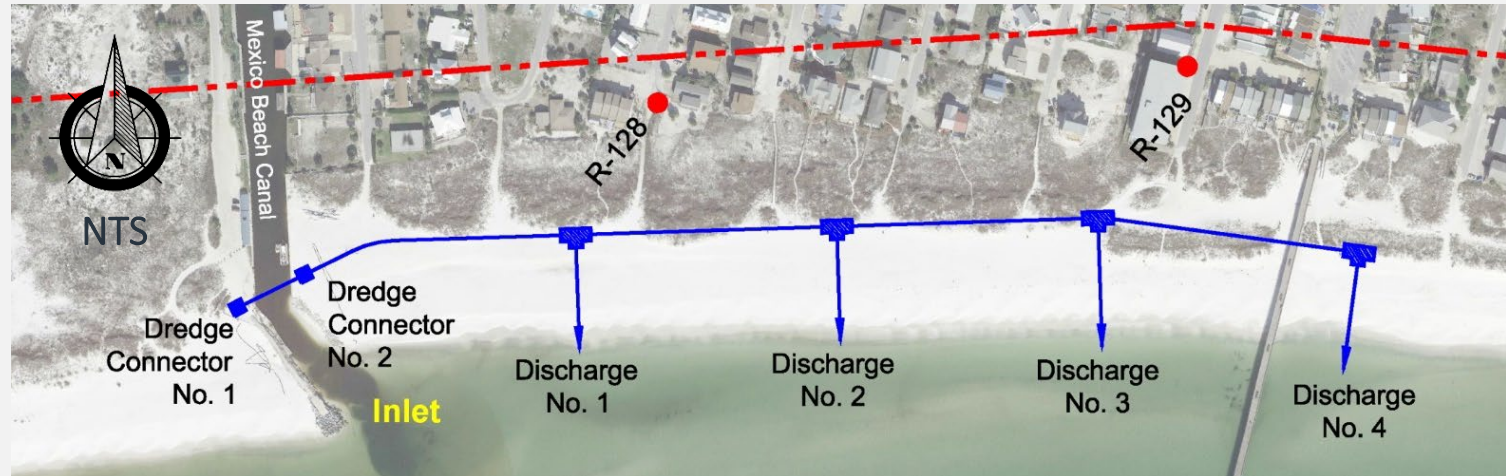
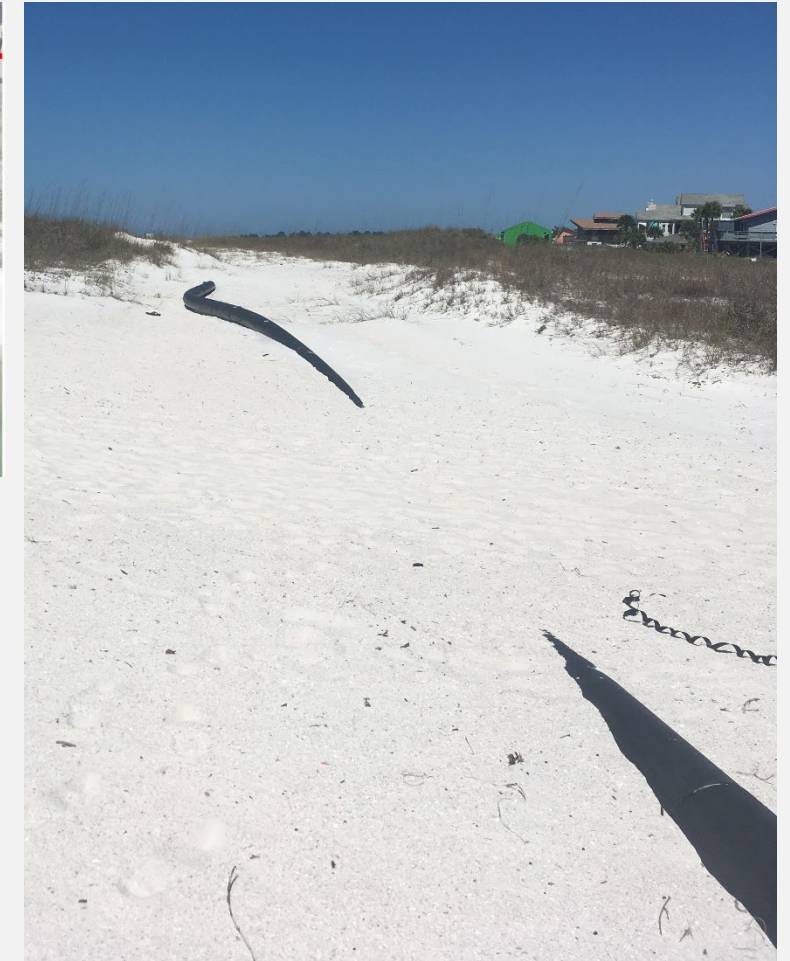
# DREDGE PIPE WITH MULTIPLE DISCHARGE POINTS

- Permitted in 2009, installed in 2010.
- Extended discharge 2,000 feet to the east.
- Installed under the inlet and buried 3 feet below grade on east side per USFWS conditions.
- Difficult to clear clogged pipeline.

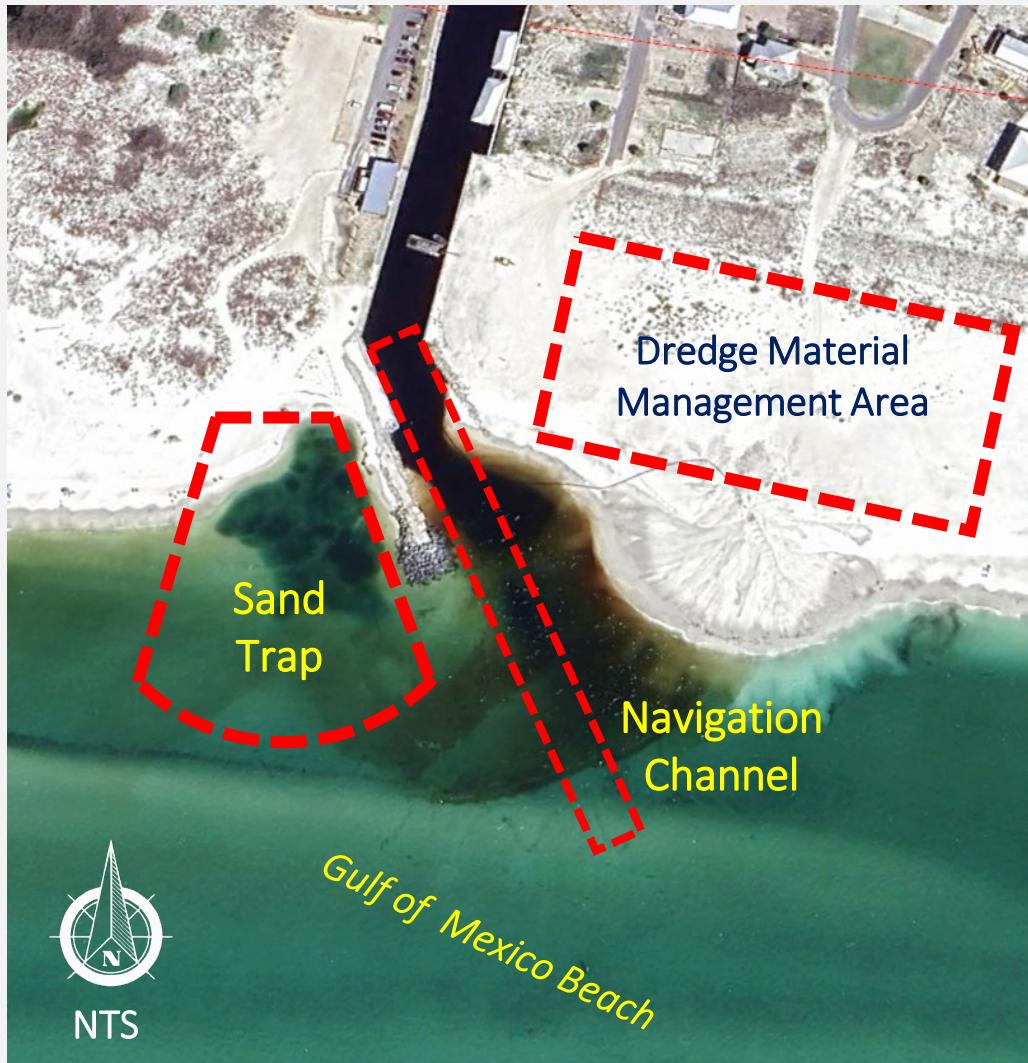
# UPDRIFT SEDIMENT TRAP AND CHANNEL

- DEP/USACE Permits – 2007 and 2009
- Dredge west beach sand trap.
- Maintenance dredge channel: 658' long x 50' wide, -8' NAVD88 deep with 2' allowable over dredge.
- Permit authorizes an average annual of 250,000 yds<sup>3</sup>/yr of the dredged, beach quality sand on the eastern (downdrift) beach below the mean high-water line.
- Stockpile dredged material (DMMA).

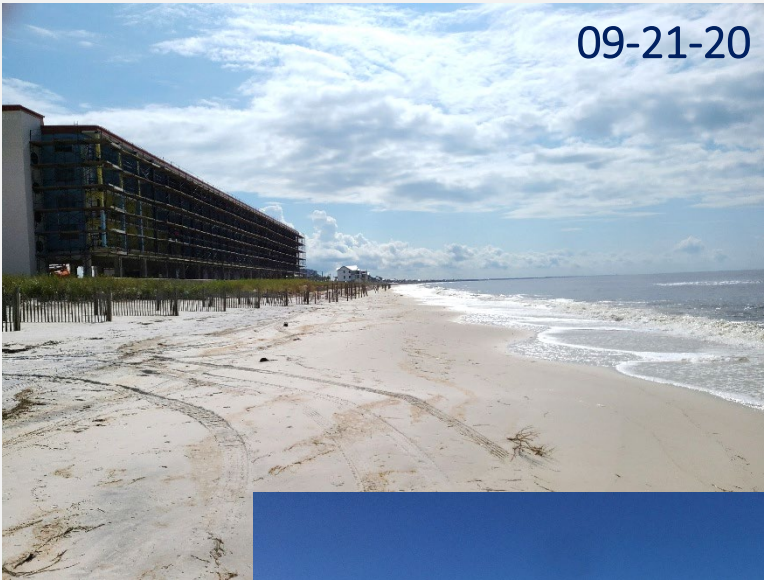
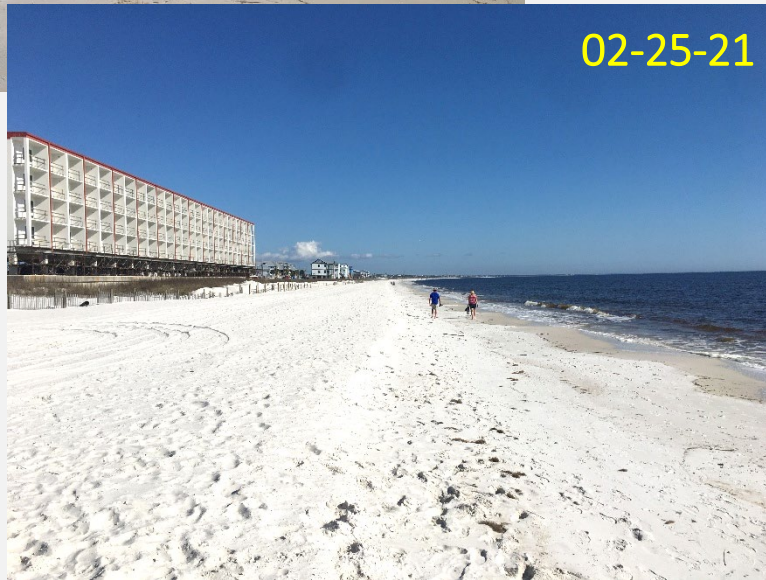
# SAND BYPASSING – TRUCK HAUL

- DEP Permit Modification – 2019
- 2021 implementation of the inlet bypassing of sand stockpiled to the east of the inlet.
- Trucked haul sand to the “critically eroded” shoreline (R-132 to R-137.8).
- 18,750 yds<sup>3</sup>; 4,750 feet (0.9 miles).
- Sand placed above the MWH line.
- Construction cost: \$397,510

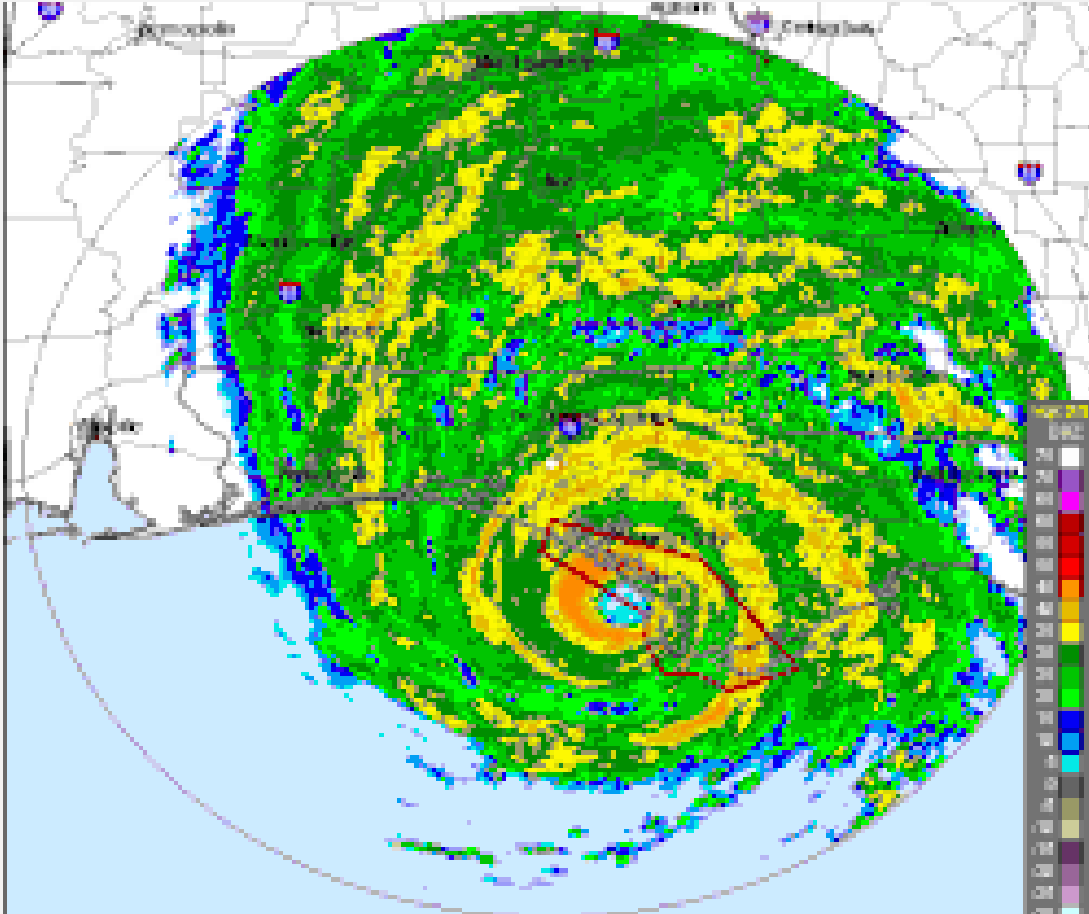
## CATEGORY B - FEMA BERMS

- 1998 and 2006
  - 121,820 yds<sup>3</sup>
  - Total cost: \$2.2 Million
- 2008 – Hurricane Gustav
  - Constructed in 2009
  - 14,345 yds<sup>3</sup>; 9,393 feet (1.8 miles)
  - R-128.5 to R-138
  - Total cost: \$780,000
- 2018 – Hurricane Michael
  - Constructed in 2019
  - 97,000 yds<sup>3</sup> ; 16,200 feet (3.1 miles)
  - R-127.5 to R-144
  - 155,320 native dune plants
  - Total cost: \$4.6 Million

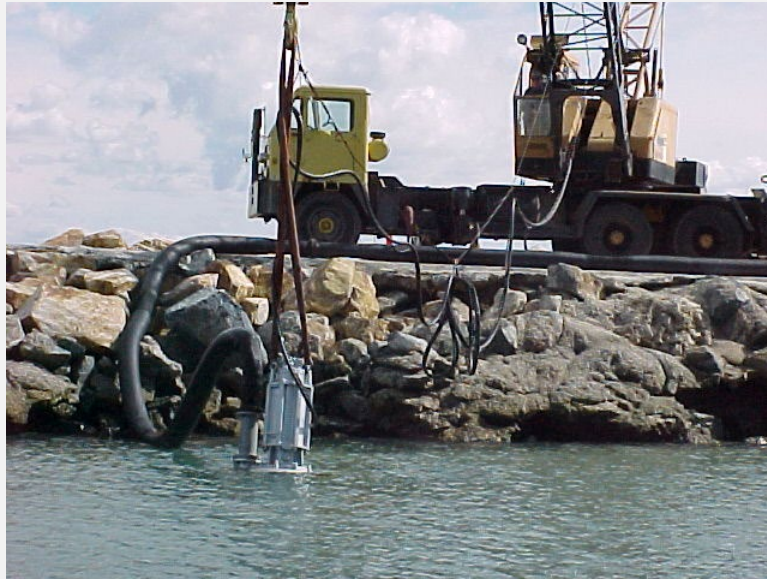
# NEW DREDGE

Dredge-head mounted  
on a mobile crane

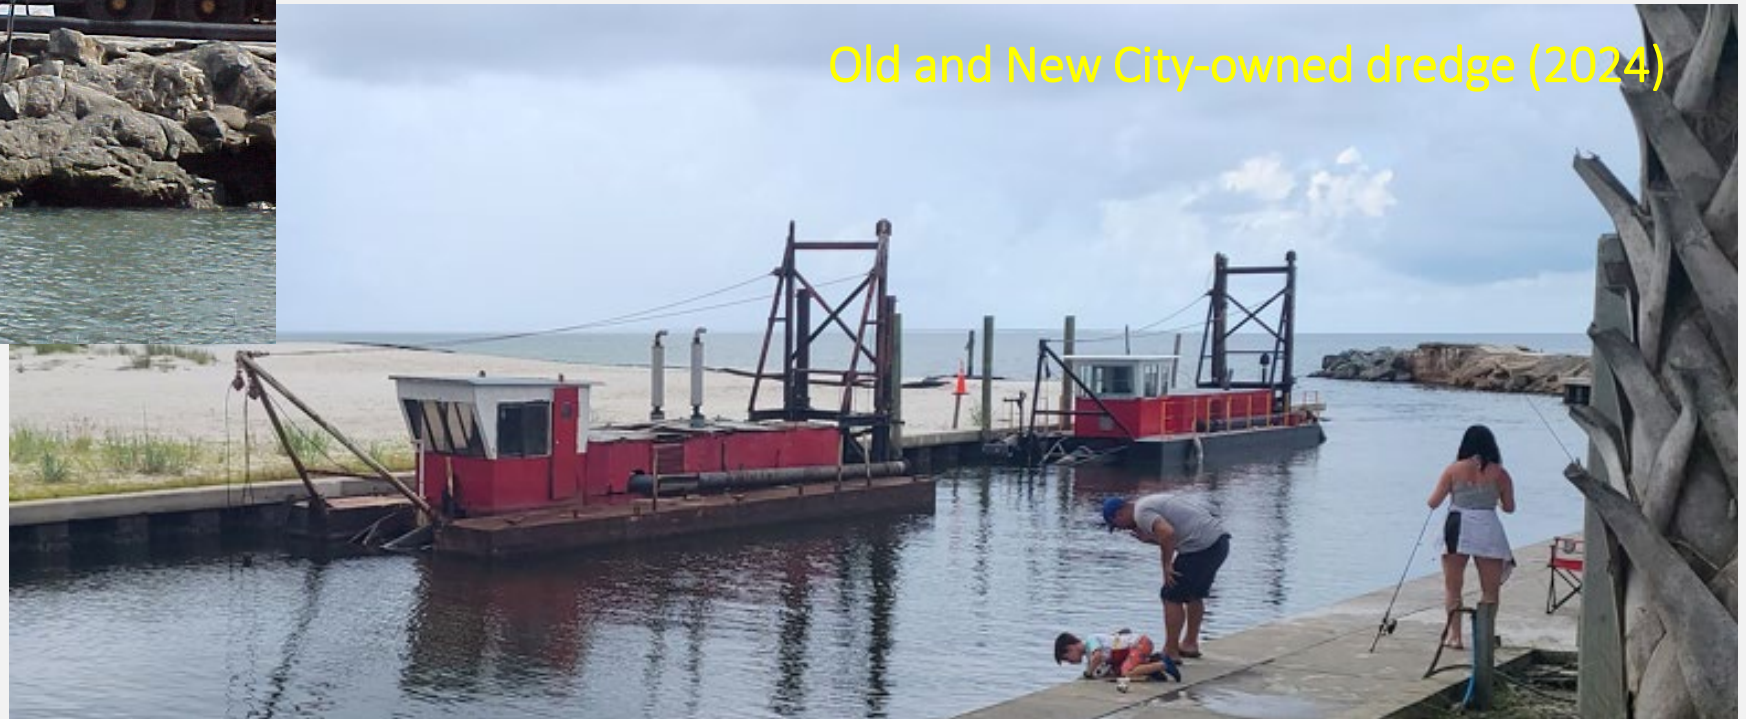
Old and New City-owned dredge (2024)

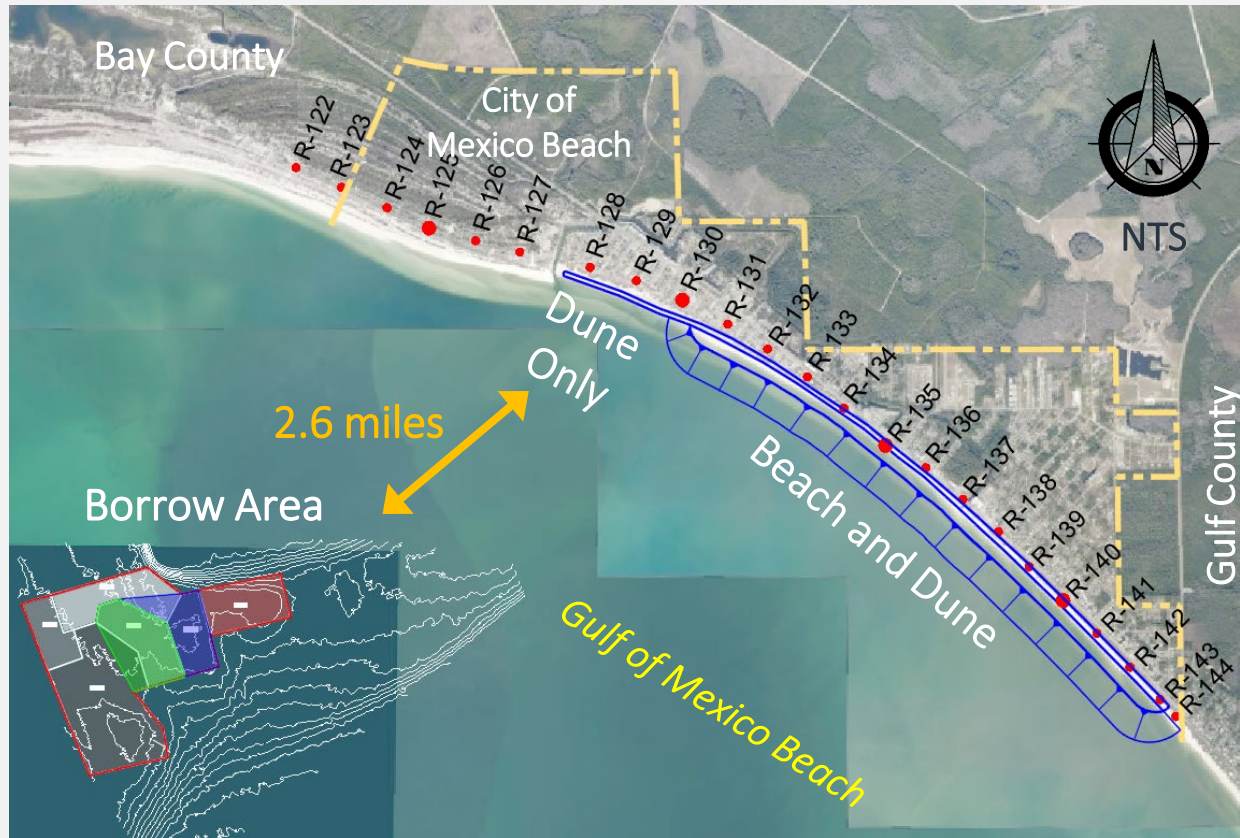
# BEACH RESTORATION PROJECT

- 3.1+/- miles (R-127.5 to R-144)
- Total volume: 920,000 yds<sup>3</sup>
- Dune only (R-127.5 to R-130)
  - 0.5 miles; 12,000 yds<sup>3</sup>
- Beach and dune (R-130 to R-144)
  - “Critically Eroded” (R-132 to R-137.8)
  - 1.6 miles; 908,000 yds<sup>3</sup>
- 618,000 native dune plants
- FRS Shell Extractor
- Weeks Marine; Bid \$27,180,950
- Commence pumping February 5<sup>th</sup>
- Completion by April 15<sup>th</sup>

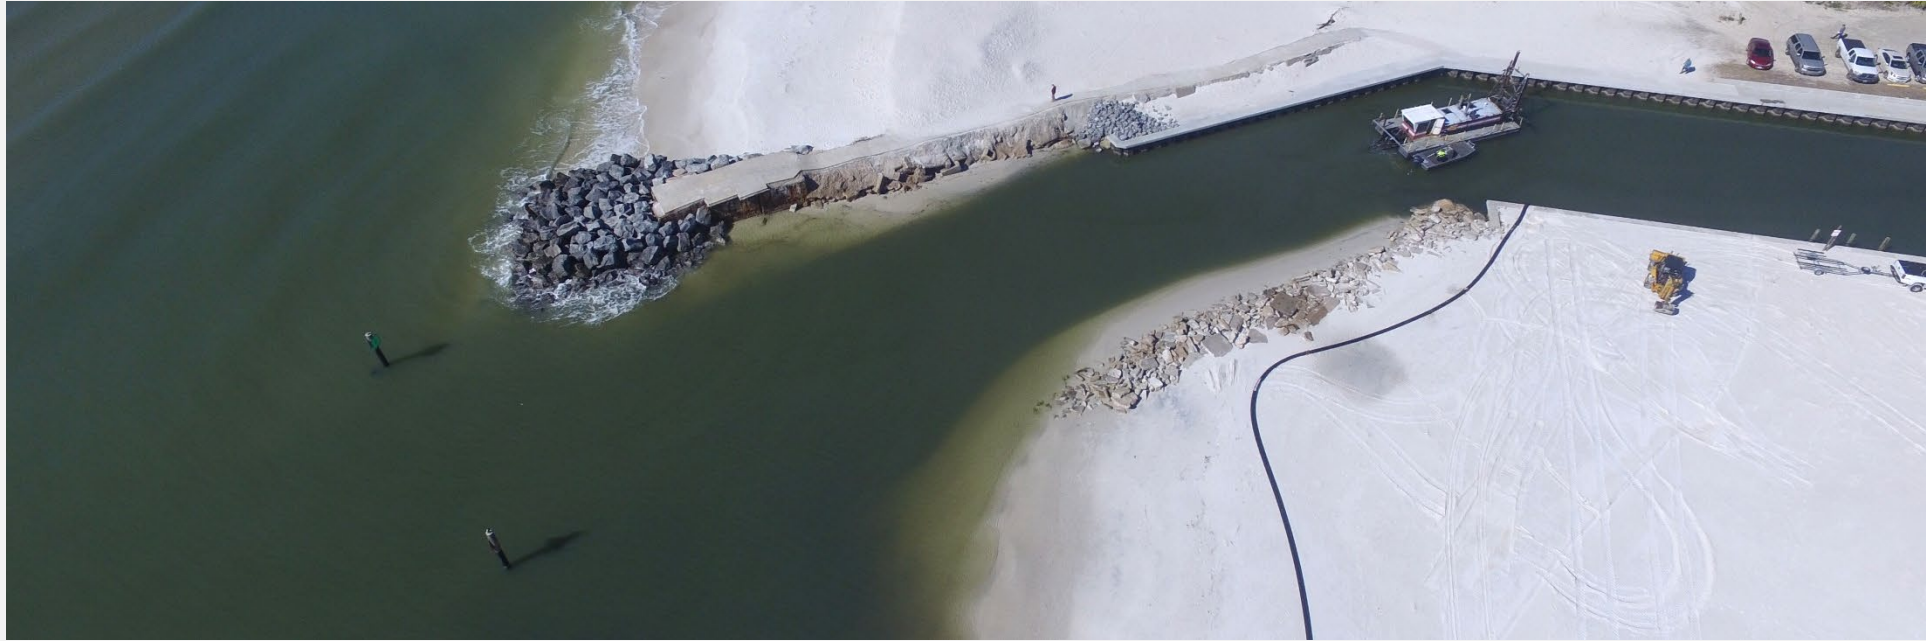
# MEXICO BEACH JETTIES

- Sand tighten the west jetty.
- Construct the east jetty.
- Reduce the volume of sand transported back into the channel.
- Reduce maintenance dredging.
- Improve safe navigability.

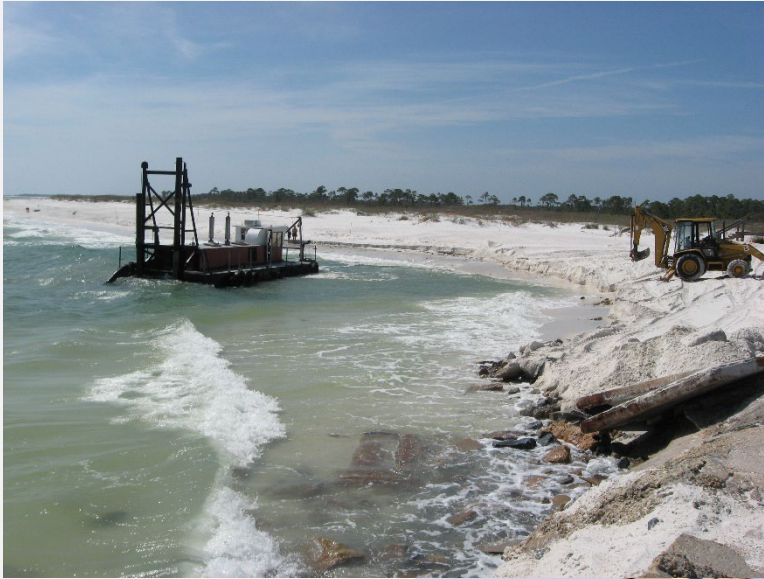
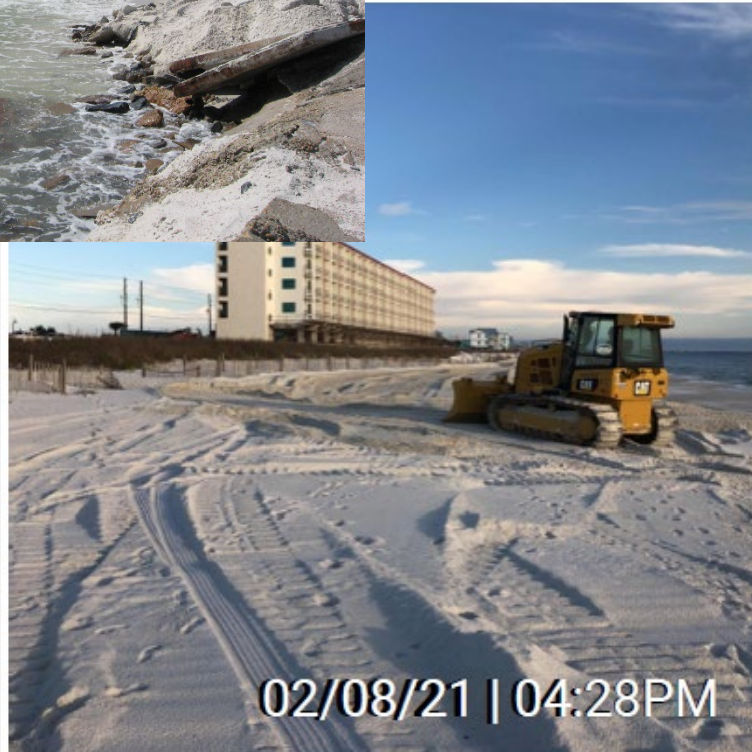
## OTHER PROJECTS

- Beach and inlet monitoring.
- Continue the current dredging protocol to maintain 32,400 yds<sup>3</sup>/yr bypassing rate.
- Extend discharge to the east.
- Conduct periodic truck haul bypassing to the “critically eroded” shoreline using the stock-piled sand.
