Natural Shoreline Infrastructure:

Adapting to the Future with Innovative Approaches to Shoreline Resiliency for Flood Risk Reduction

Brett Vivyan – Civil Engineer
West-Maritime & Coastal

The National Conference On Beach Preservation Technology

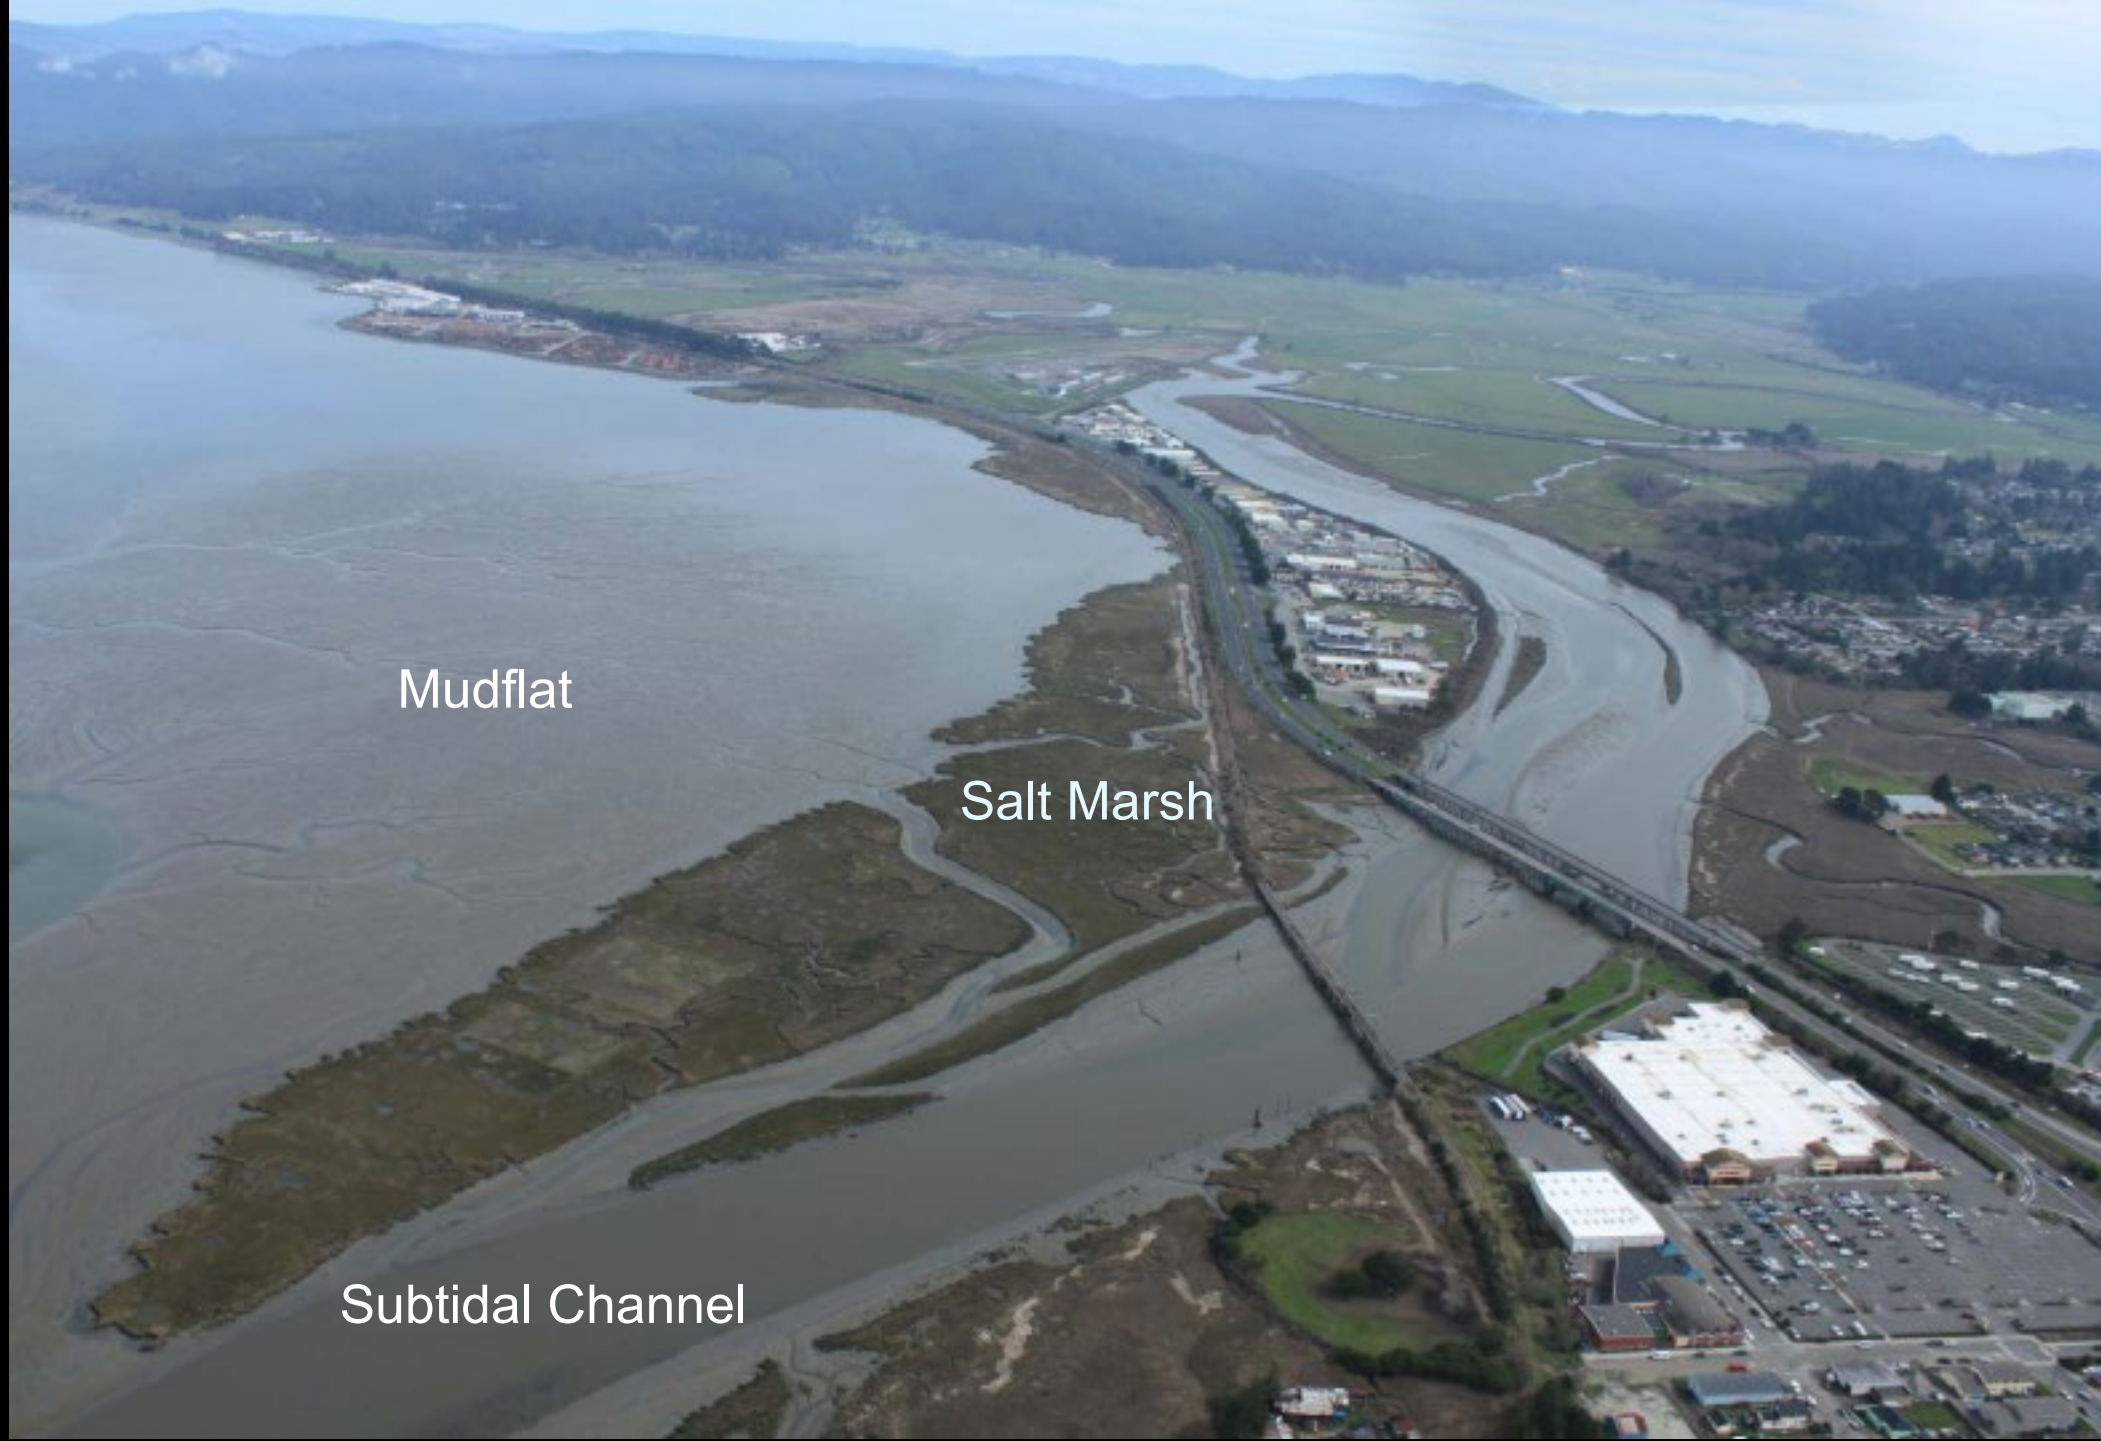
Mudflat

Salt Marsh

Subtidal Channel

TYPICAL CONTEMPORARY DEVELOPED SHORELINE

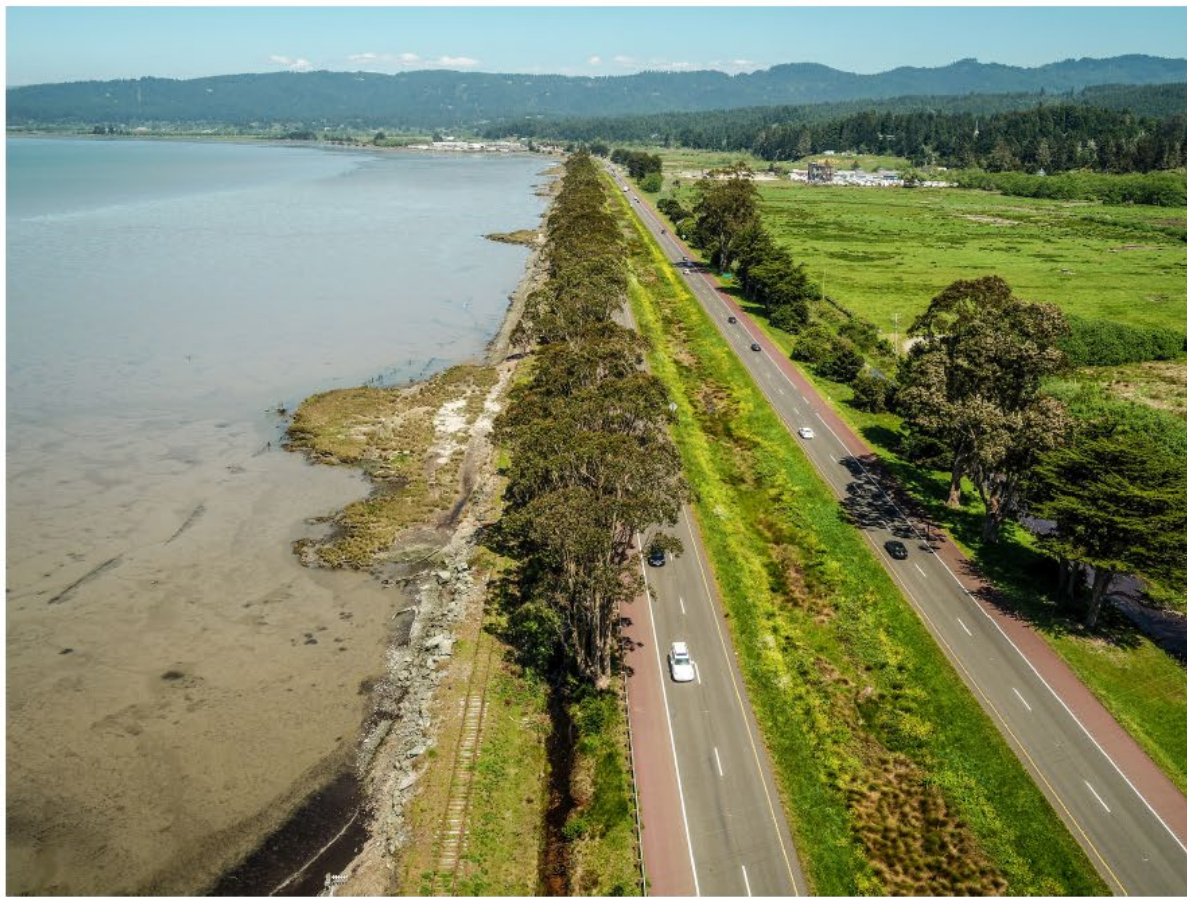
Conceptual Design

EXISTING CONDITIONS

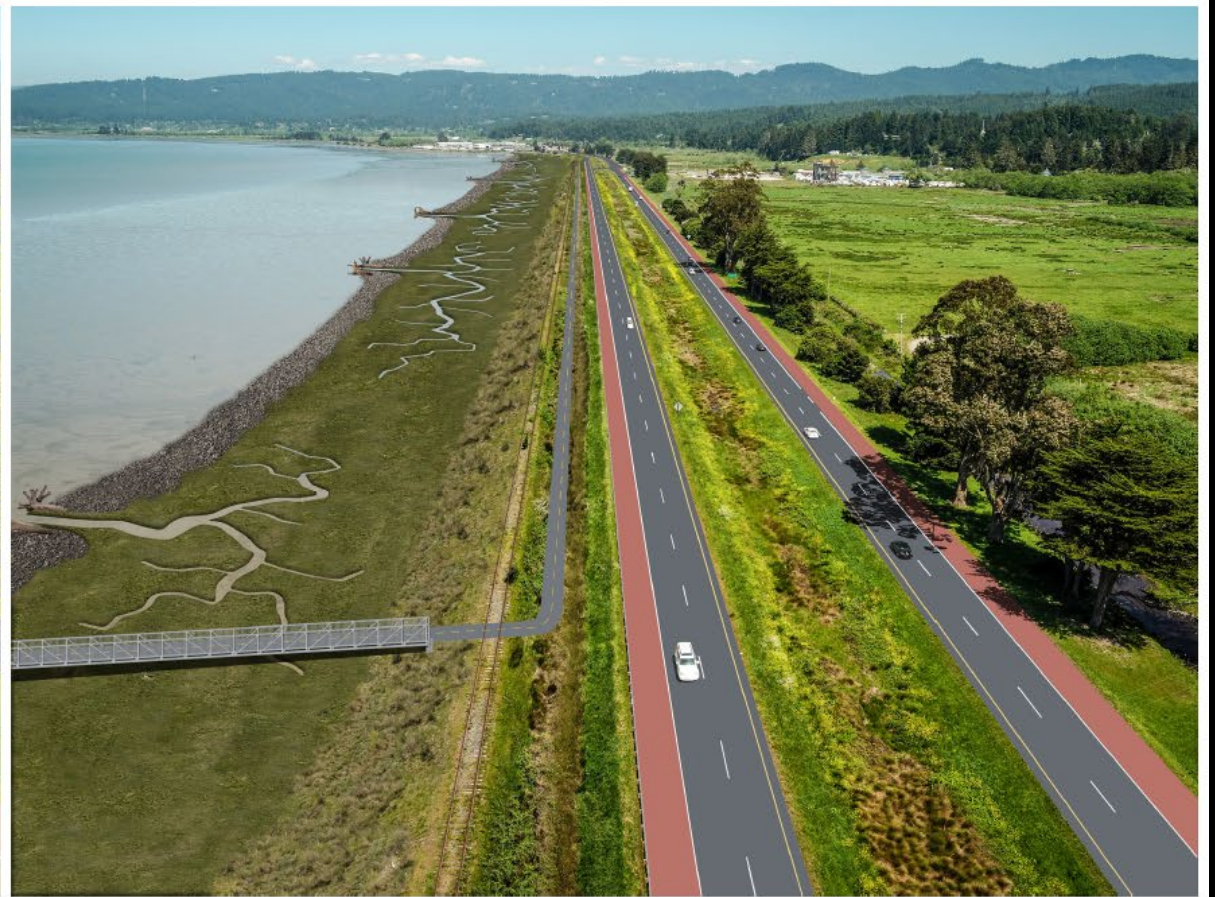
FUTURE CONDITIONS

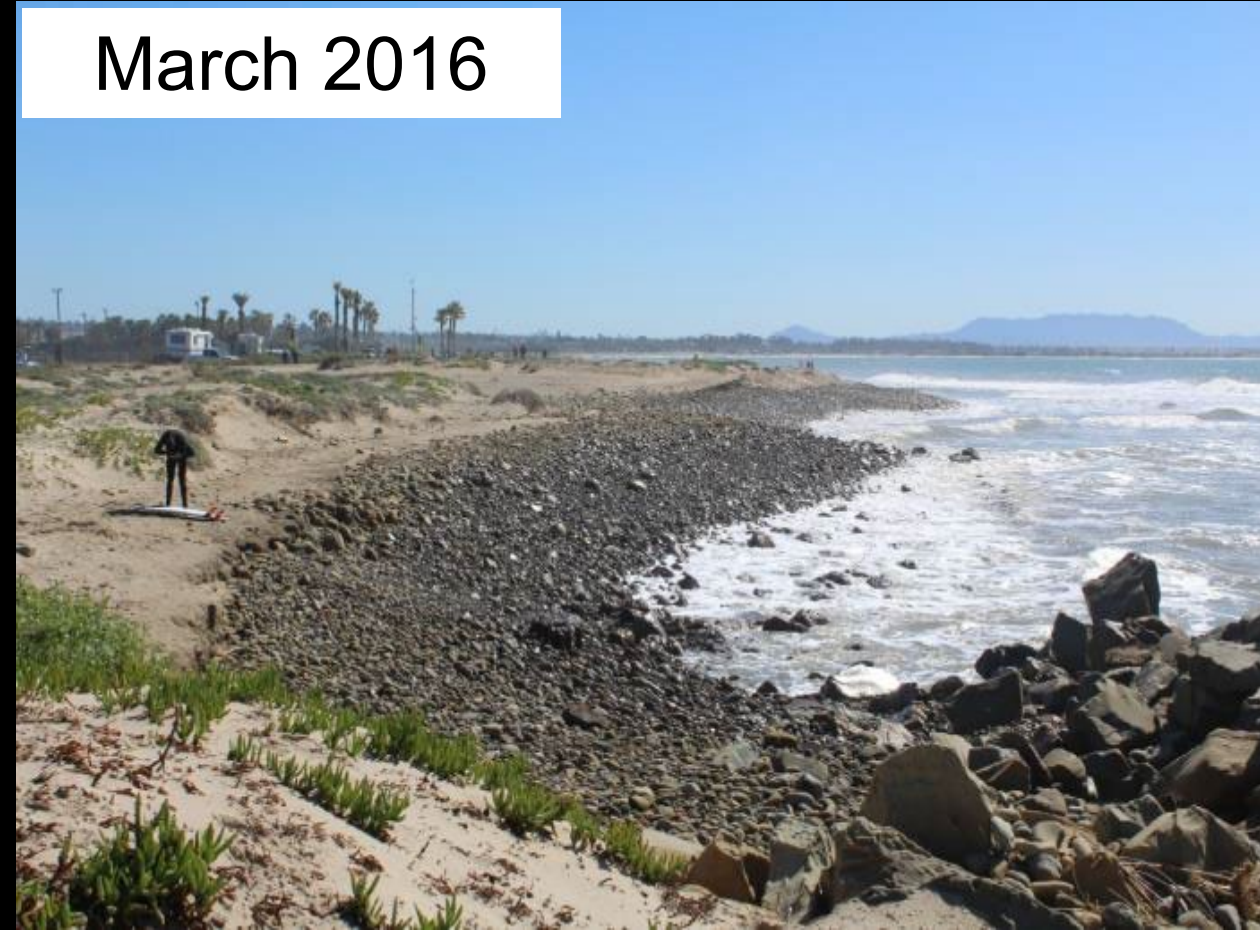
March 2016

Design Analog - Surfer's Point, Ventura, CA

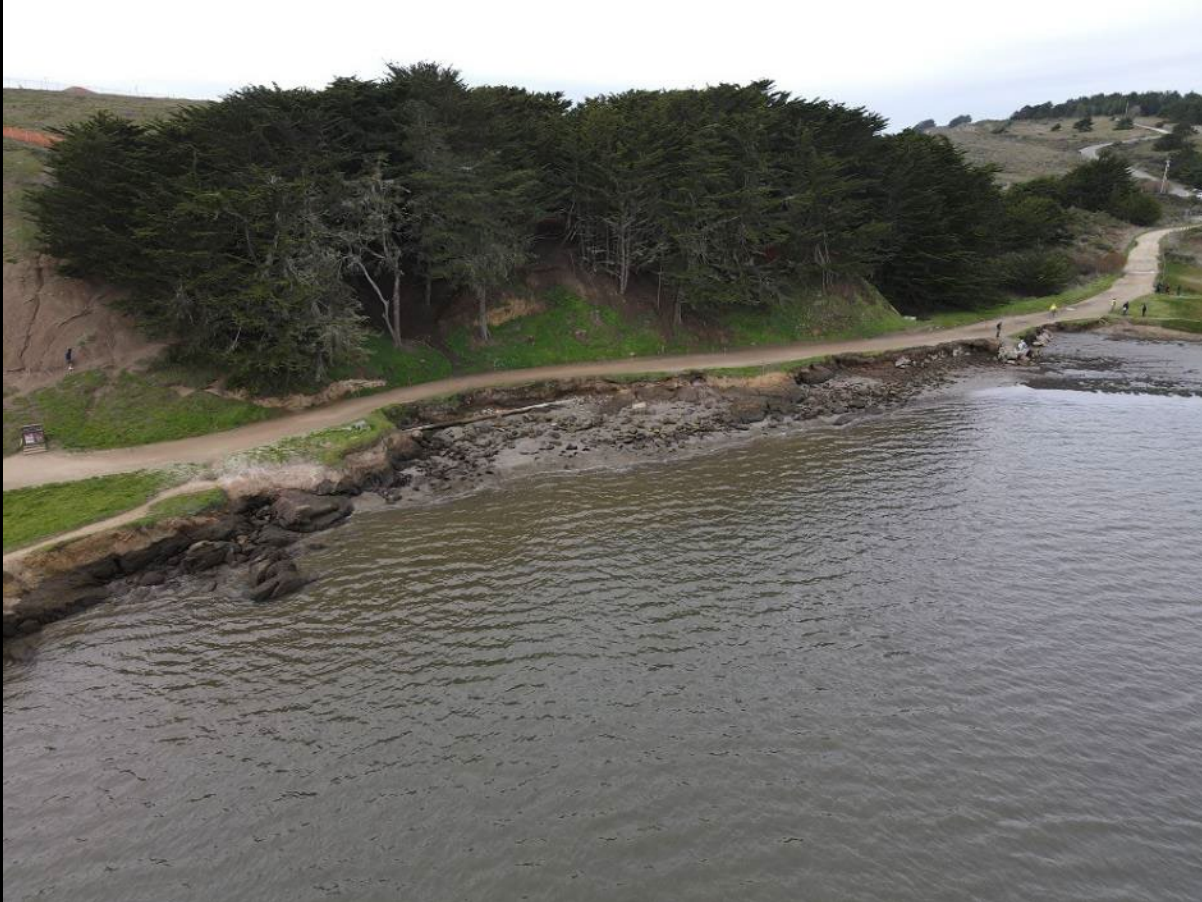
Pre-Construction

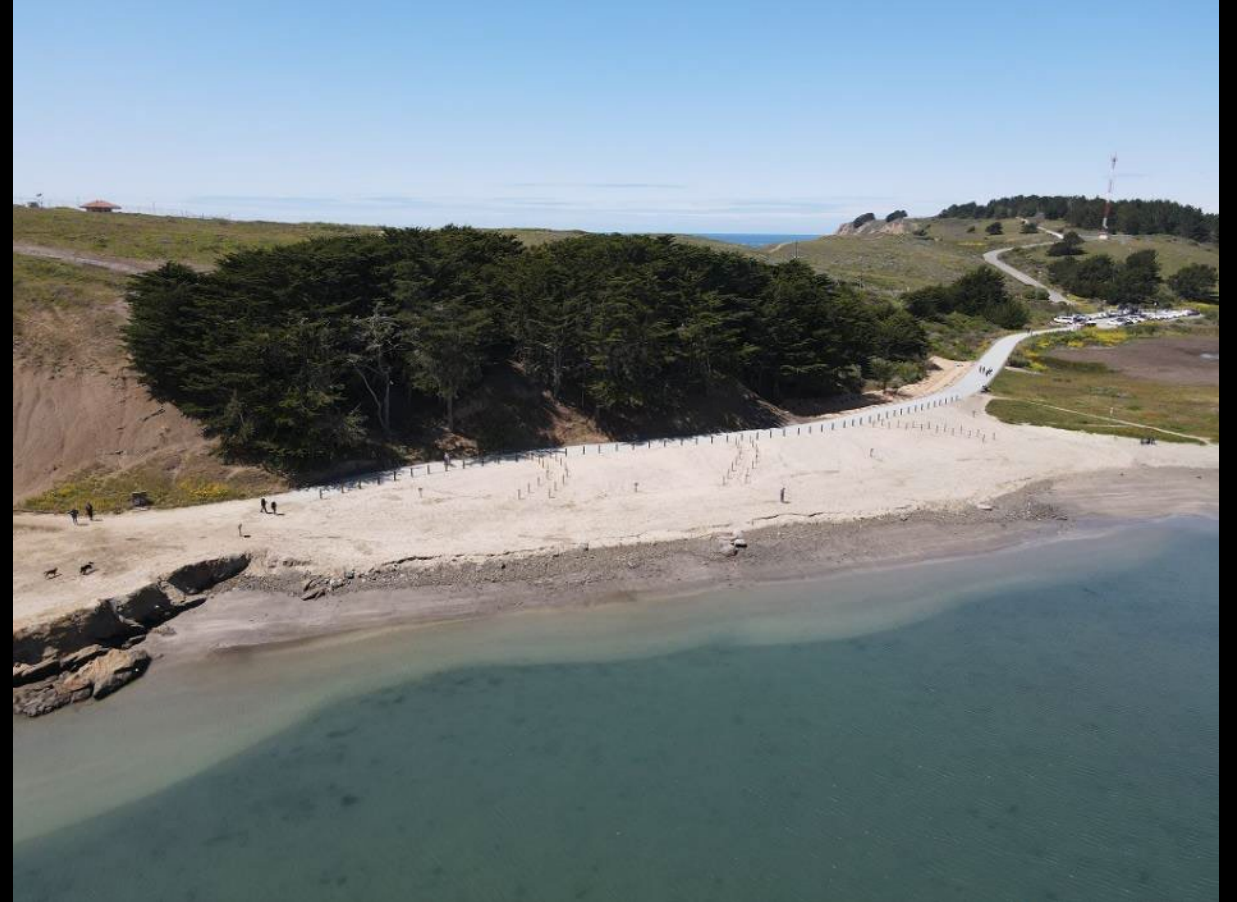
Post-Construction

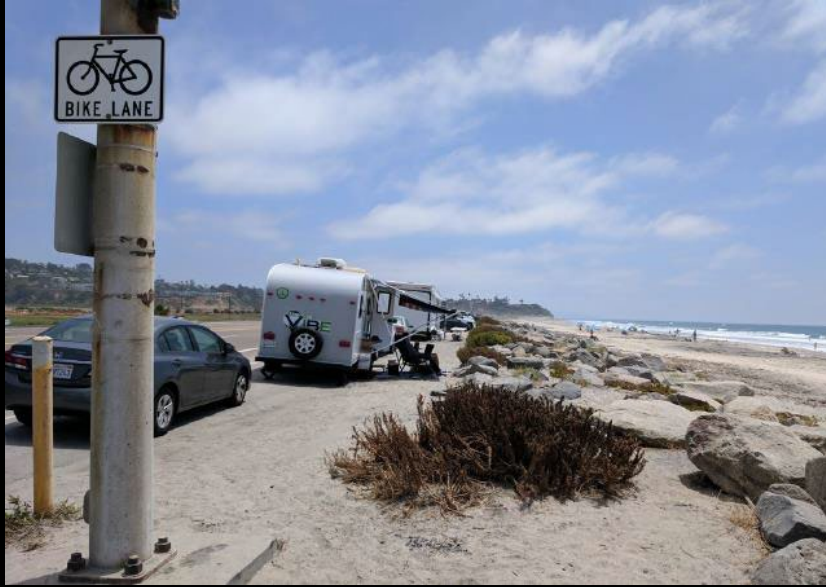
Flooding & Erosion

Shoreline Protection: Protect the Highway from chronic erosion and flooding

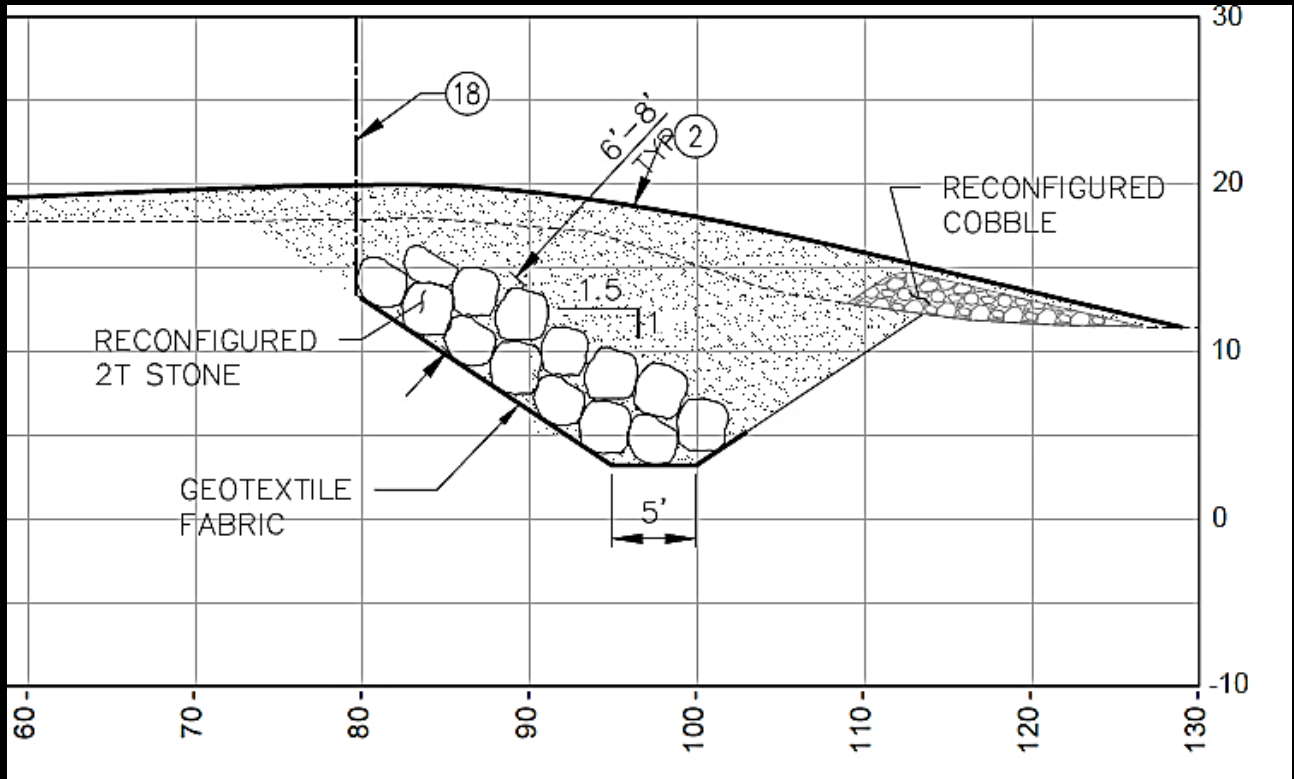
Primary Project Elements

Multi-benefit: public access, erosion and flood protection, ecosystem services

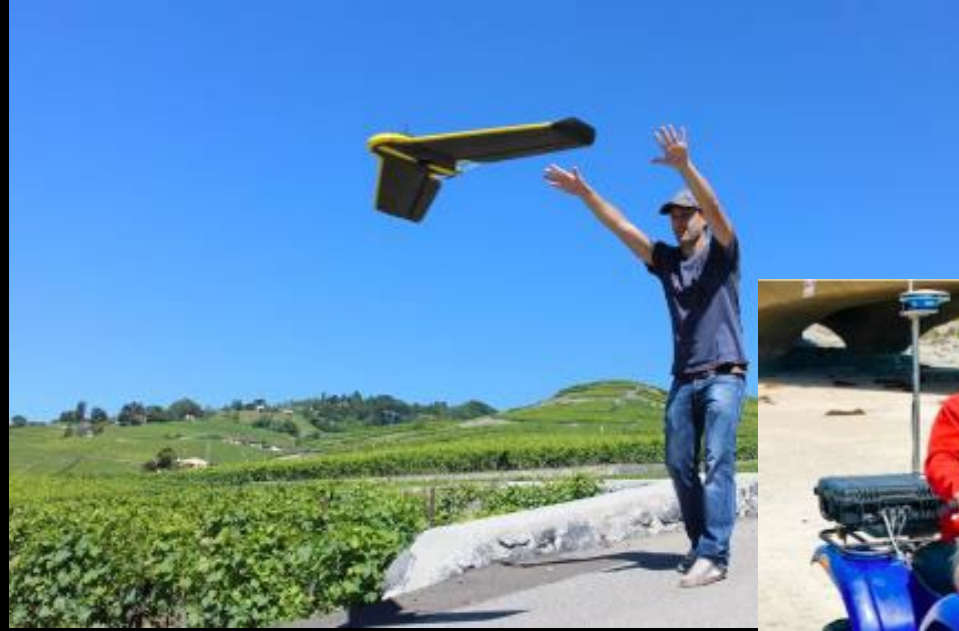
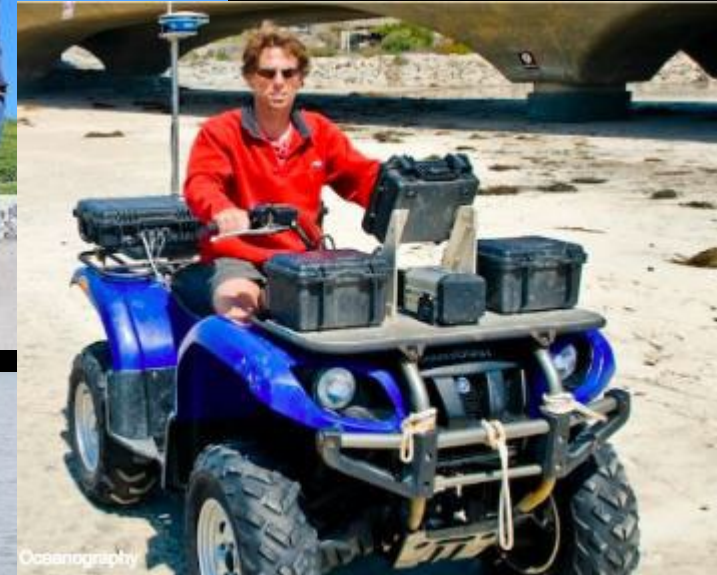
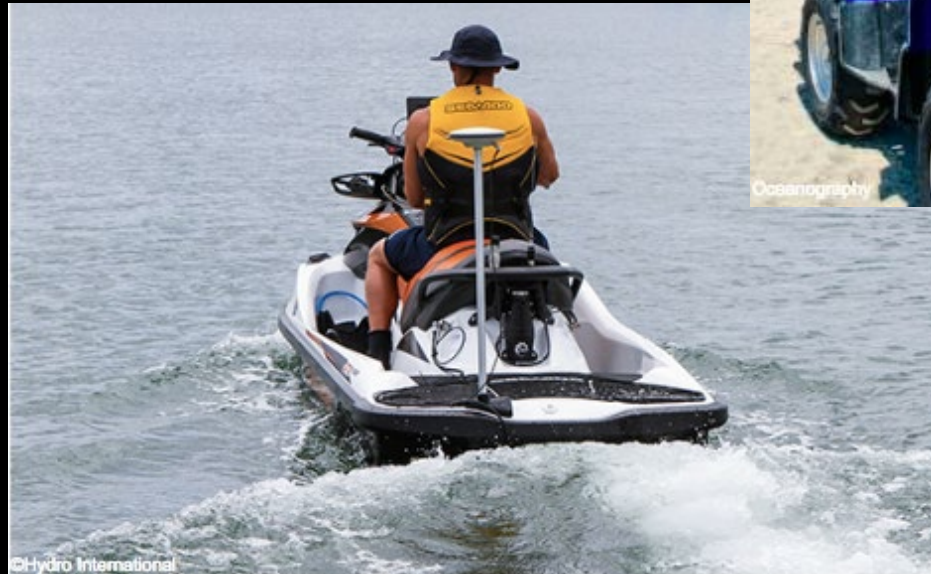
Monitoring

Quarterly

Beach & Dune Topo
Beach Bathy Photos

Annual Vegetation
Surveys Extreme Event
Documentation

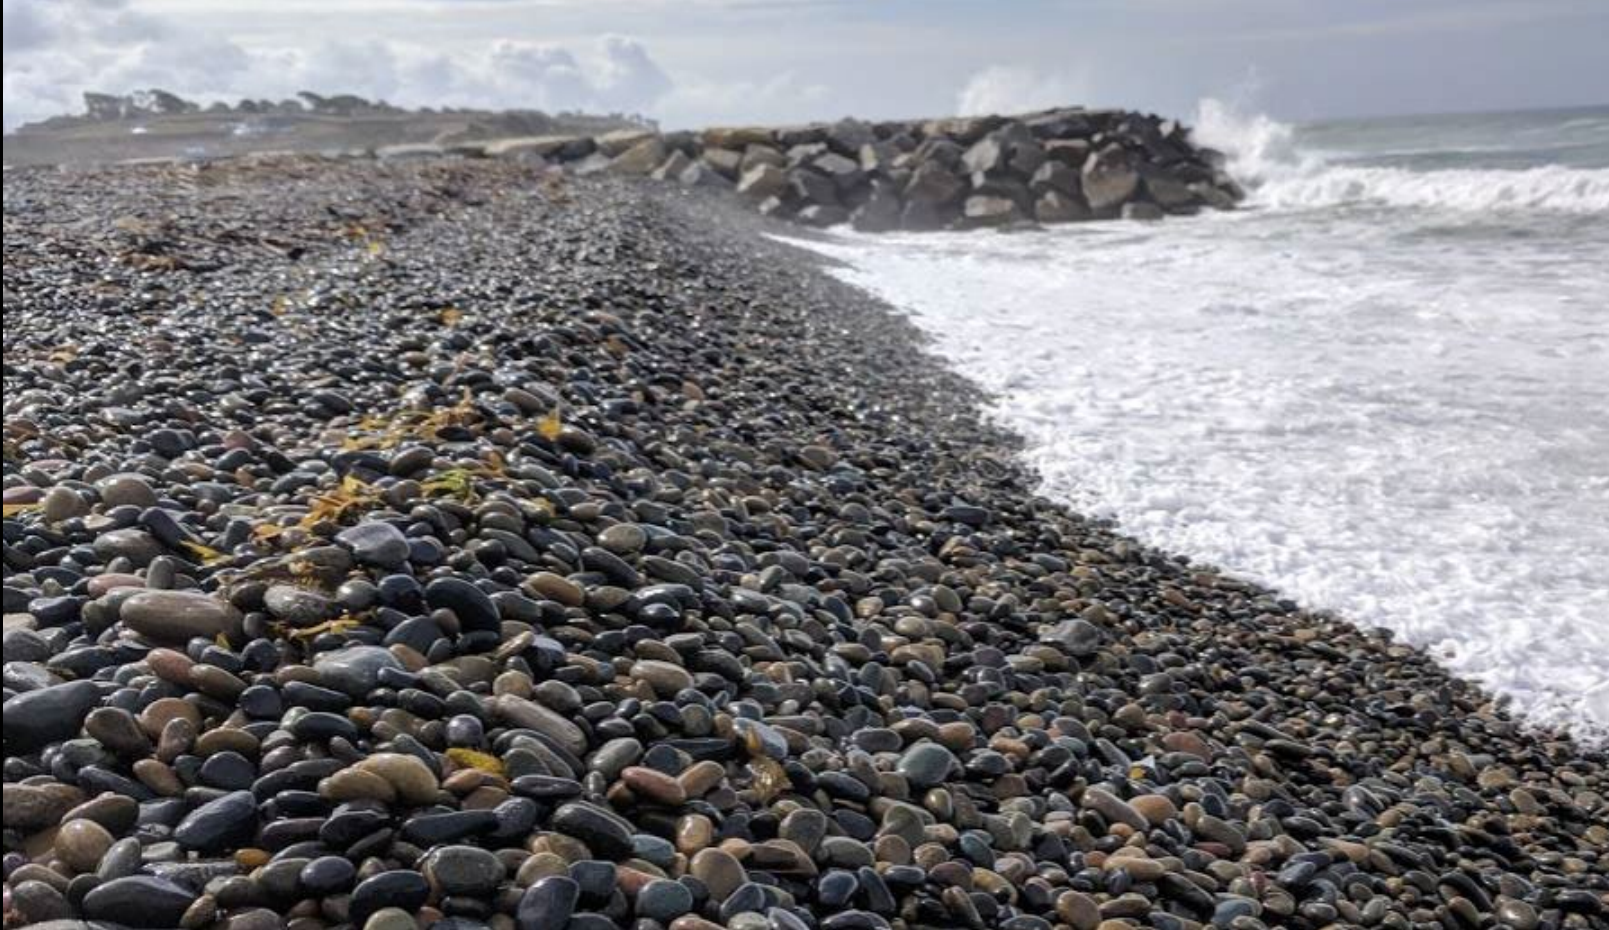
What level of shoreline protection is provided by cobble berms?

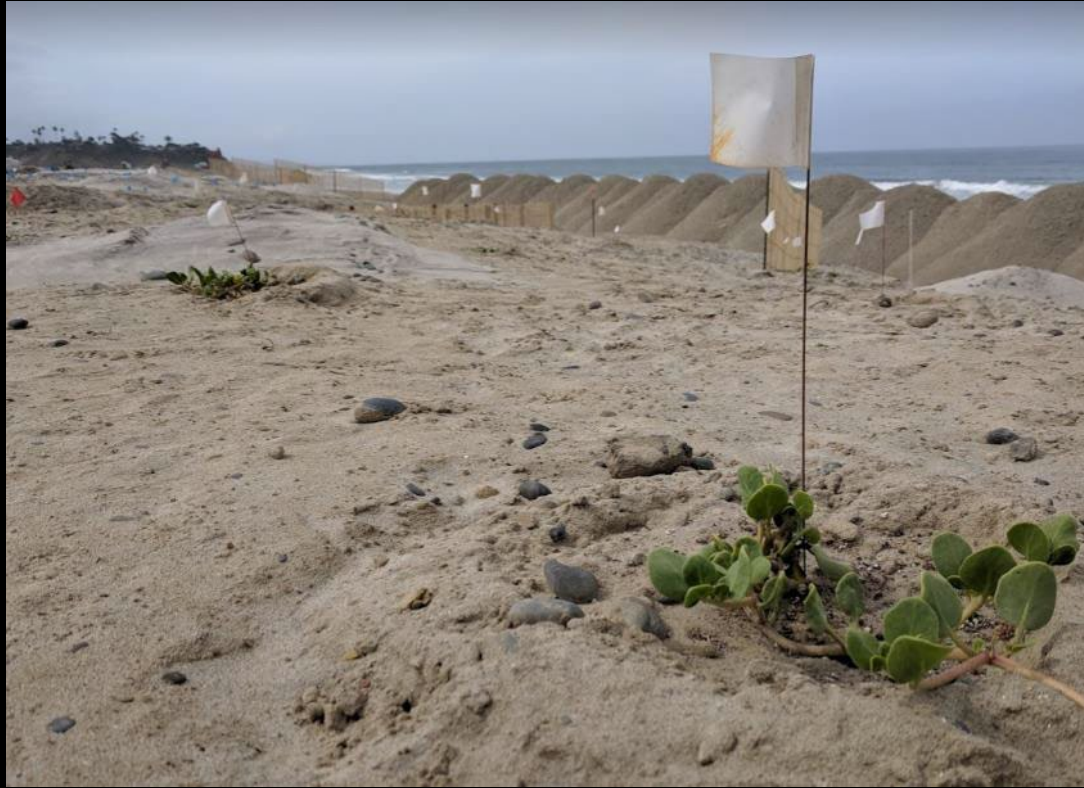
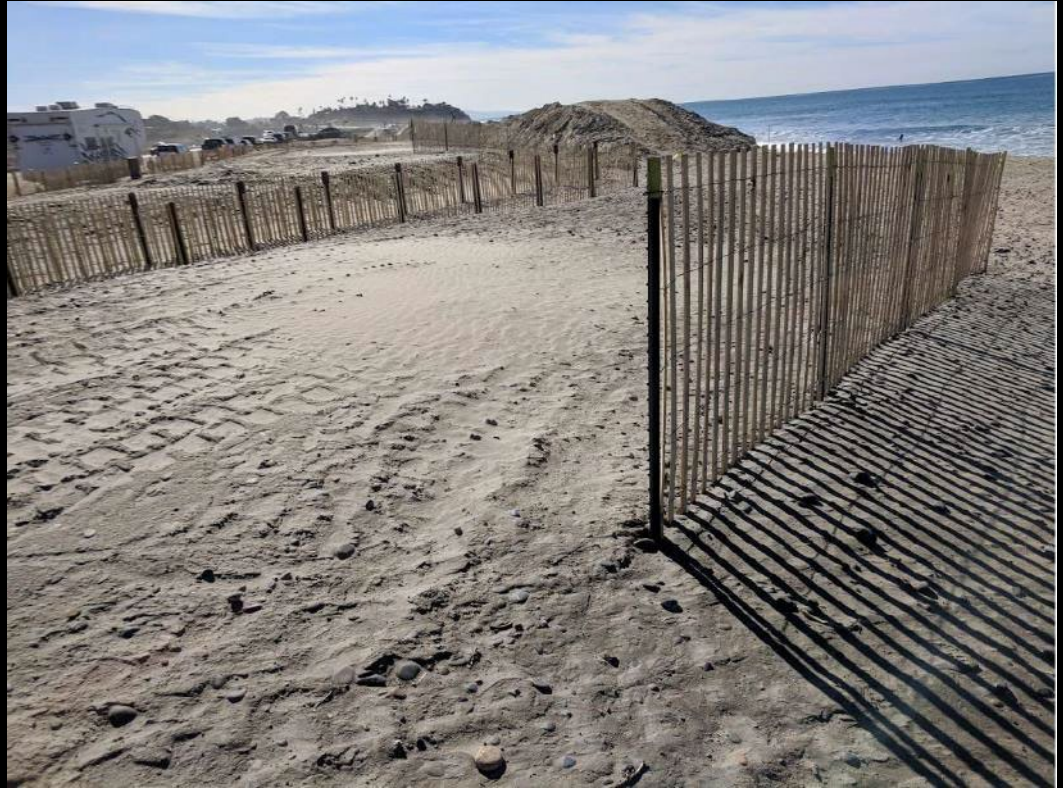
How does dune vegetation impact sand loss / Aeolian deposition?

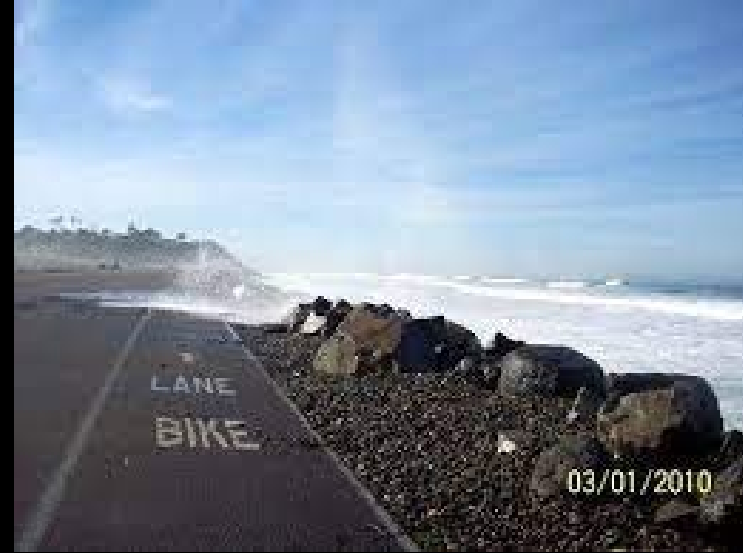
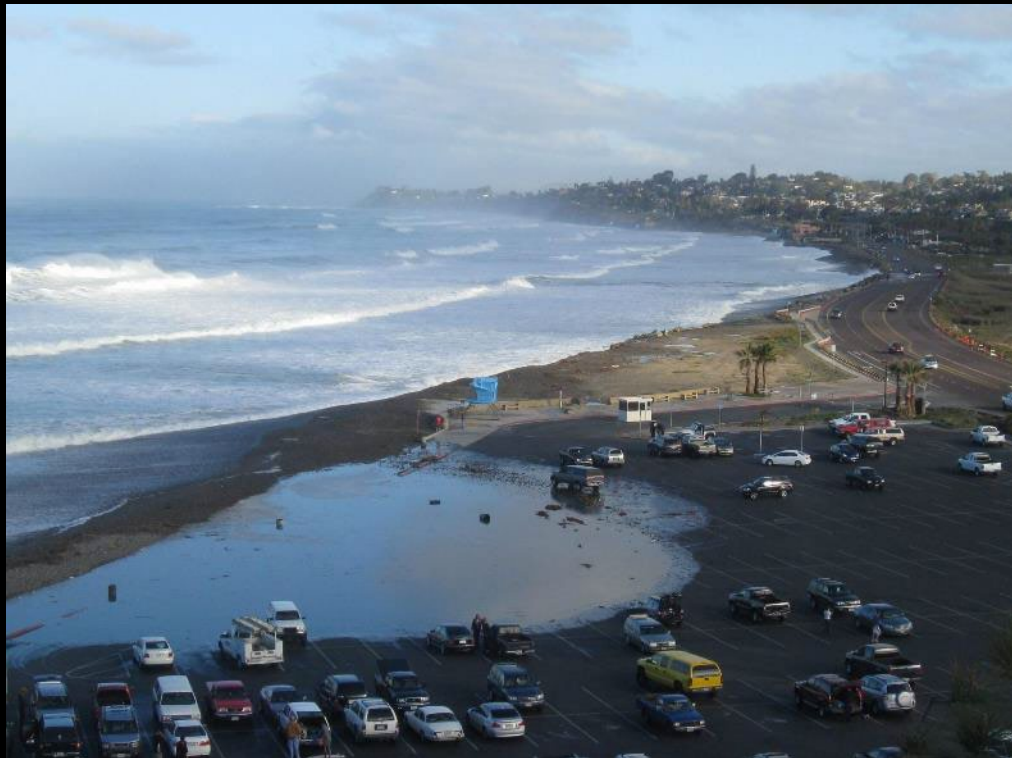
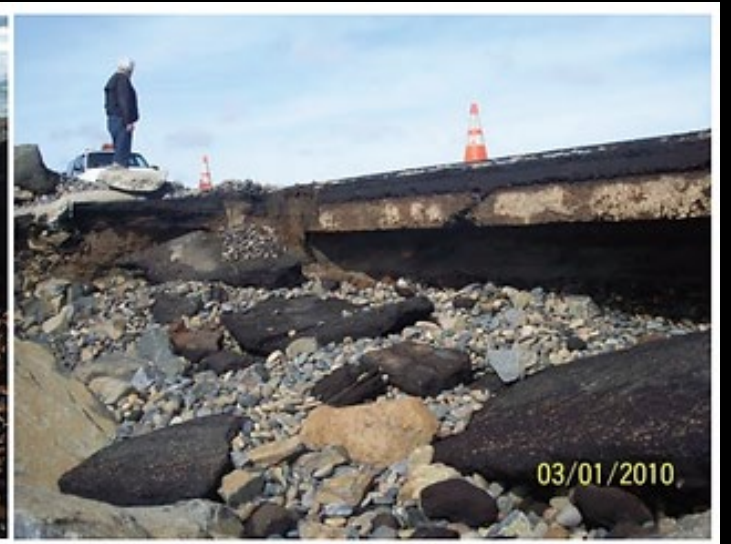
Historical Storm Context

- Wave height: 3-4'
- 11-15 sec period
- 5.5' high tide

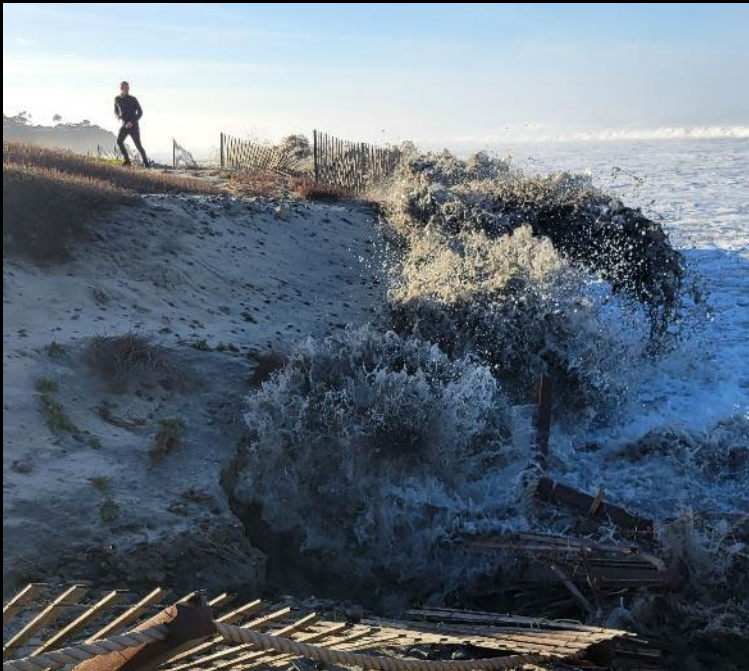
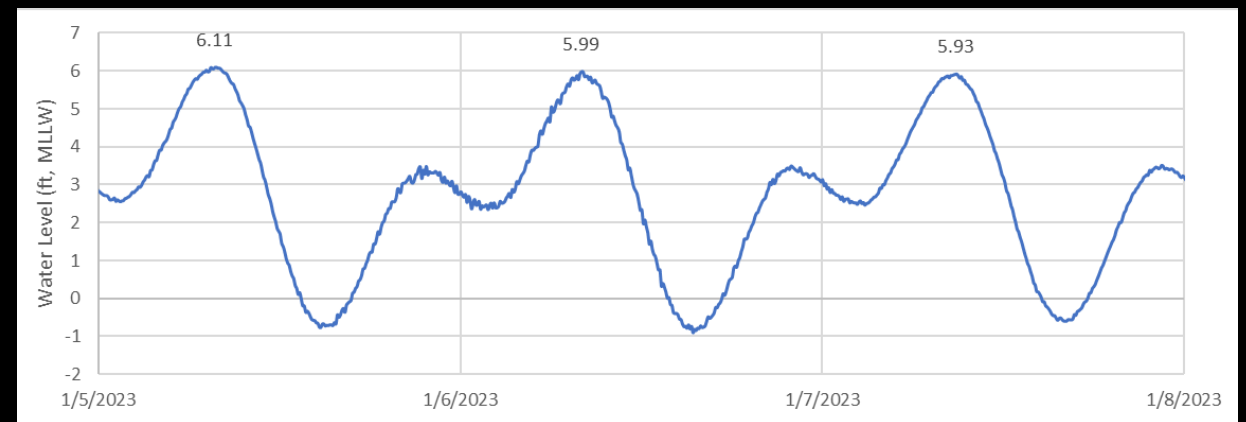
Jan 6th, 2023 15-20yr return period wave event

- Wave height: 11.5 ft
- 17 sec period
- ~6' high tide

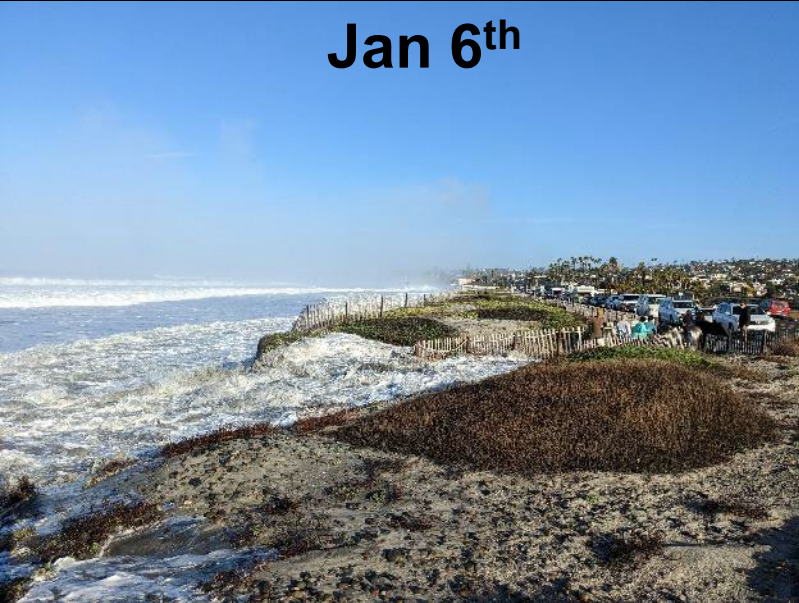
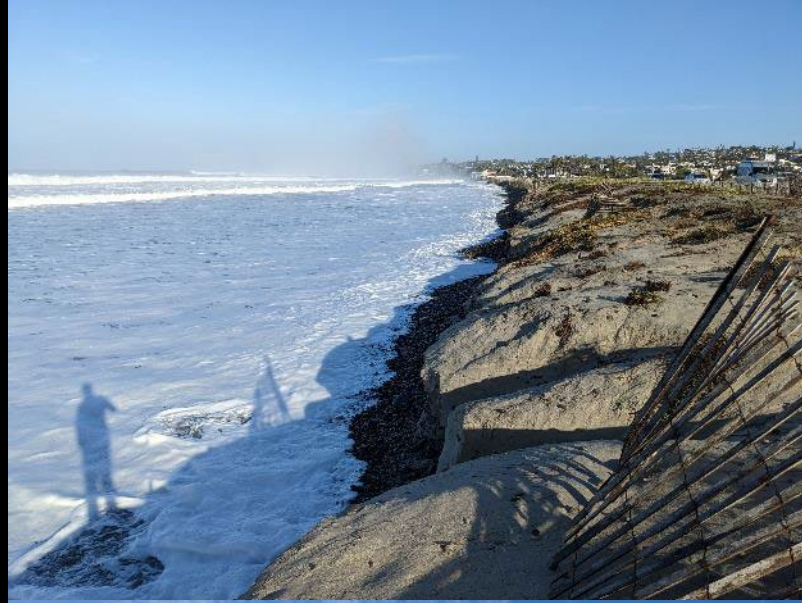
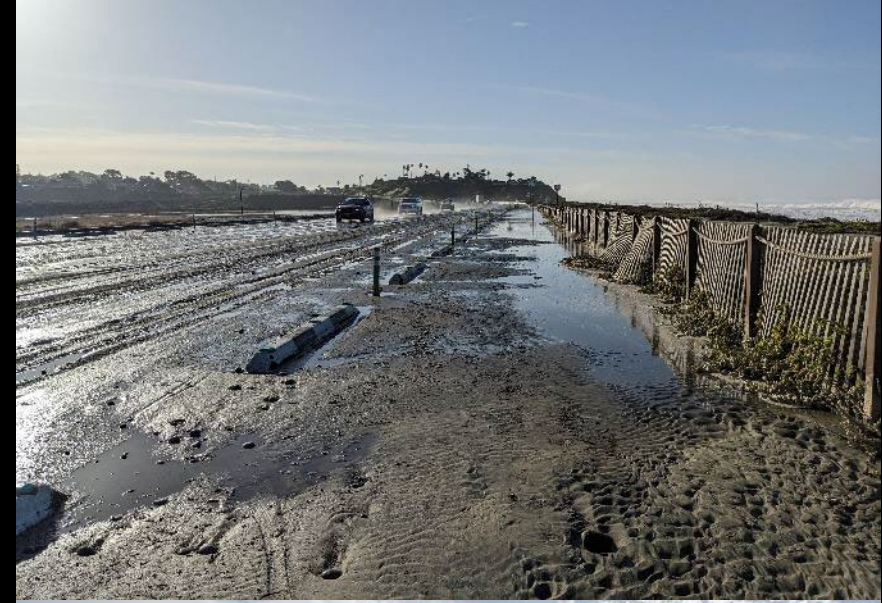
Jan 6th Observations – South

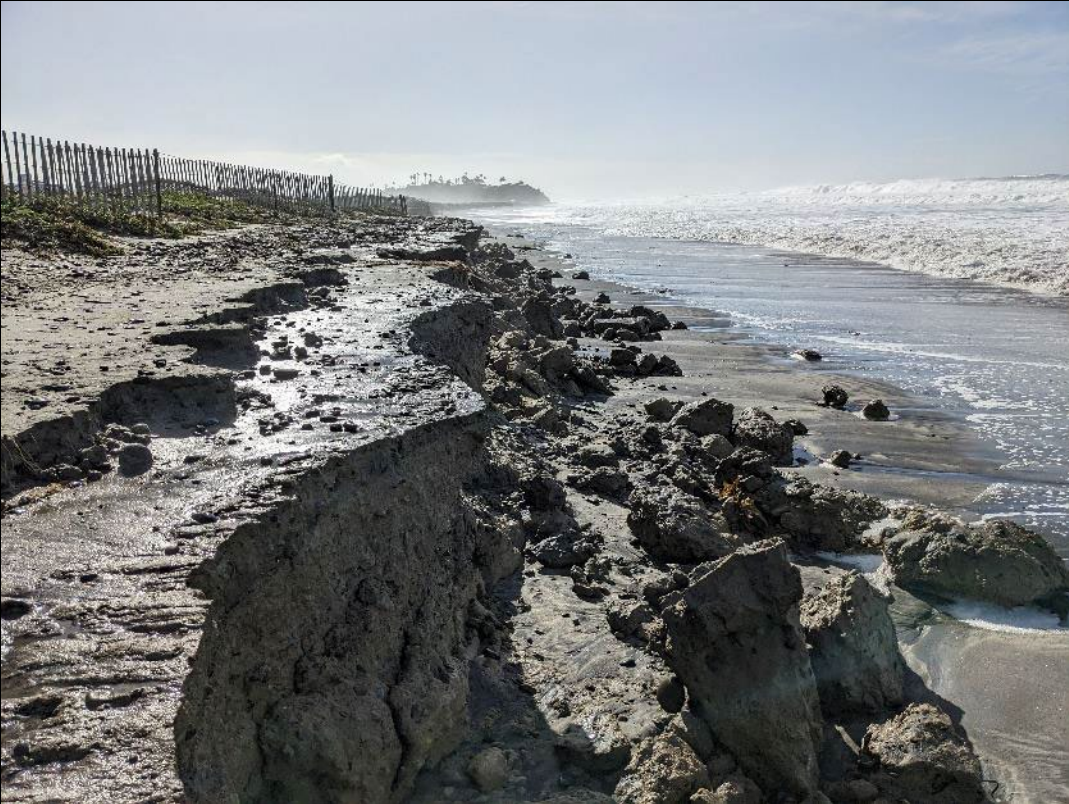
Jan 6th, 2023

Post-Storm Recovery

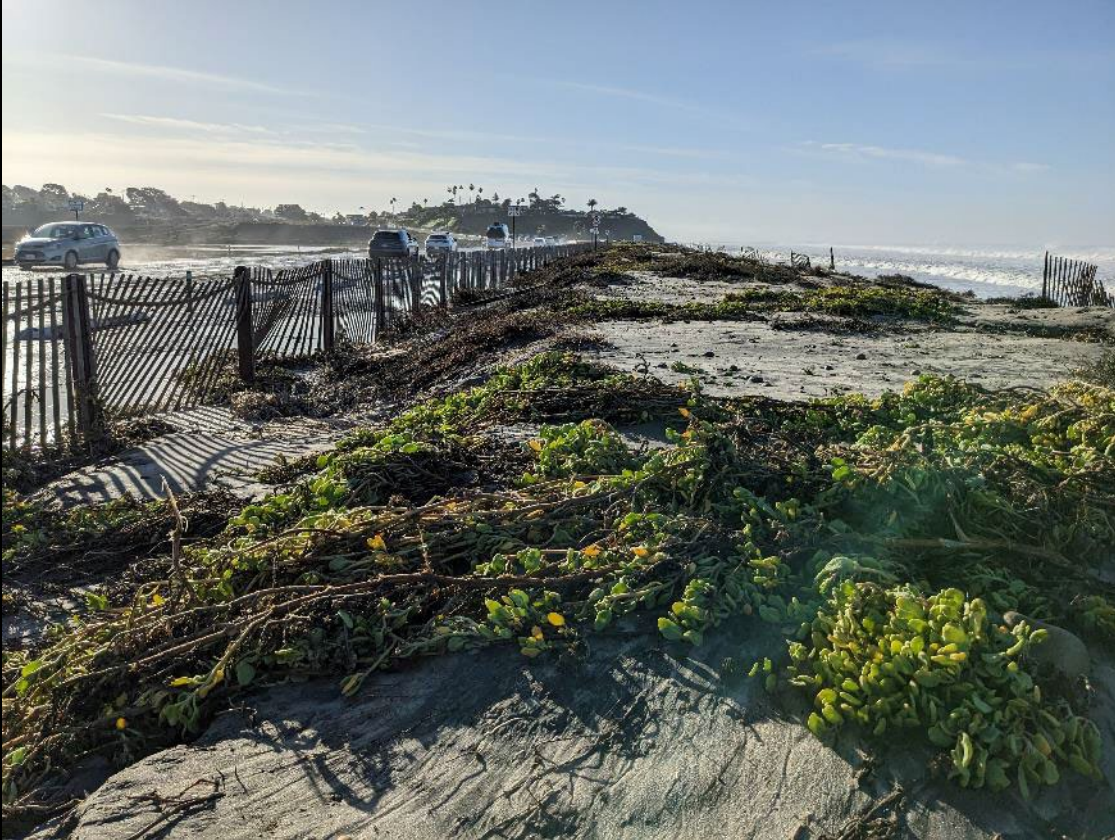
Jan 6th, 2023

Post-Storm Recovery

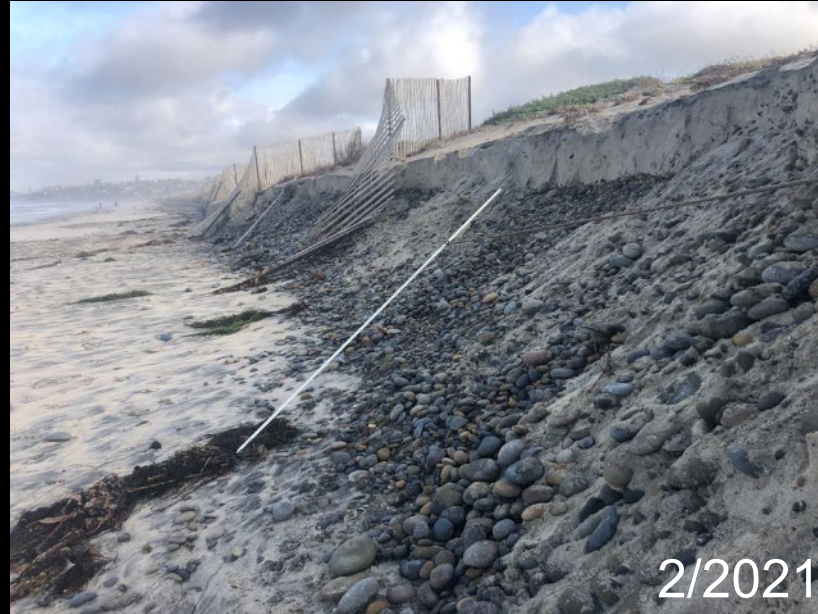
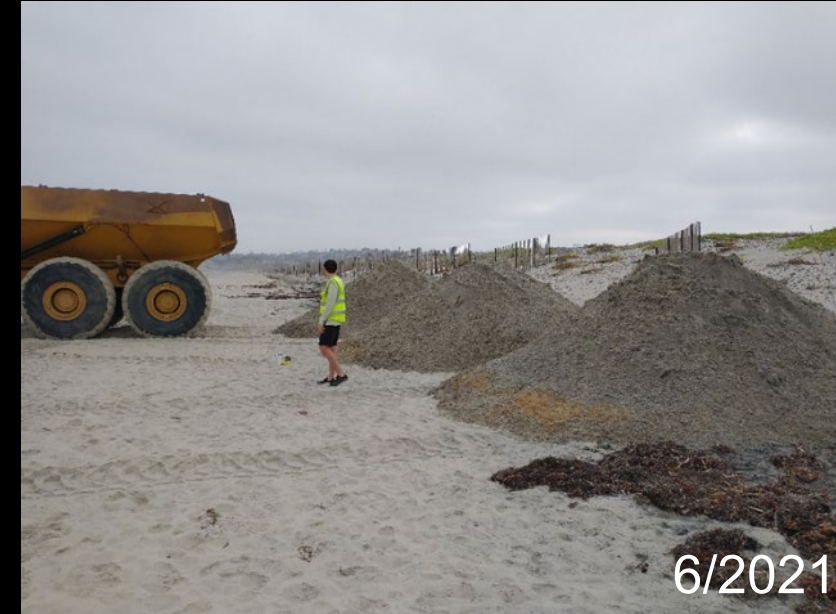
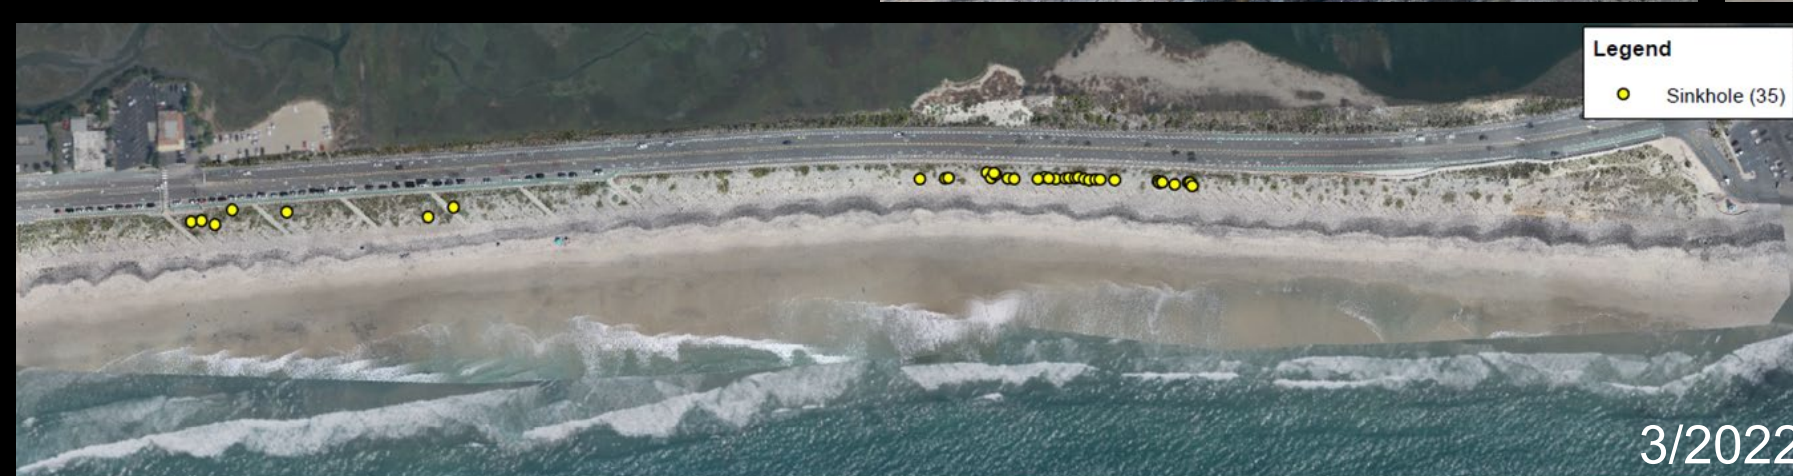
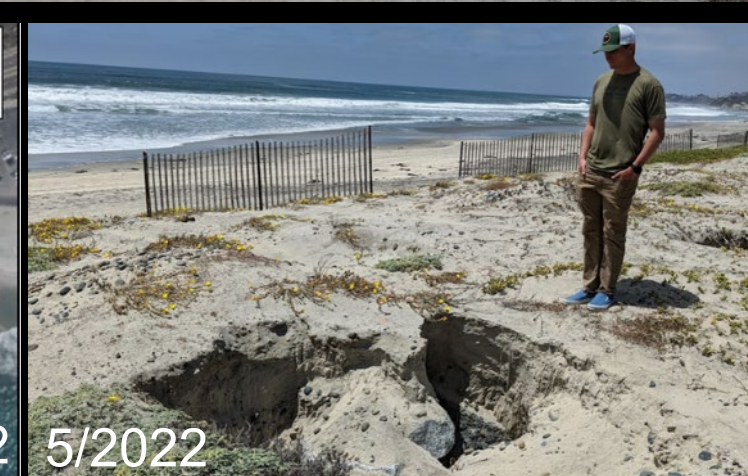
Maintenance

- Dune toe maintenance
- Sinkholes
- Opportunistic beach nourishment
