Adaptation Solutions for Florida's

Coastal Communities

2025 FSBPA
Panama City Beach, Florida

Jenna N. Phillips, MSc. Senior Director

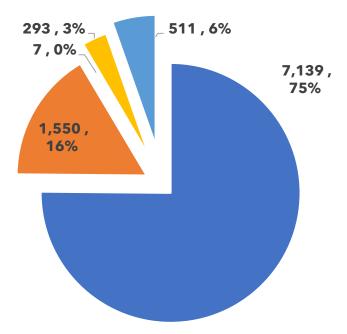
FWC Shoreline Statewide Dataset

- Marsh, wetlands, swamp
- Man-made structures and riprap
- Rocky shore and banks, wave-cut platforms, scarps
- Tidal flats, mud flats, vegetated low banks
- Beaches (sand, sandy slopes and scarps, gravel and mixed beaches)

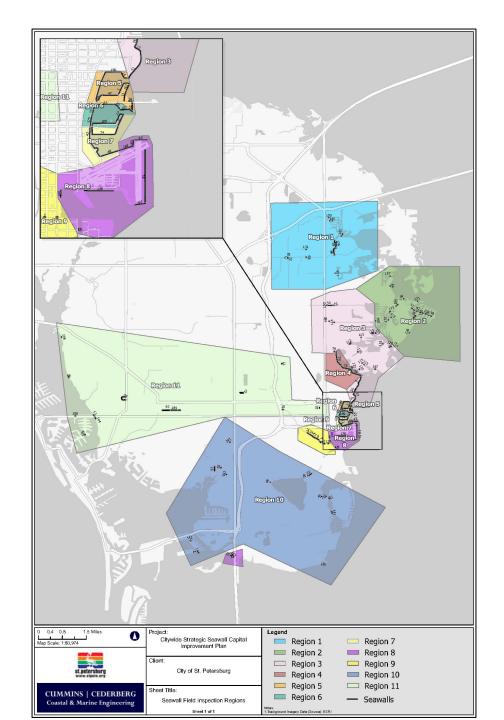
Field Region Map Overview

Region	Linear Feet of Seawall	Quantity of Wall Segments	Quantity of Report Cards with Subsections
1	6151.27	21	30
2	5444.17	43	47
3	9108.4	34	47
4	6194.42	3	17
5	6317.86	9	16
6	4993.77	10	25
7	5171.57	4	14
8	8238.28	10	17
9	5064.83	13	19
10	5414.92	29	37
11	9979.69	19	31
Totals	72079	195	300

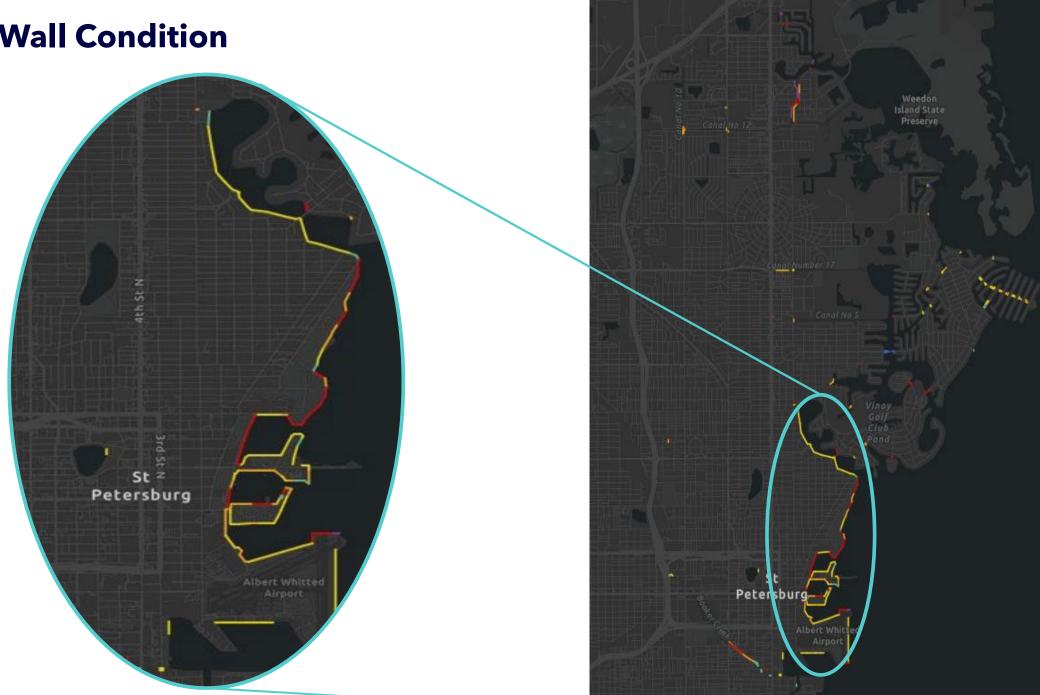
Preliminary Wall Condition

Mapping

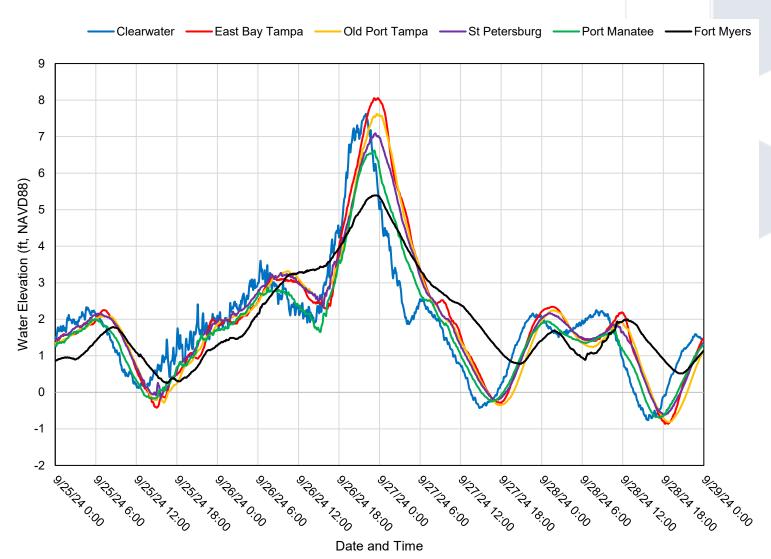
Storm Surge Vulnerability – Helene

- Category 4 hurricane at landfall in Perry, FL
- Helene moved quickly at 23mph
- Eye of the storm approx. 170 miles south-southwest of Tampa
- St. Petersburg NOAA station peak surge = +7.09 feet NAVD (per FEMA FIS is between a 25-year and 50-year return period storm)

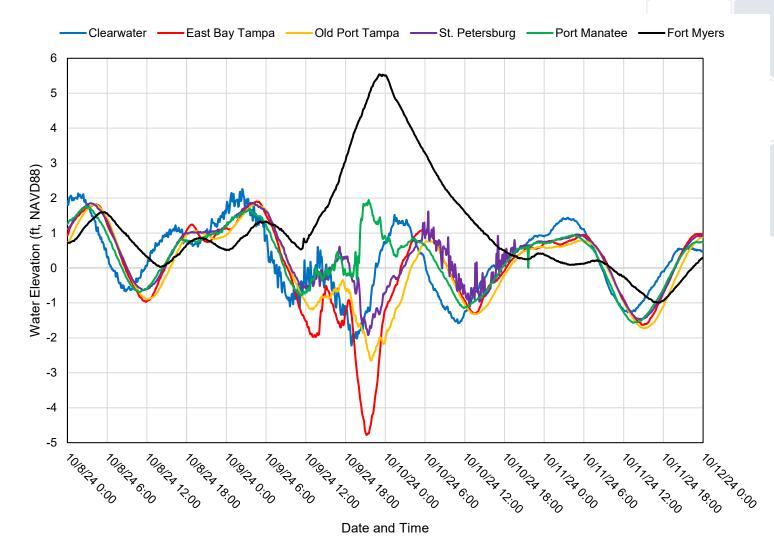
Storm Surge Vulnerability – Milton

- Category 3 hurricane at landfall in Siesta Key, FL on October 9th, 2024
- 24-hr rainfall of 18.54 inches and a peak 3-hour rainfall total of 9.04 inches on October 9th
- St. Petersburg NOAA station peak surge reached +1.86 feet, NAVD88
- Reverse storm surge in the Tampa Bay with recorded water level at East Bay station of -4.78 feet, NAVD88

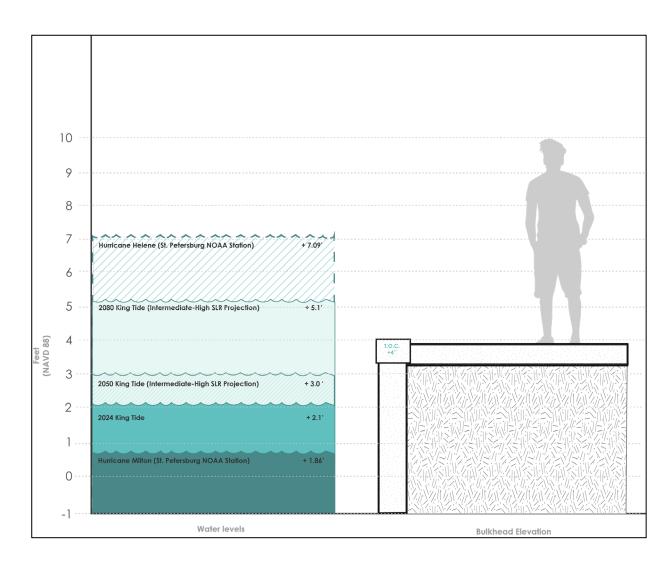
Seawall Elevation Summary

Cap Elevation (ft- NAVD)	Length of Wall (LF)	% of Total Length
< +2.0 ft	1,270	2%
+2.0 to +3.0 ft	9,371	13%
+3.0 to 4.0 ft	19,816	28%
+4.0 to 5.0 ft	12,920	18%
> +5.0 ft	24,156	34%
