HURRICANE IRMA IMPACTS TO SOUTHWEST FLORIDA LEE – CHARLOTTE BARRIERS NOVEMBER 6, 2017

CHARLOTTE BARRIERS

MANASOTA KEY POST-IRMA CONDITIONS

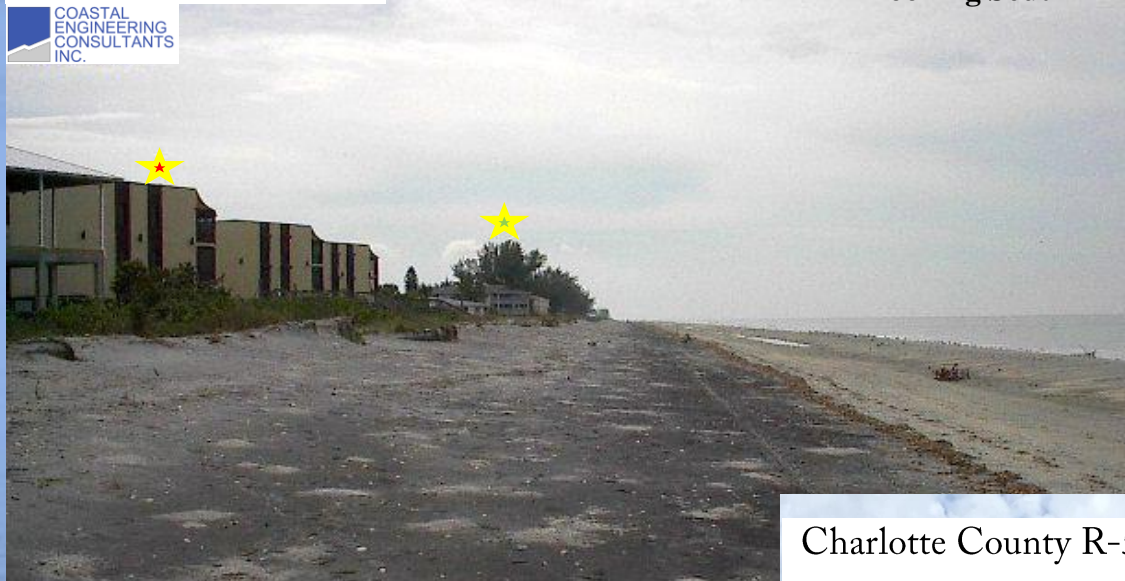
Charlotte County R-5

November 2001
Looking South

2001 Beach
Erosion Study
Conditions

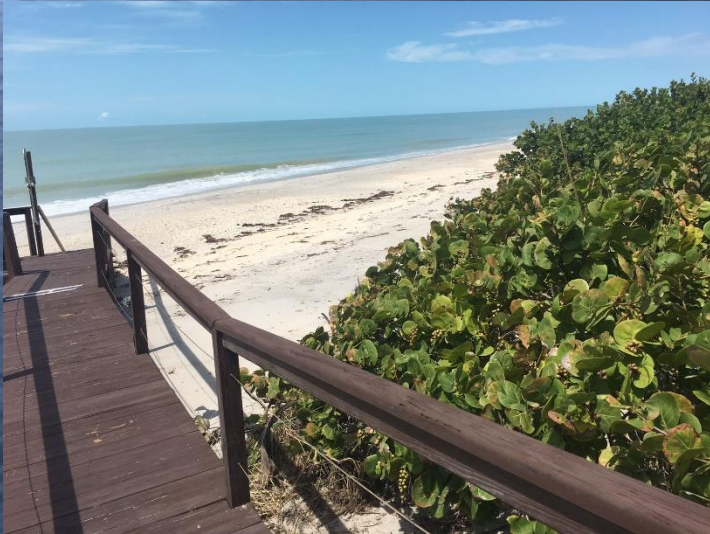
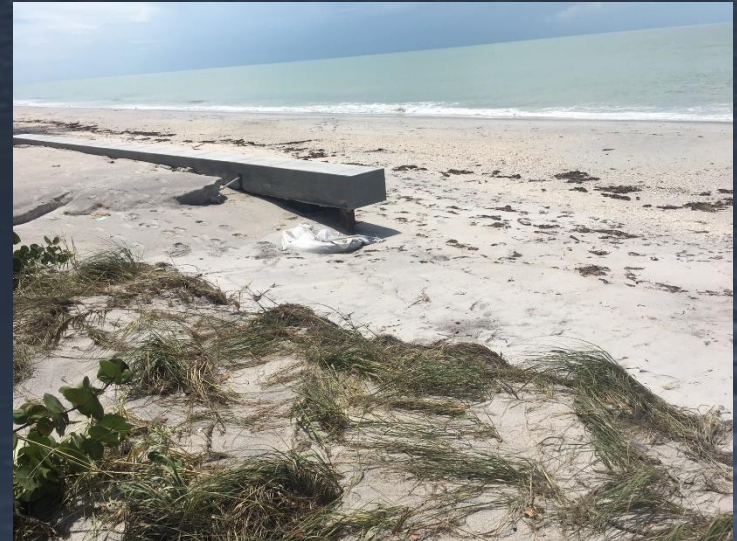
- Some Segments Experienced Erosion While Other Segments Experienced Accretion
- Minor Flanking of Armoring Structures
- No Net Increase in Design Quantities for Restoration Plan

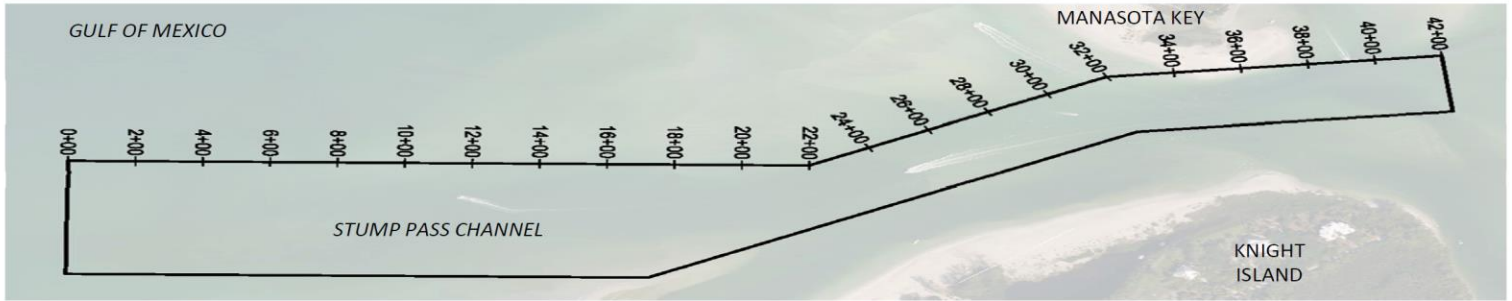
STUMP PASS NAVIGATION CHANNEL

INFILL VOLUME = 36,820 CY
